FIRE DAMAGE EVALUATION AND REPAIR OF PRECAST CONCRETE GARAGE

The evaluation of the extent of damage a concrete structure may have sustained from a fire, as well as the adequacy of affected members to remain in service, involves a systematic assessment of post-fire conditions. This article describes an evaluation of fire damage and subsequent development and implementation of repairs to the Woodlands Waterway Marriot Parking Garage located in Spring, TX.

Woodlands Waterway Marriott Parking Garage Evaluation and Repairs

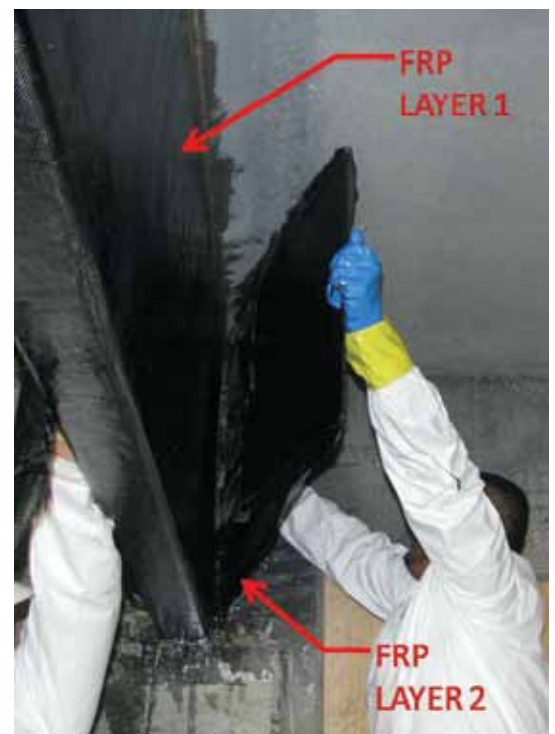
the support. This layer provided the necessary supplemental shear capacity. The upper end of the fabric was extended to within several inches of the flange soffit. In addition to providing the shear capacity, the fabric also served to confine the repair material for the corner spalls. The second layer consisted of a short section of fabric placed at the end of the stem. This layer was oriented in a plan view “U-shaped” configuration such that it extended around the end of the stem (Fig. 3 and 4) and for 3 ft (0.9 m) on each face toward the midspan of the member. The purpose of the second layer was to provide supplemental strength to a localized region of the stem exhibiting more extensive cracking.

1. Patch materials along the stem corners were allowed to cure, and cracks 0.01 in. (0.3 mm) and wider were epoxy injected.
2. Surface preparation was specified to achieve a texture equivalent to ICRI Concrete Surface Profile (CSP) 3. Corners at the end of the stems were ground to eliminate sharp edges.
3. Initial cutting of the FRP material was performed in the presence of the fabric manufacturer.
4. A solvent was applied to the concrete surface immediately prior to epoxy adhesive application.
5. The FRP material was saturated in the epoxy adhesive.
6. After allowing the solvent to flash off the concrete surface, the epoxy adhesive was applied to the concrete surface and allowed to set for several minutes.

7. The first layer of FRP was installed and pressed into place.
8. The second layer of FRP was installed immediately after the first layer. Epoxy adhesive was applied to the end of the stem prior to the application of the second layer. Due to the tight gap between the end of the stem and the face of the wall, a sacrificial FRP extension wrapped on a piece of cardboard was used to facilitate pulling the FRP around the end of the stem.
9. All repaired areas were painted with acrylic-latex coating.
