NEW YORK HALL OF SCIENCE GREAT HALL RESTORATION

BY ASIM JABBAR AND JEFF BINDER

New York Hall of Science Great Hall

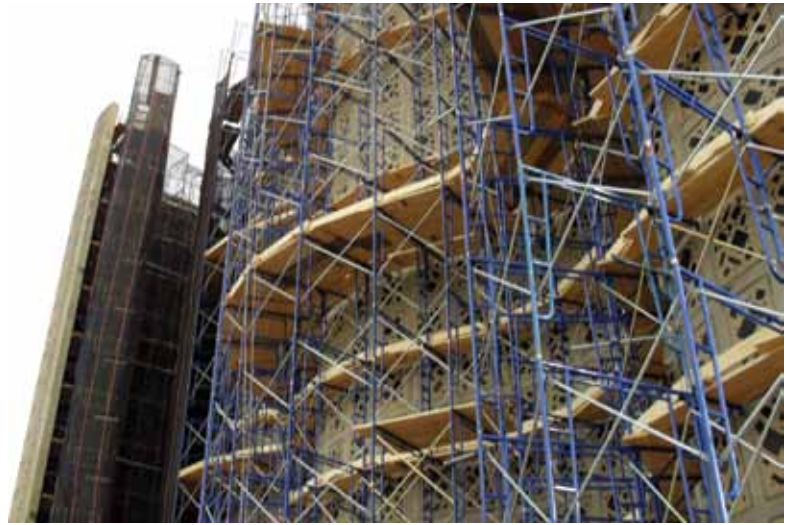
Because of the abnormal shape of the building, the scaffolding frames were kept a few feet away from the building and outriggers were used to butt up against the building

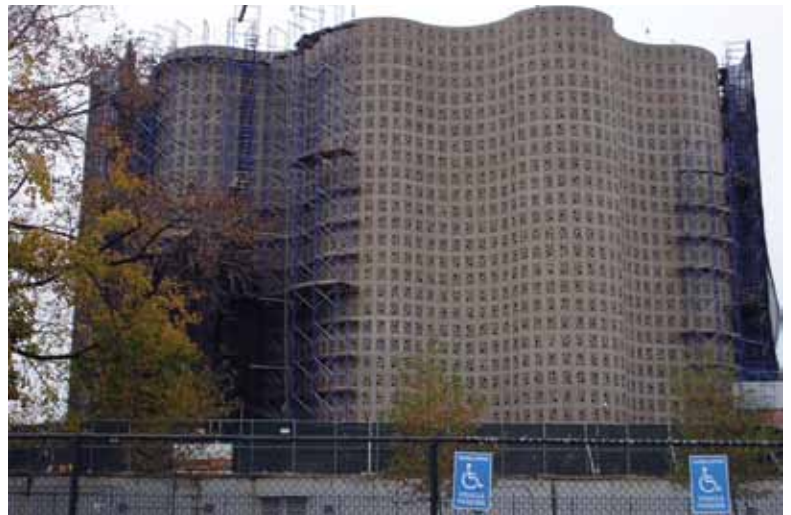
Fencing was installed around the perimeter of the structure; areas outside, however, were open to visitors and constant monitoring was required to ensure their safety
