# RETROFITTING HIGH-RISE STRUCTURES USING FRP COMPOSITE MATERIALS

BY DAVID WHITE

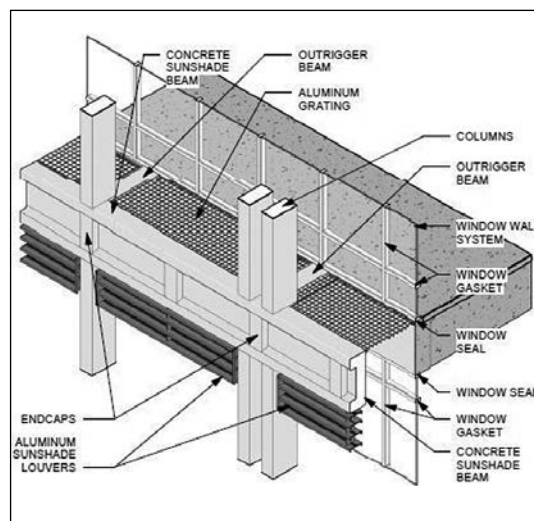
Fig. 2: Isometric view at midlevels on north and south building façades (Diagram courtesy of Johnston, LLC Architects, Houston, TX)

In addition, a series of FRP repairs were made to repair and strengthen the building façade and the sunshade and outrigger beams. A unidirectional carbon fiber-reinforced polymer (CFRP) fabric was installed longitudinally along the flanges of the sunshade beams. A  $\pm 45$ -degree, double-bias CFRP fabric was installed on both faces of the web to provide shear reinforcement and intersect the pre-existing cracks (Fig. 4). This same fabric was also used on the outrigger beams for added stability at the corners (Fig. 5). Once the FRP repairs were completed, an elastomeric, anti-carbonation coating was installed over the entire façade to provide protection against the elements and for improved aesthetics (Fig. 1).
