HIBERNIA BANK BUILDING

SAN FRANCISCO, CALIFORNIA

SUBMITTED BY SIKA CORPORATION

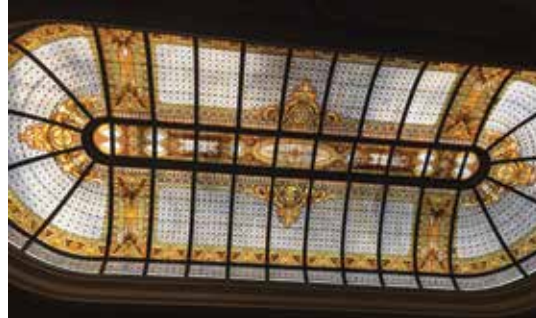
Fig. 3: Tiffany-style skylight over main banking hall

blocks and brick masonry which surround a huge interior banking hall. Riveted steel trusses that span over the banking hall support a thin lightly reinforced concrete roof slab that has large openings for historic stained glass skylights (Fig. 3) that amazingly remain intact to this day.

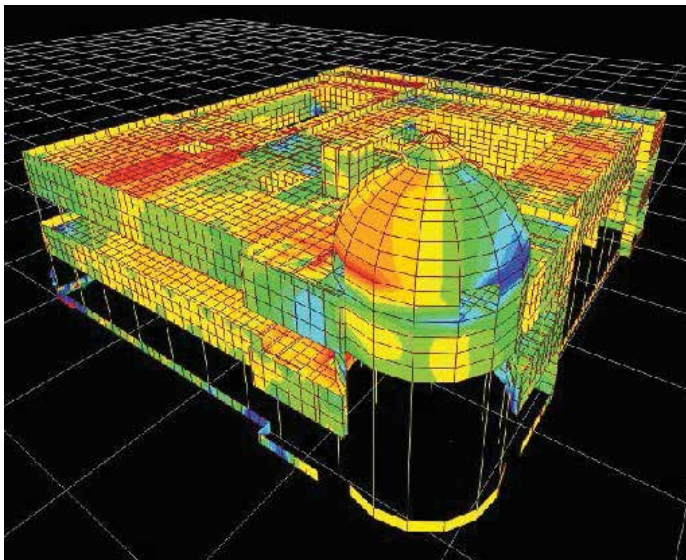
Fig. 4: SAP finite elements analysis

Limited, 3D non-linear analysis using SAP software was also performed at the building. Non-linear gap elements were incorporated, allowing modeling of uplift/rocking of the piers and walls at their base or at the soil-structure interface.
