April 5, 2022
ICRI 2022 Spring Convention

Case Study – Precast Concrete Louver Repairs

Christopher Kottra
Principal
Building Technology Consultants, Inc.

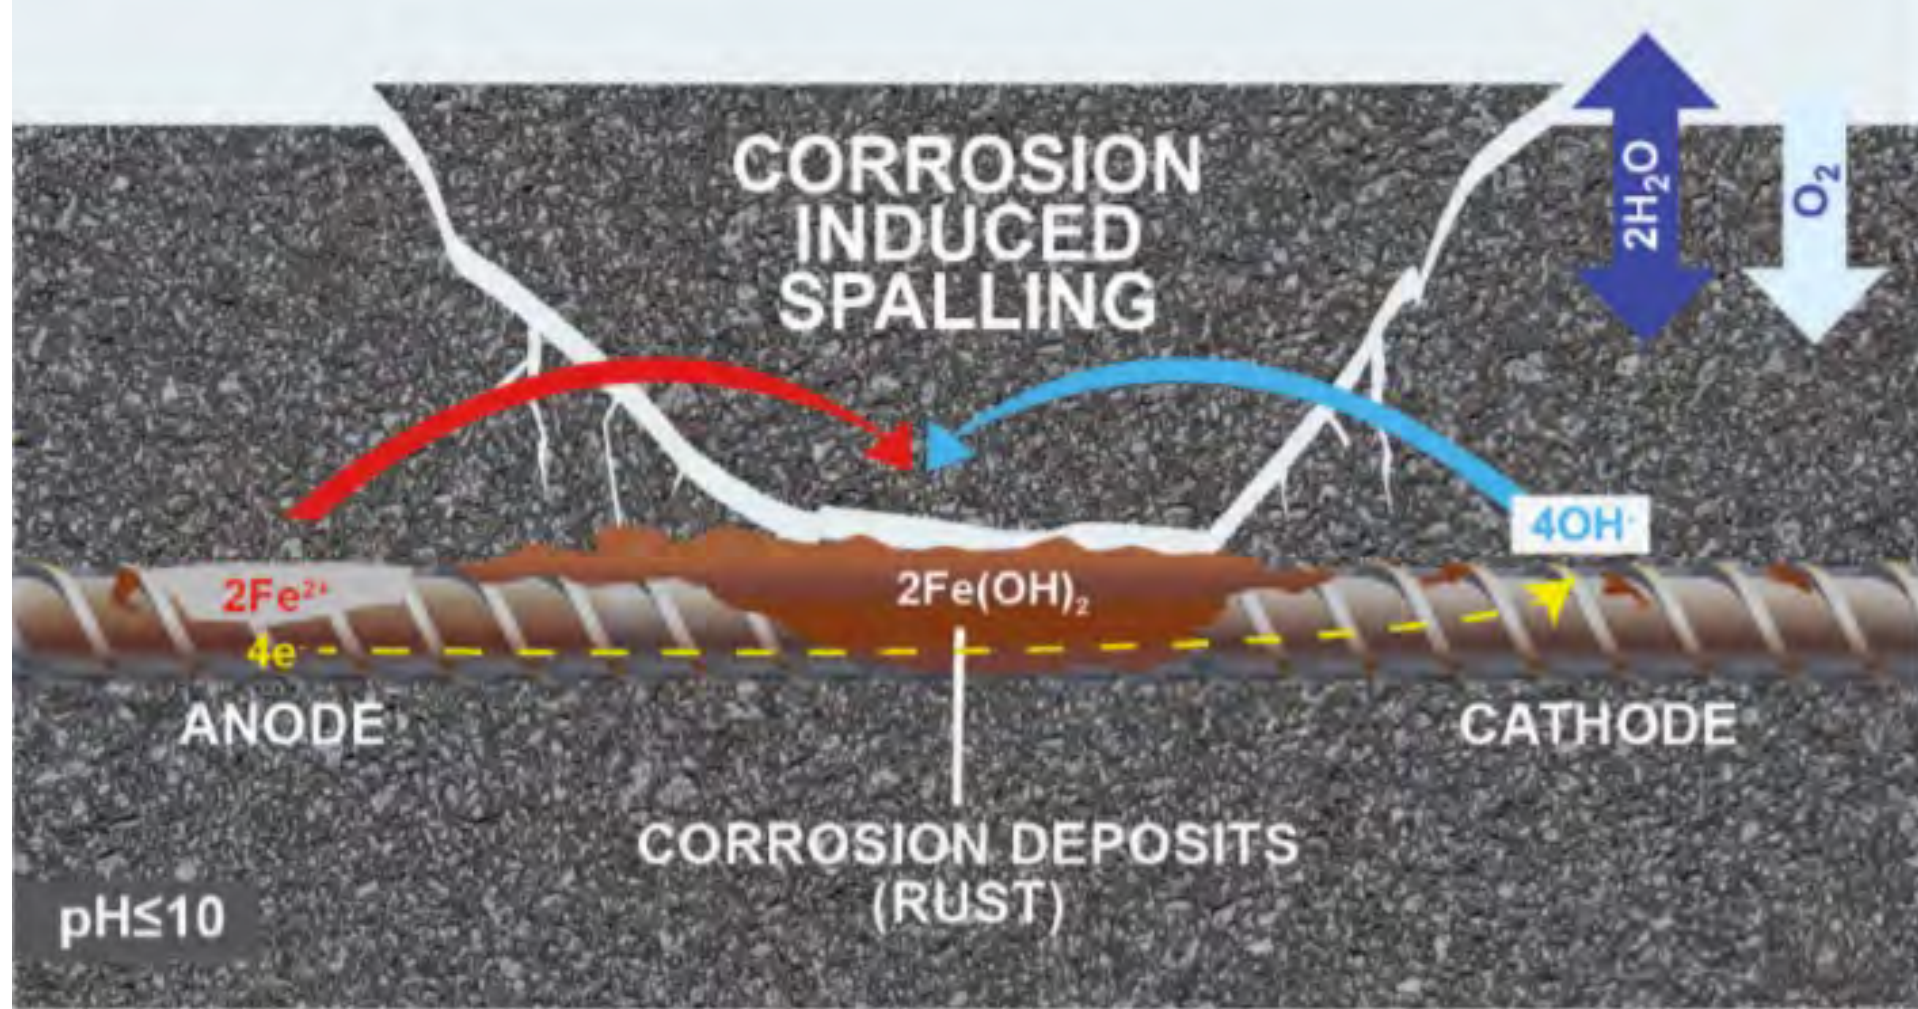
Figure A

Ring Anode Effect (Halo Effect)

- Accelerated corrosion of reinforcing around patches
- Occurs when patch properties are different than surrounding concrete
 - Conductivity
 - pH
 - Permeability (moisture)

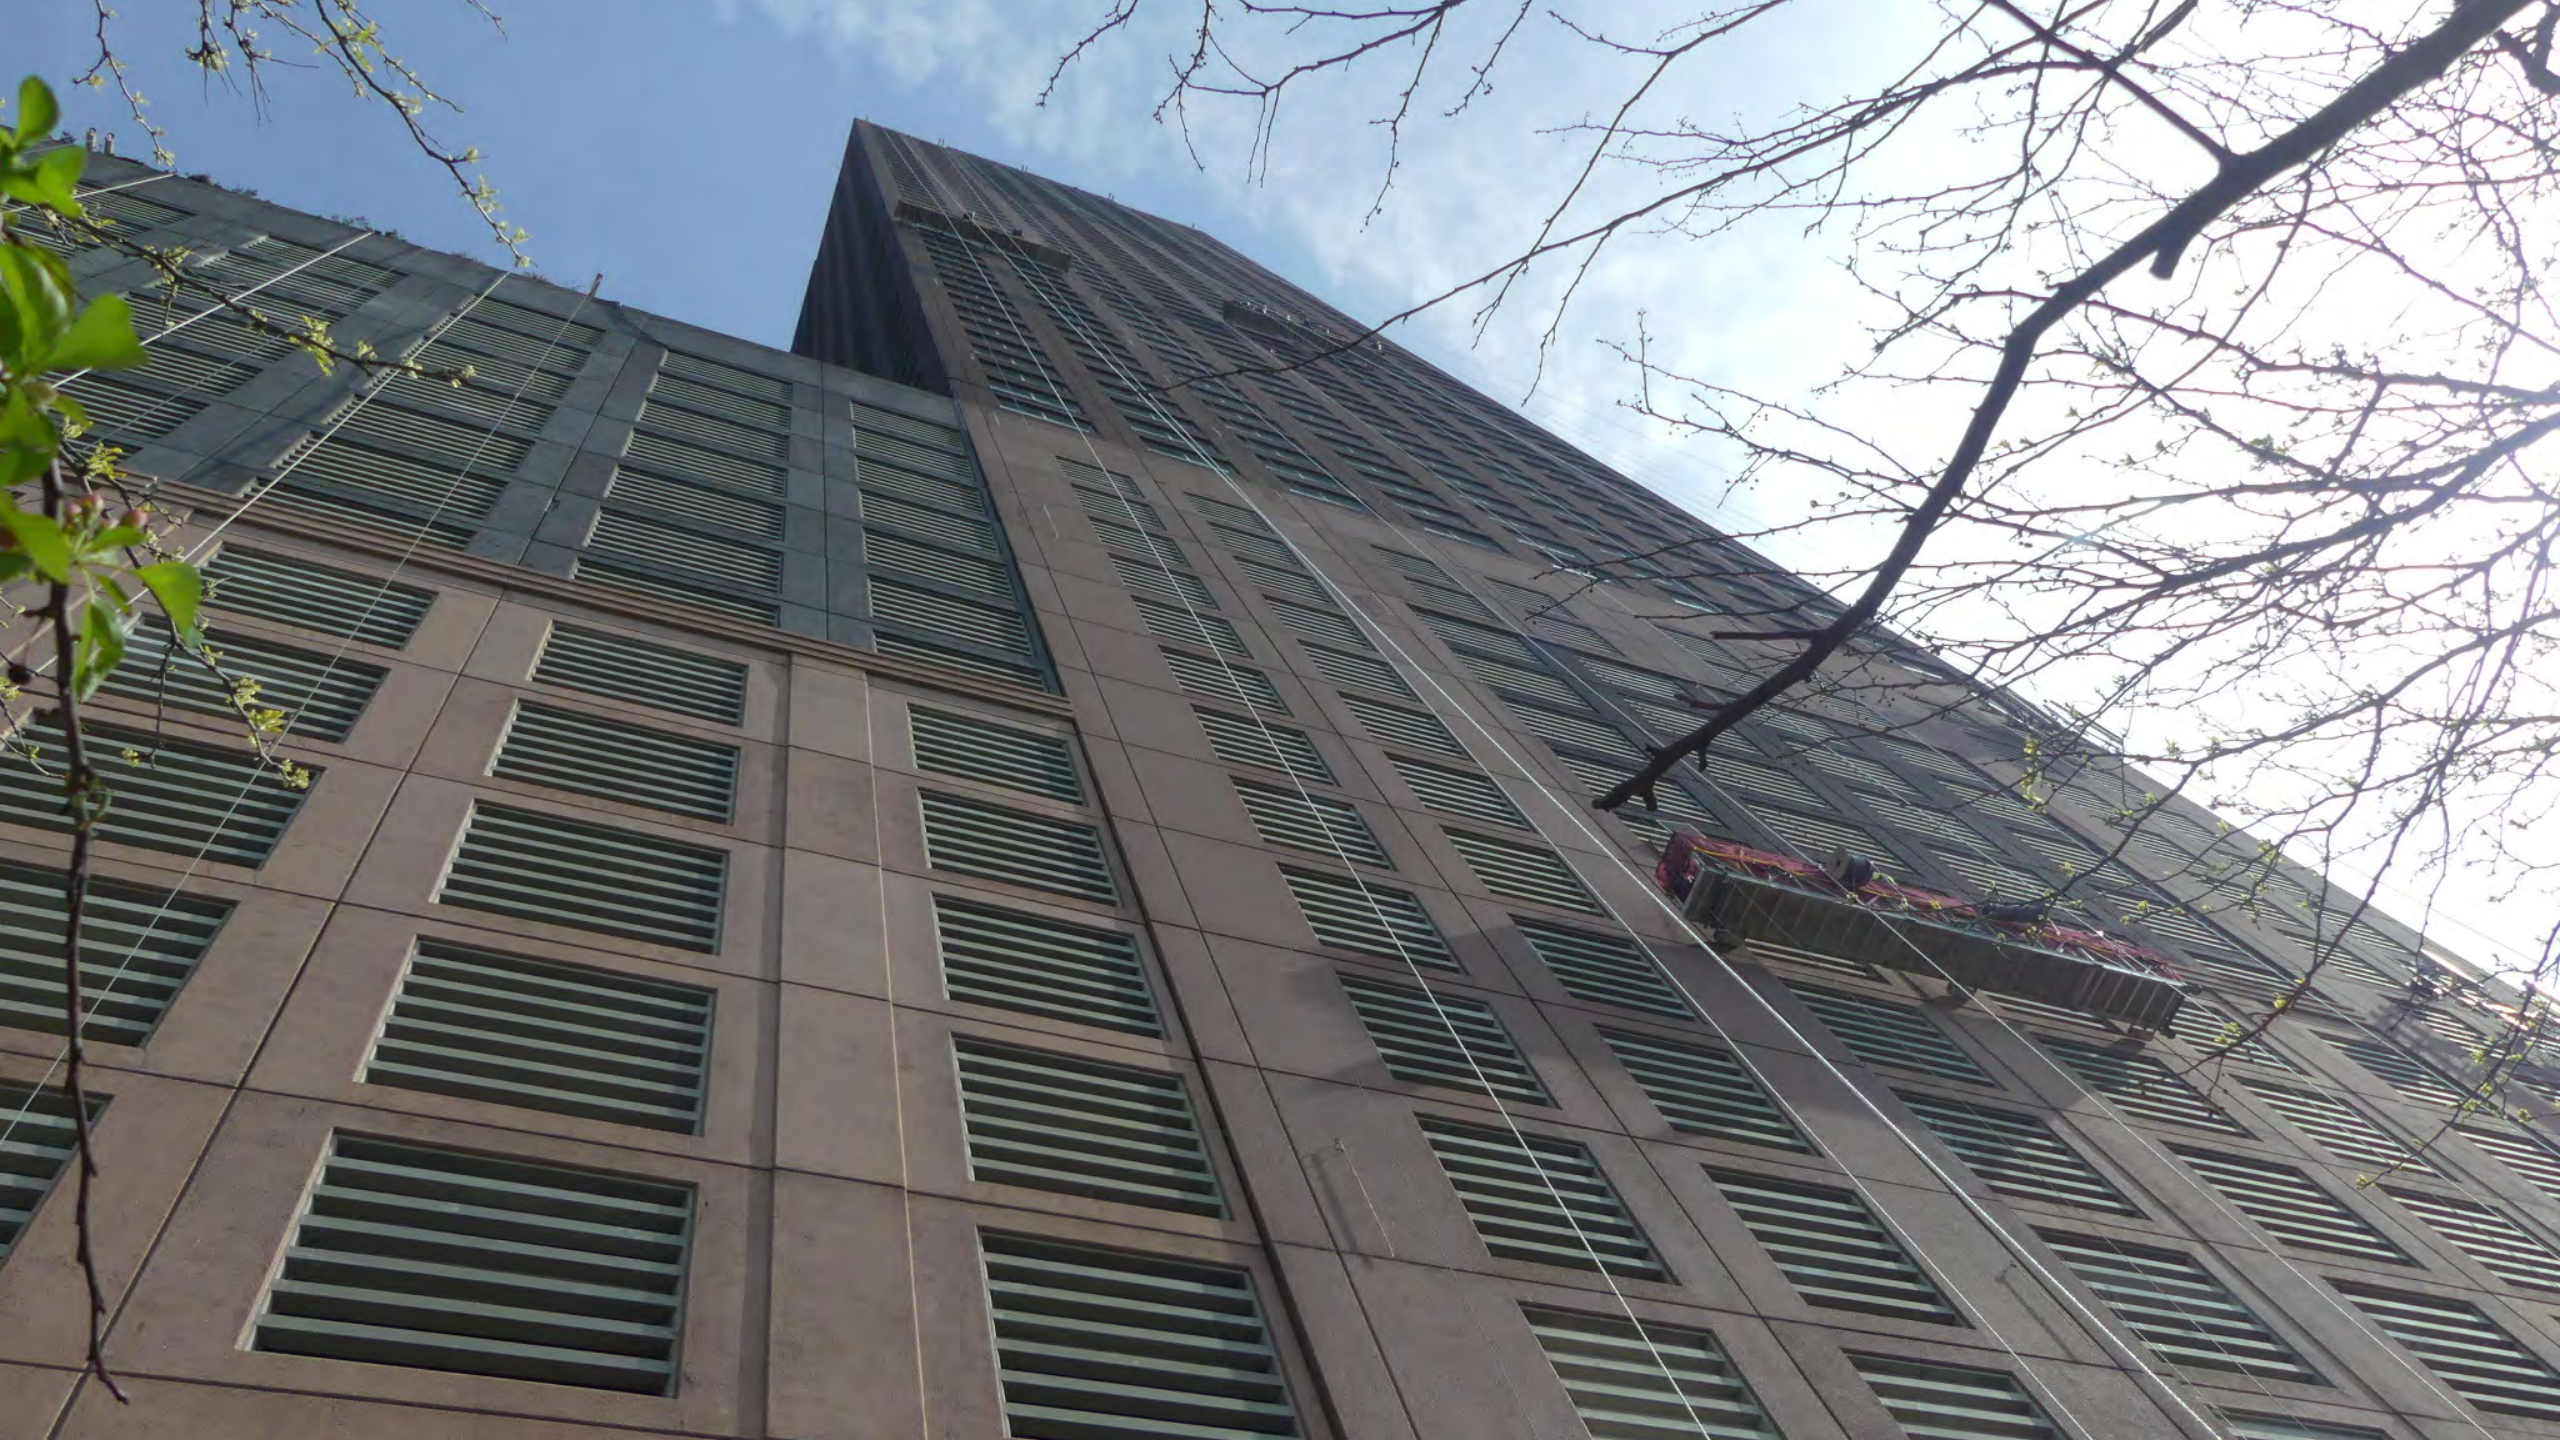
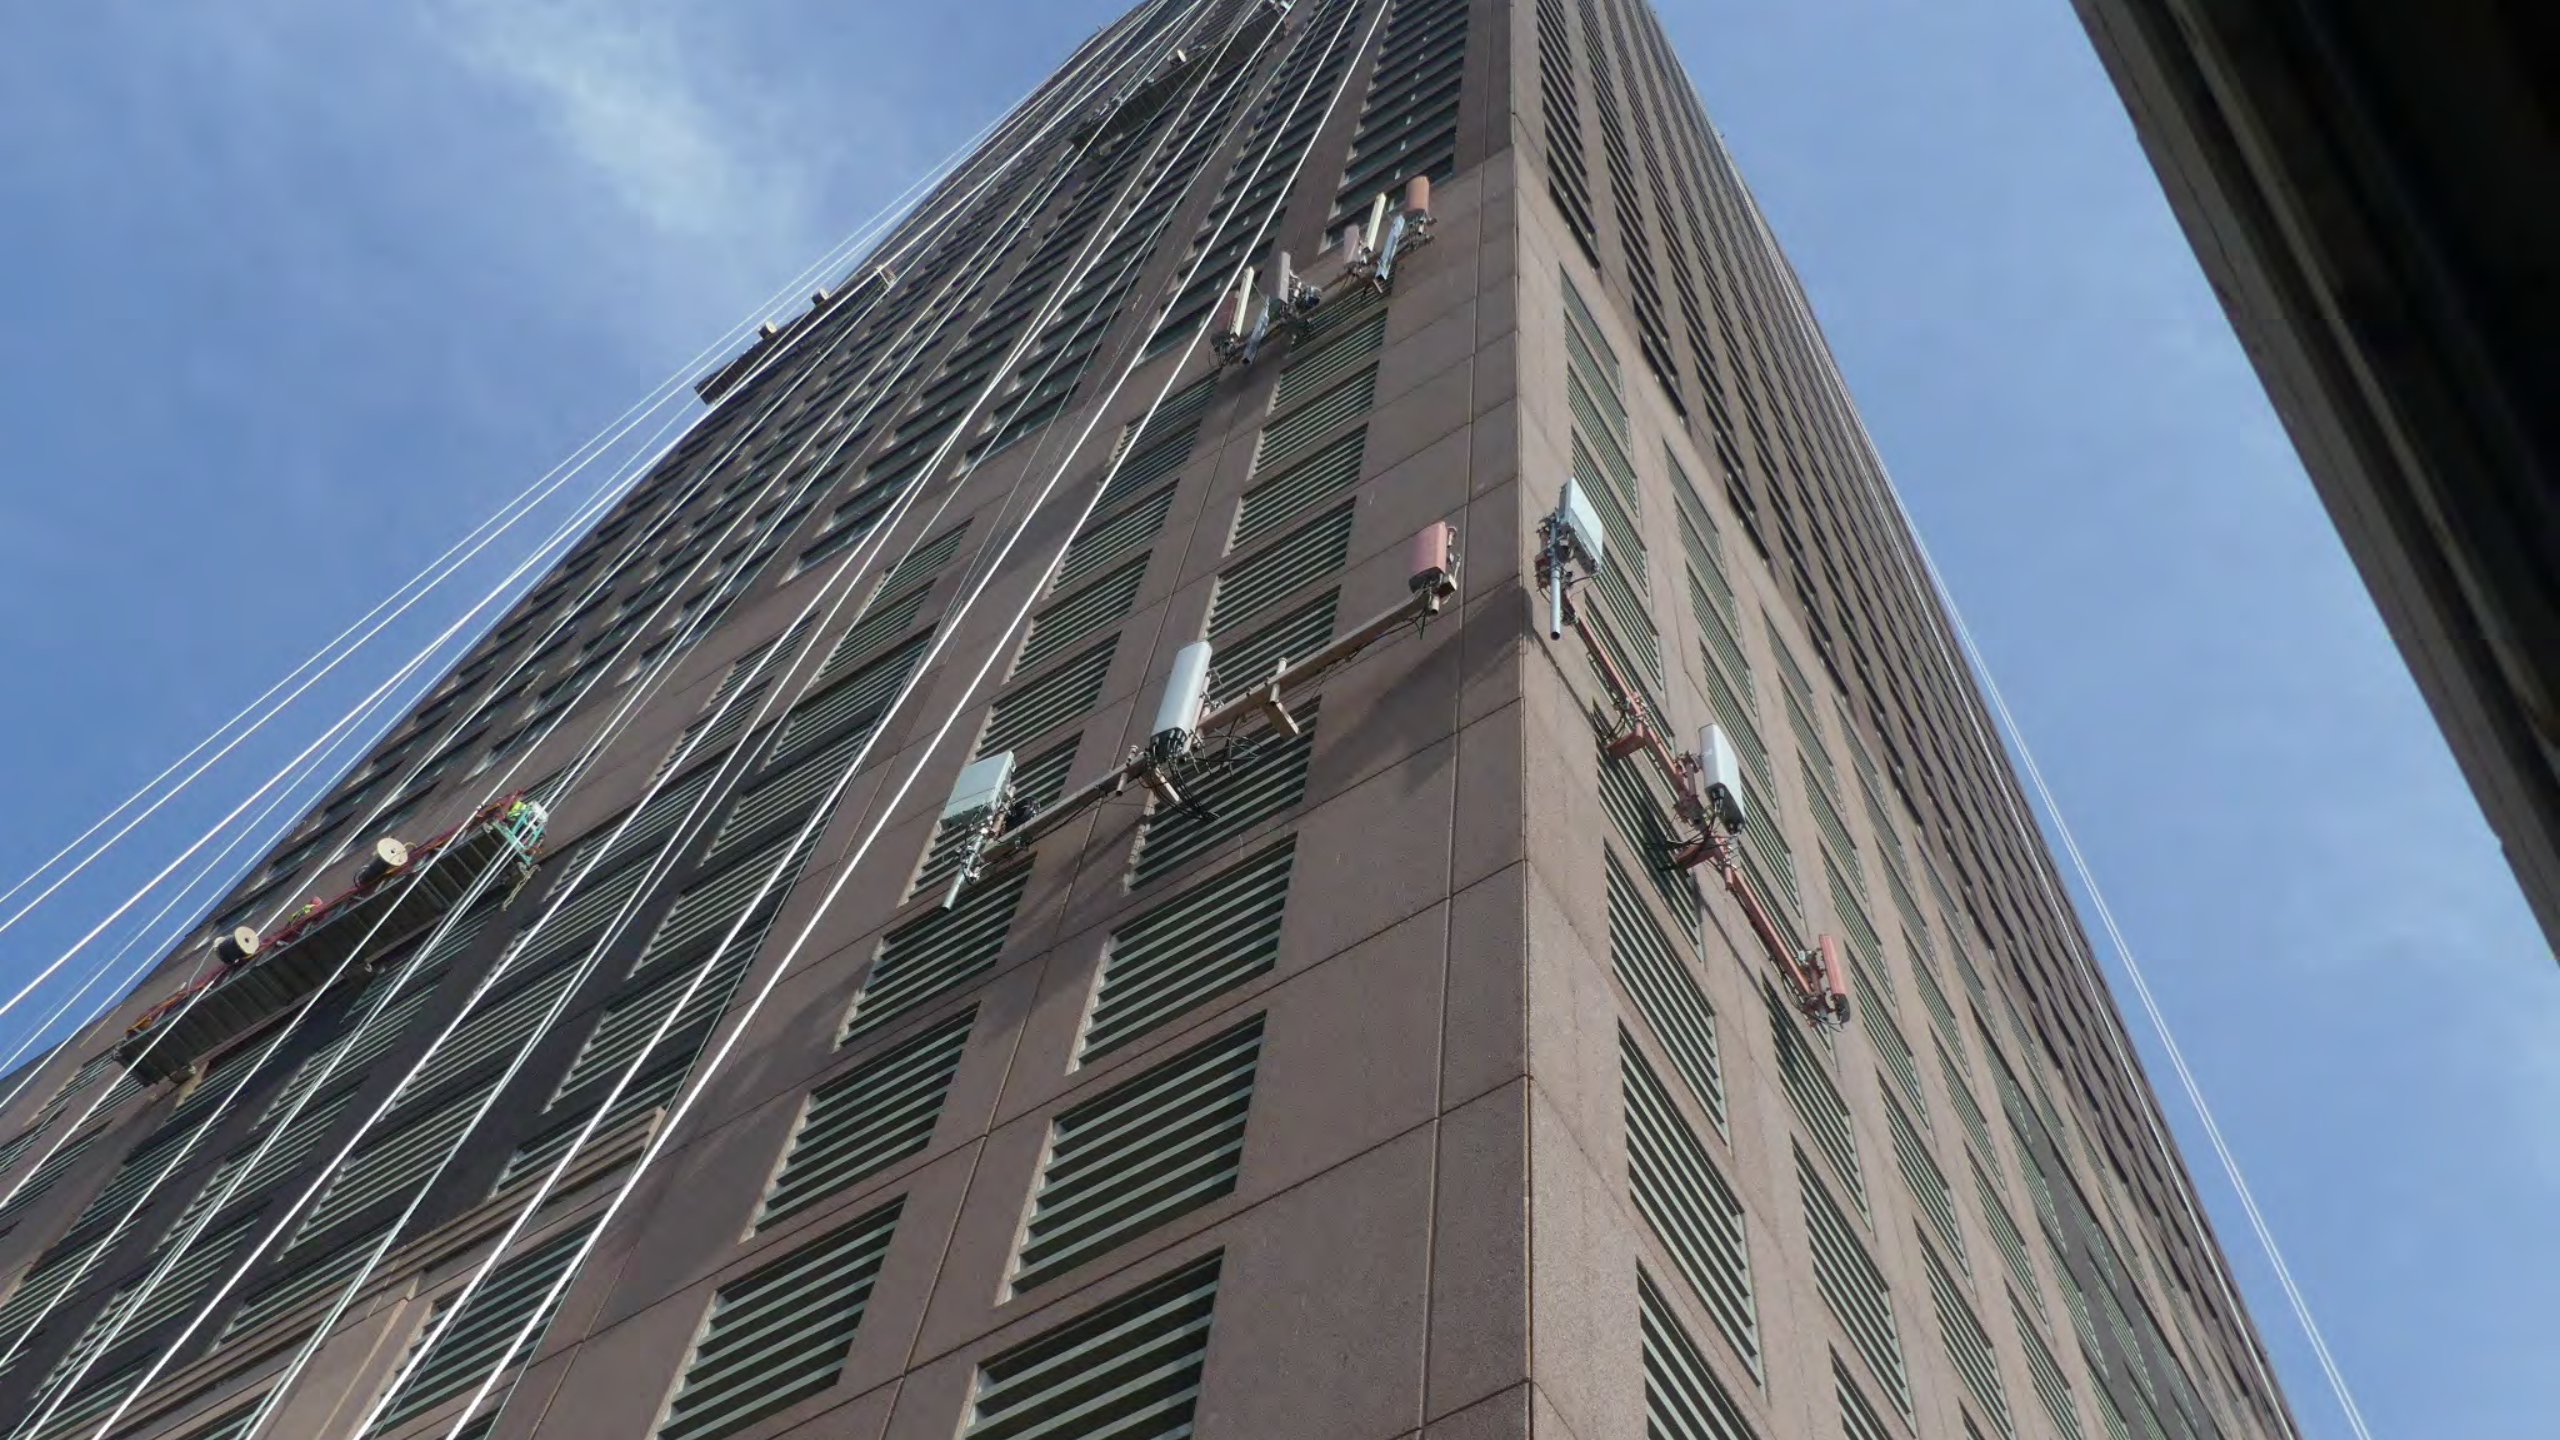
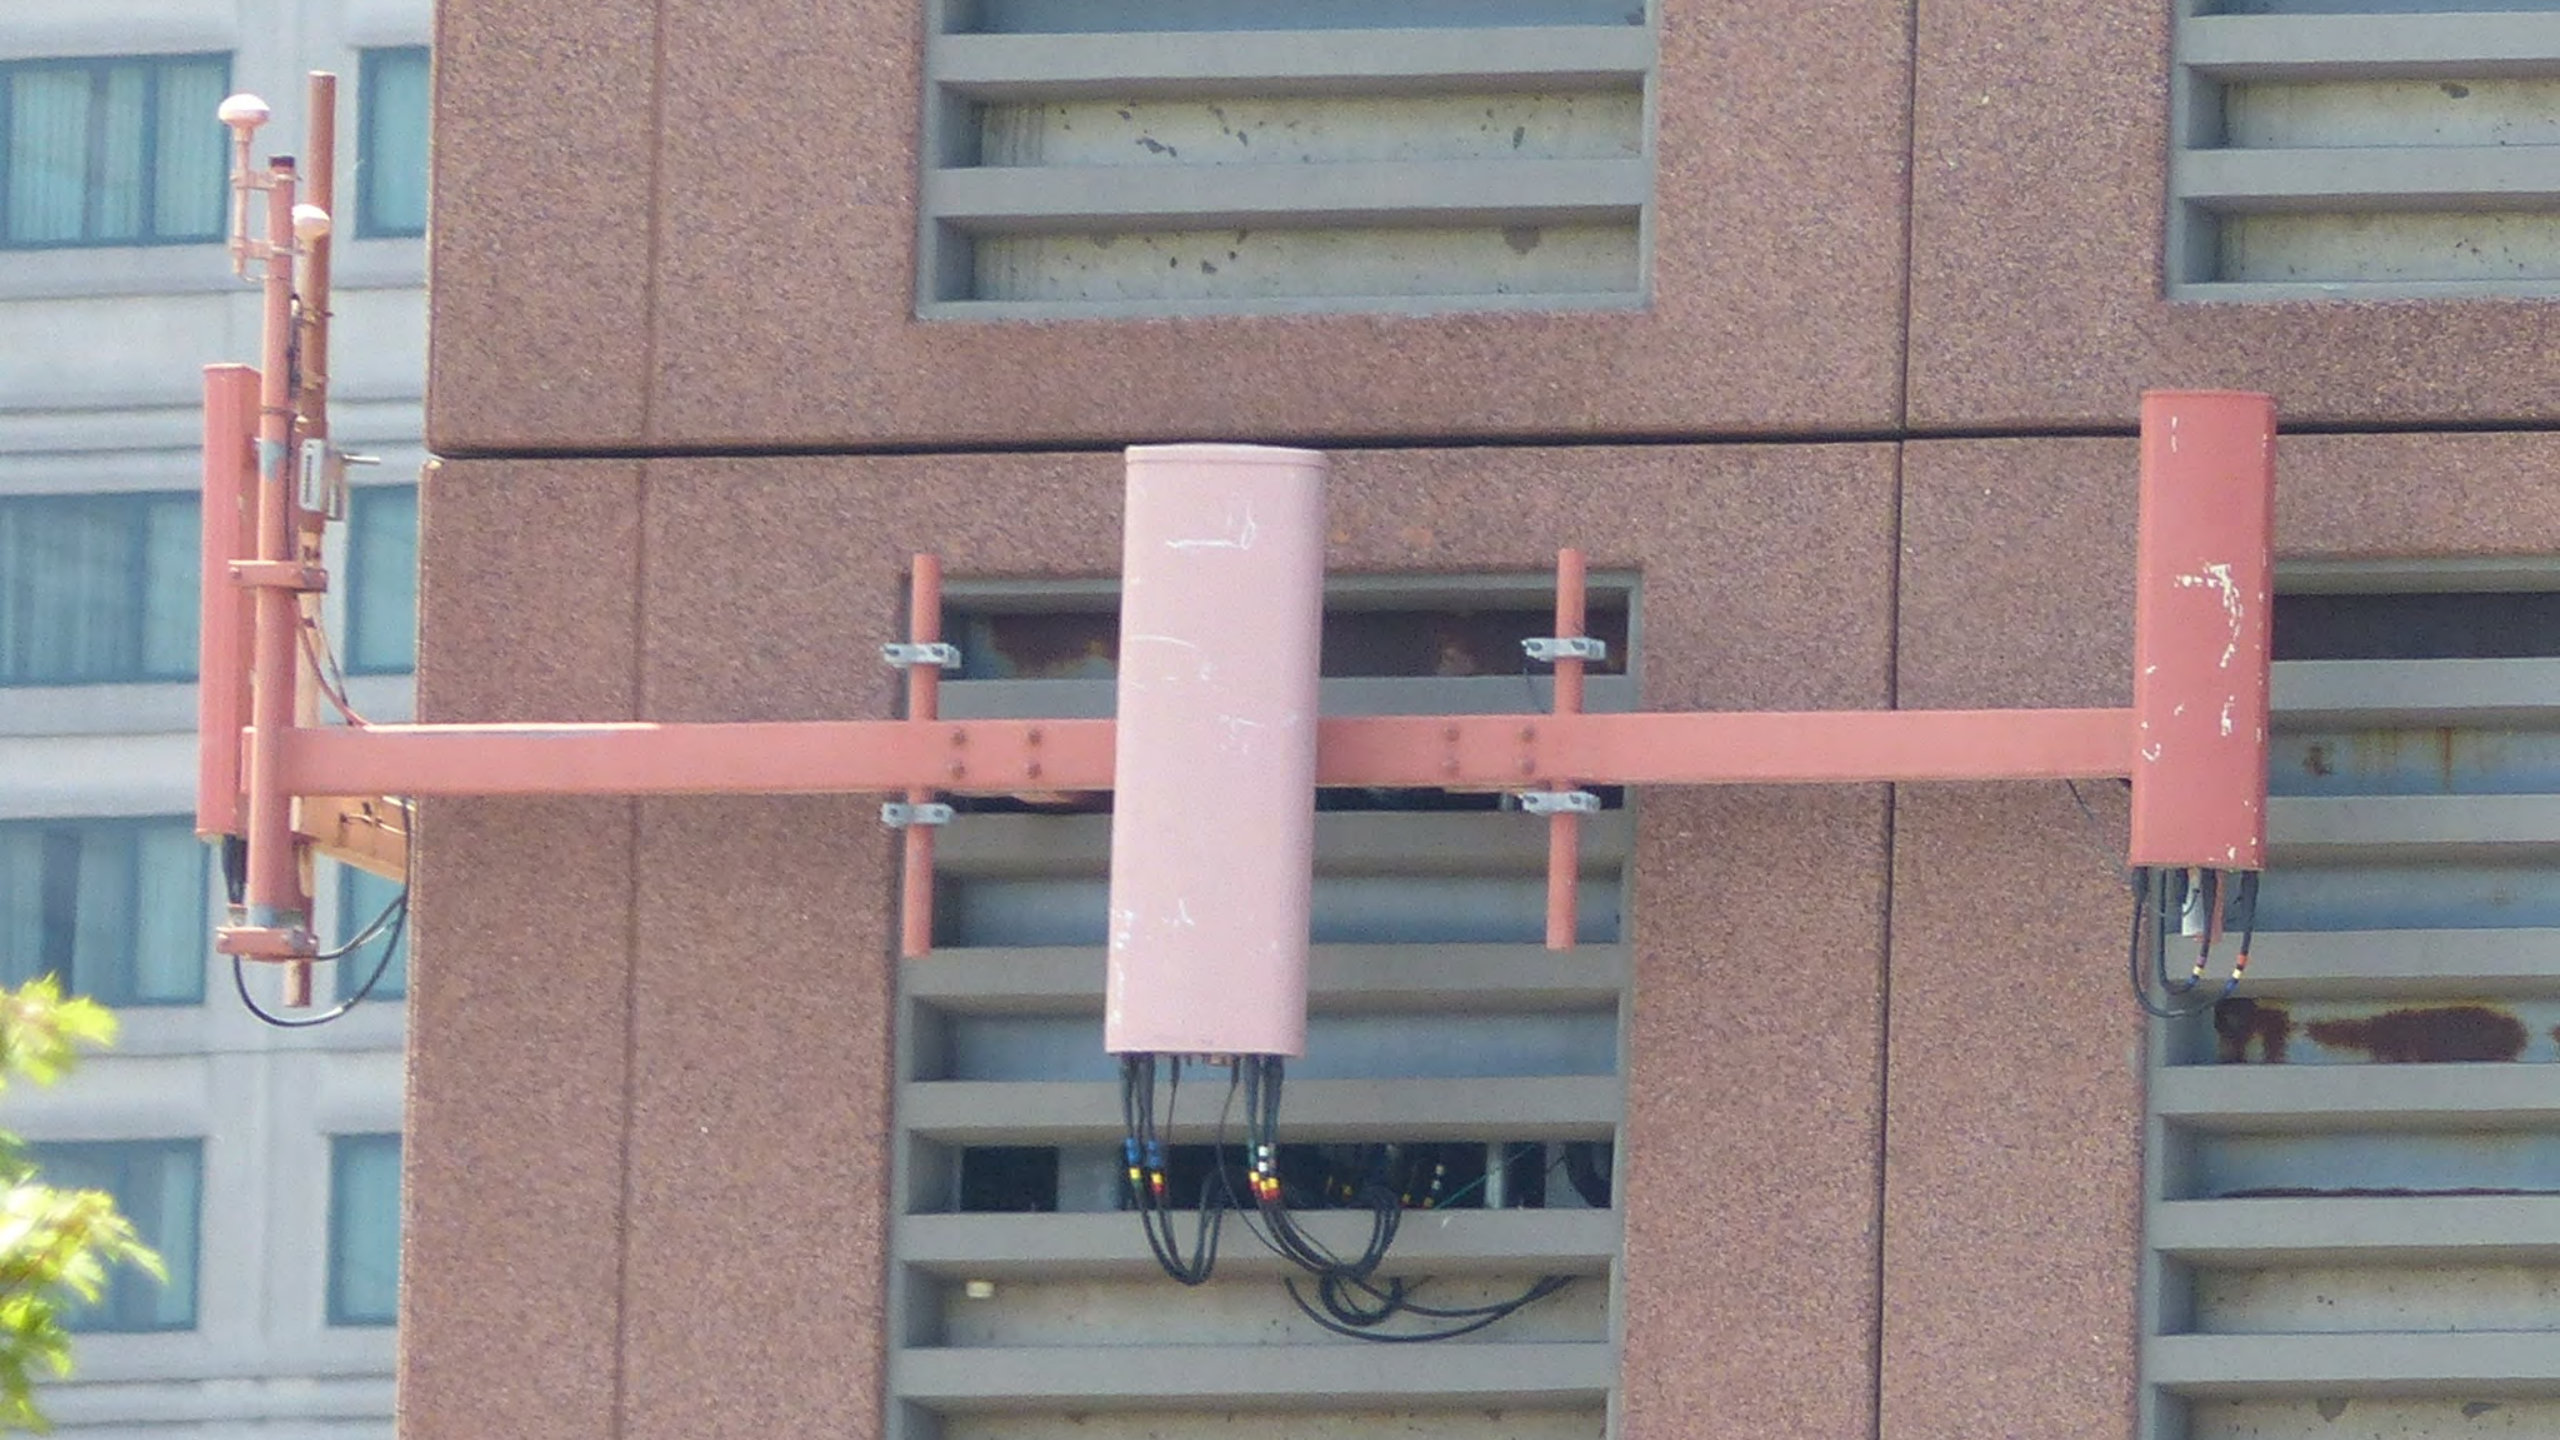
- Logistical challenges early on:
 - Longer lead-time for replacement louvers
 - Access around wall-mounted cellular equipment
- Contractor ran 8 swingstages
- Flexibility in daily work
