April 5<sup>th</sup>, 2022  
ICRI 2022 Spring Convention

# Petrographic Analysis of Precipitation-Damaged Freshly Placed Concrete

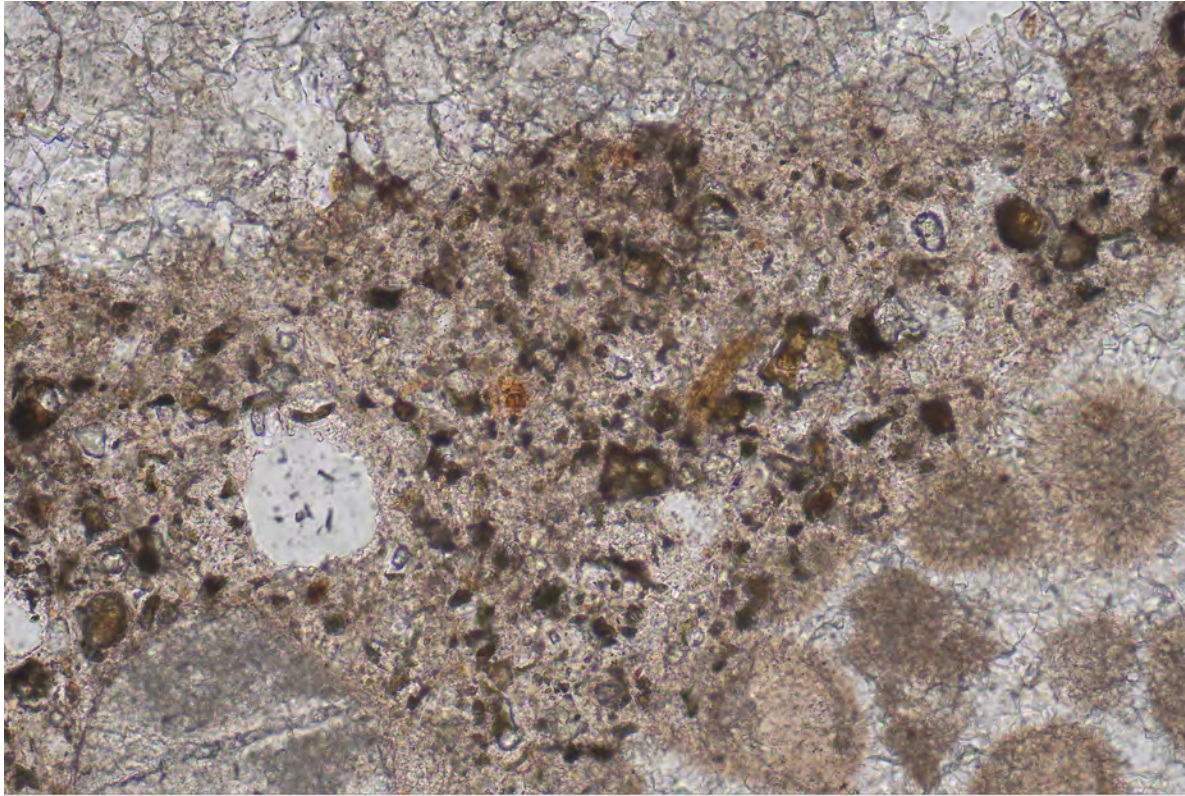
**Moderate w/cm**

- Detailed assessment; high magnification
- Composition of the cementitious paste, estimate w/cm (see photos above), detailed examination of microcracks, determine potential causes of distress.

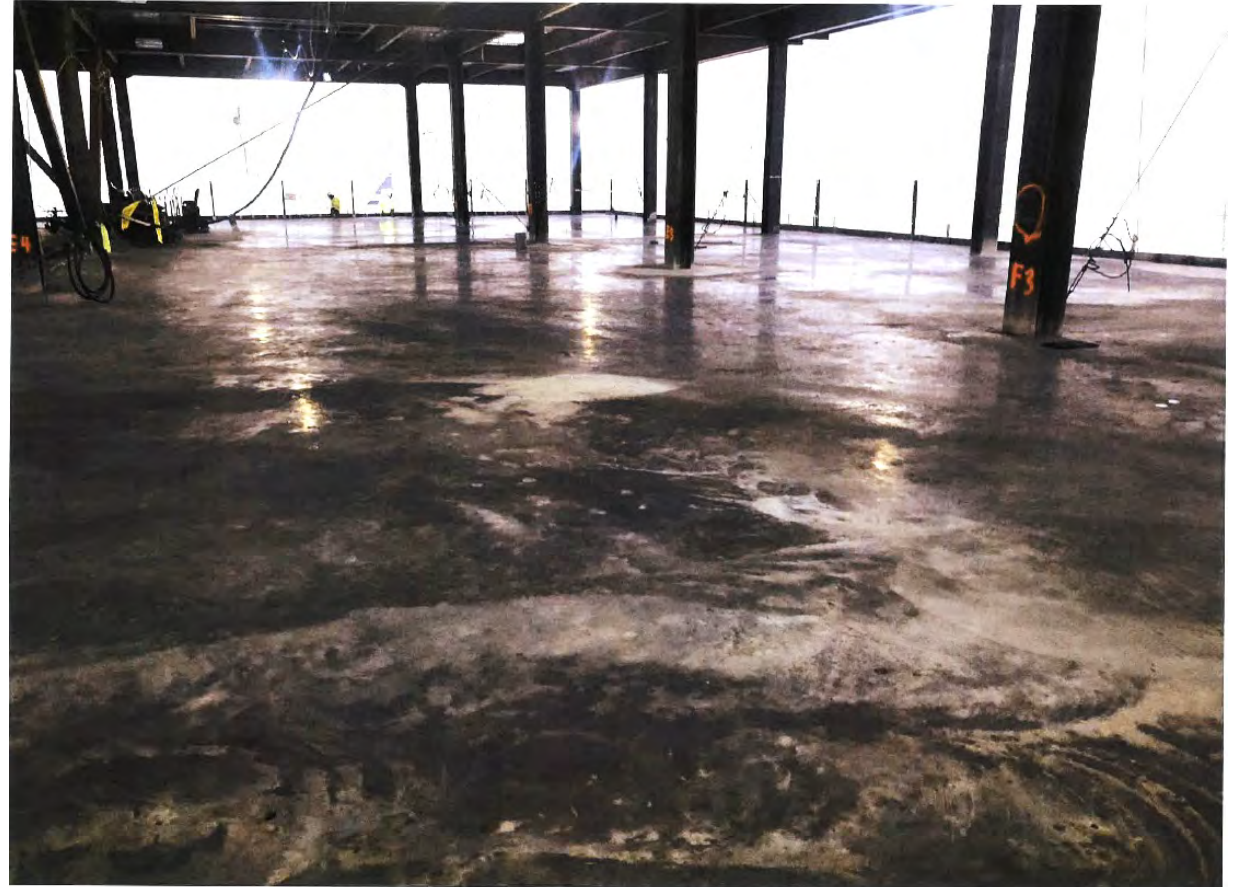
- First level cast-in-place concrete slab on metal deck
  - Placed in February 2021.
  - Mix design – 5,000 psi, 0.40 w/cm, 6.5% air content, normal weight.
  - Concrete cylinder QC testing indicated 28-day strength >5,000.

- Exposed to water dripping from melting snow on metal decks above during placing and finishing
- Pitting, scaling, etc. observed mid-February during site inspection.

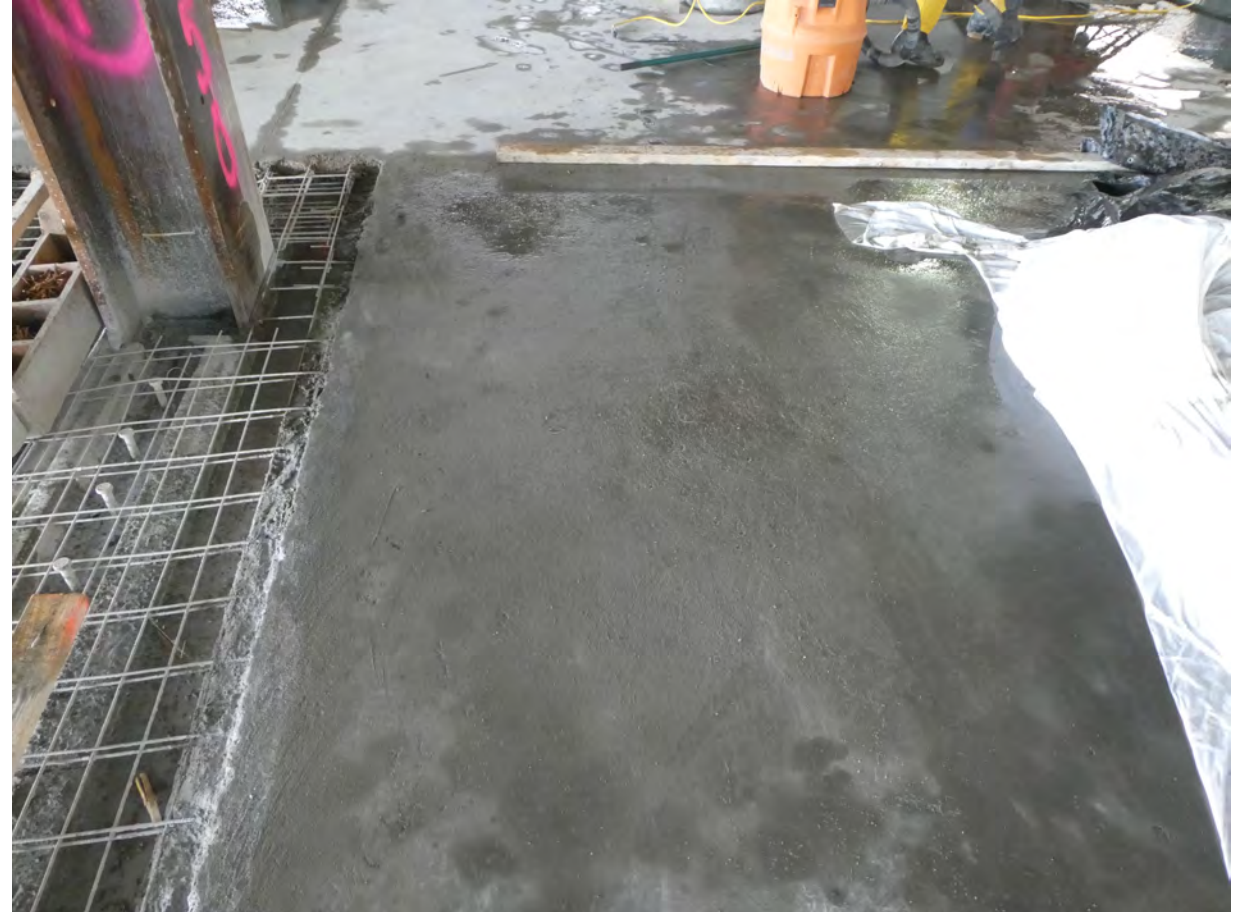
- Cast-in-place concrete slab on metal deck; 4000 psi , 0.45 w/cm, lightweight.
- Snow on roof deck melted and fell ~30 feet onto the slab, eroding parts of the surface.
- Contractor stopped finishing operations (hard troweling), waited for it to stop, removed excess water, and completed finishing operations.
- The Owner directed the Contractor to demolish and replace the worst areas and investigate the remaining portions.
