# **CONFIGURATION**

# REINFORCED CONCRETE BRIDGE DECK Nominally 200 mm thick; Waterproofing membrane was originally • 50 mm asphalt pavement installed; overlay; Removed in 1982 and asbestos-modified asphalt overlay placed; CONCRETE REPAIR

# DO-MINIMUM REHABILITATION PROJECT

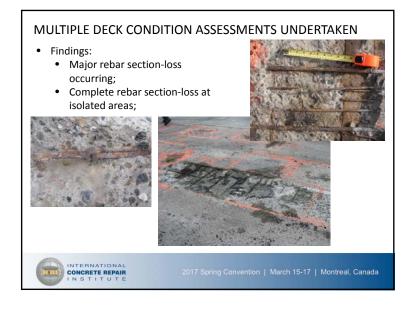
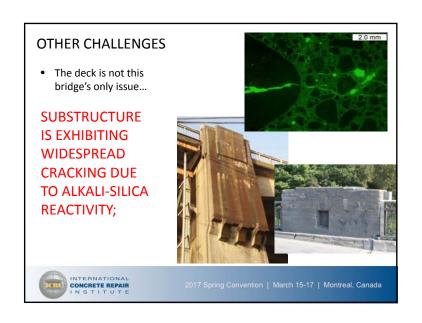
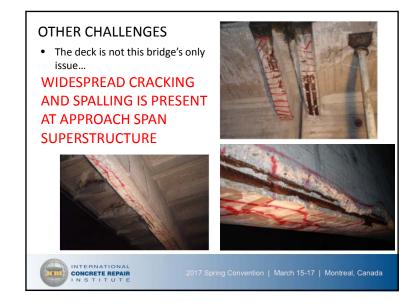
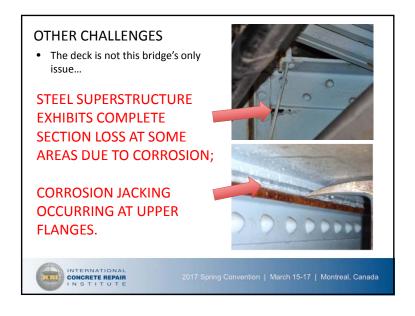
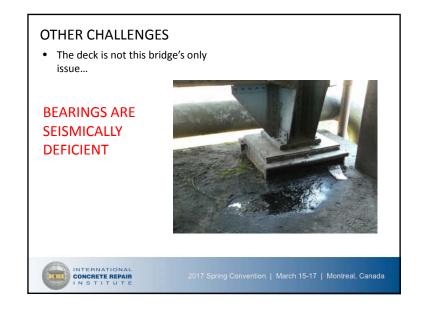
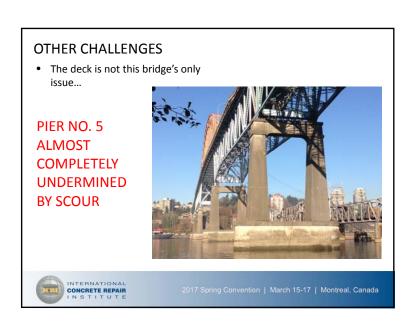
# MULTIPLE DECK CONDITION ASSESSMENTS UNDERTAKEN • Findings: • Widespread delaminations; • Up to 32% in some spans; • Major soffit spalling at steel truss spans; • Major soffit spalling at steel truss spans;
