October 11, 2021
ICRI 2021 Fall Convention

Evaluation of Chemical Attack to a Semi-Elliptical Concrete Conduit

Timothy M. Montgomery
Structural Engineer VI
CDM Smith Inc.

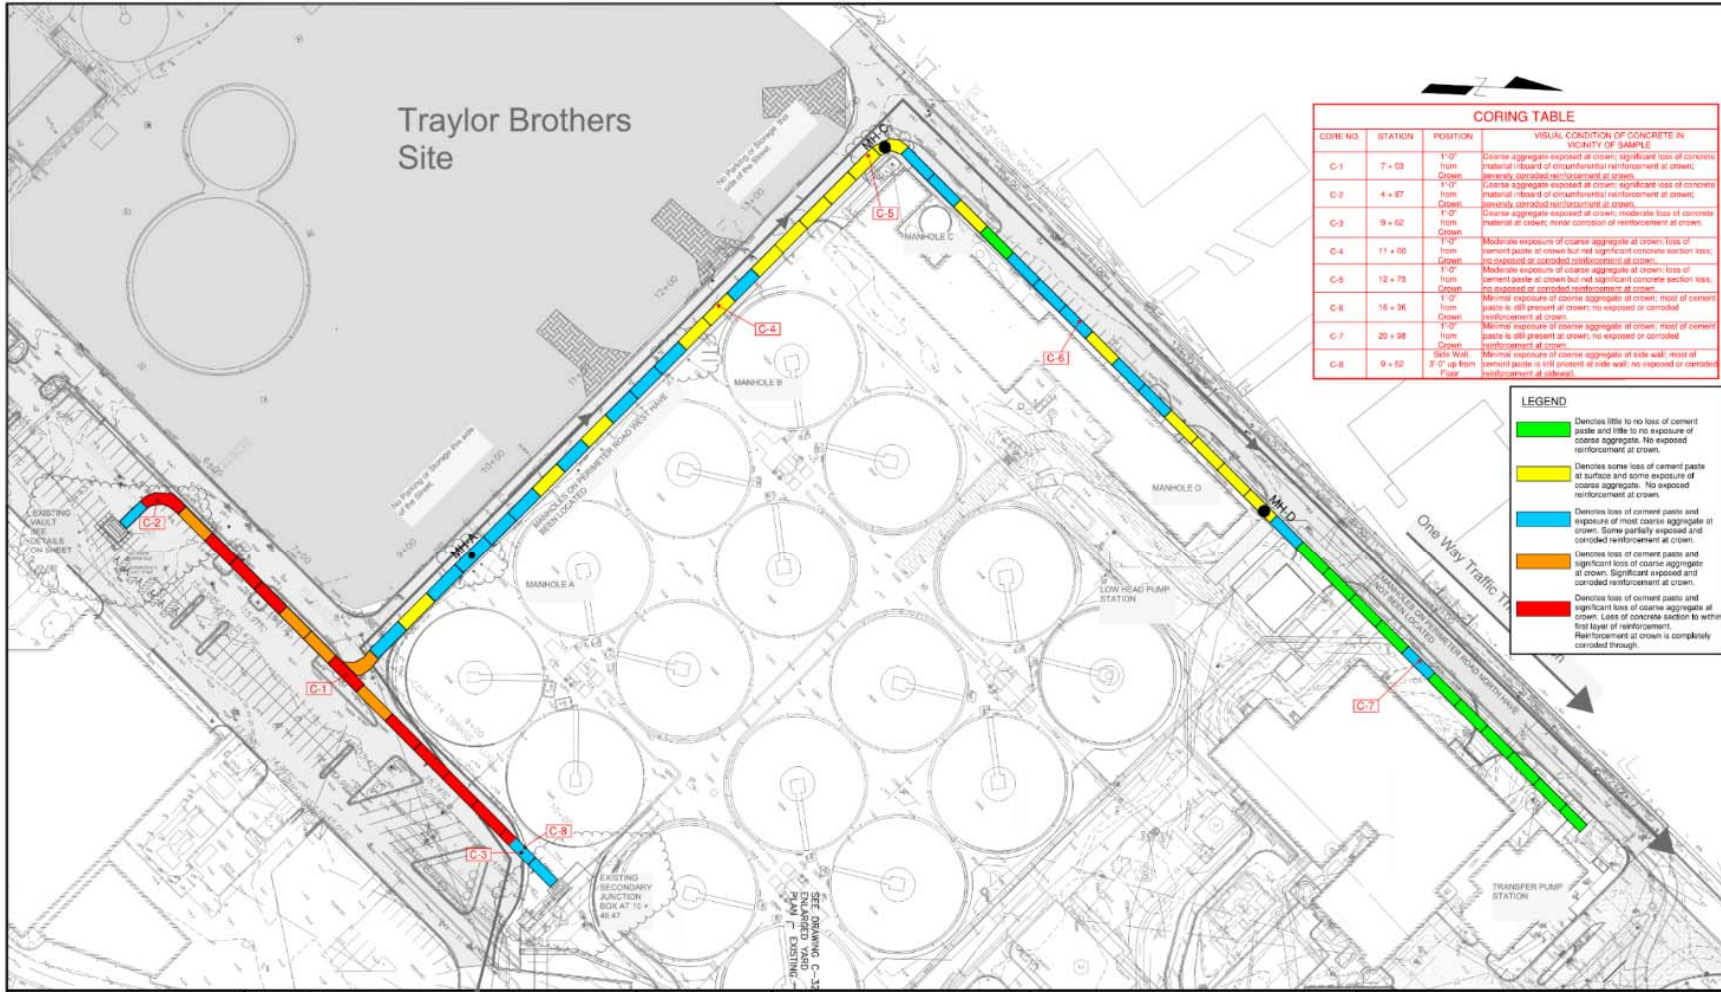
CONCRETE REPAIR PLAN

CORING TABLE			
CORRE NO.	STATION	POSITION	VISUAL CONDITION OF CONCRETE IN VICINITY OF SAMPLE
C-1	7 + 03	1'-0" from Crown	Coarse aggregate exposed at crown; significant loss of concrete material inboard of circumferential reinforcement at crown; generally corroded reinforcement at crown.
C-2	4 + 47	1'-0" from Crown	Coarse aggregate exposed at crown; significant loss of concrete material inboard of circumferential reinforcement at crown; generally corroded reinforcement at crown.
C-3	9 + 02	1'-0" from Crown	Coarse aggregate exposed at crown; moderate loss of concrete material at crown; minor corrosion of reinforcement at crown.
C-4	11 + 05	1'-0" from Crown	Moderate exposure of coarse aggregate at crown; loss of cement paste at crown but not significant concrete section loss; no exposed or corroded reinforcement at crown.
C-5	12 + 75	1'-0" from Crown	Moderate exposure of coarse aggregate at crown; loss of cement paste at crown but not significant concrete section loss; no exposed or corroded reinforcement at crown.

C-6	16 + 36	1'-0" from Crown	Minimal exposure of coarse aggregate at crown; most of cement paste is still present at crown; no exposed or corroded reinforcement at crown.
C-7	20 + 98	1'-0" from Crown	Minimal exposure of coarse aggregate at crown; most of cement paste is still present at crown; no exposed or corroded reinforcement at crown.
C-8	9 + 63	Side Wall 3'-0" up from Floor	Minimal exposure of coarse aggregate at side wall; most of cement paste is still present at side wall; no exposed or corroded reinforcement at side wall.

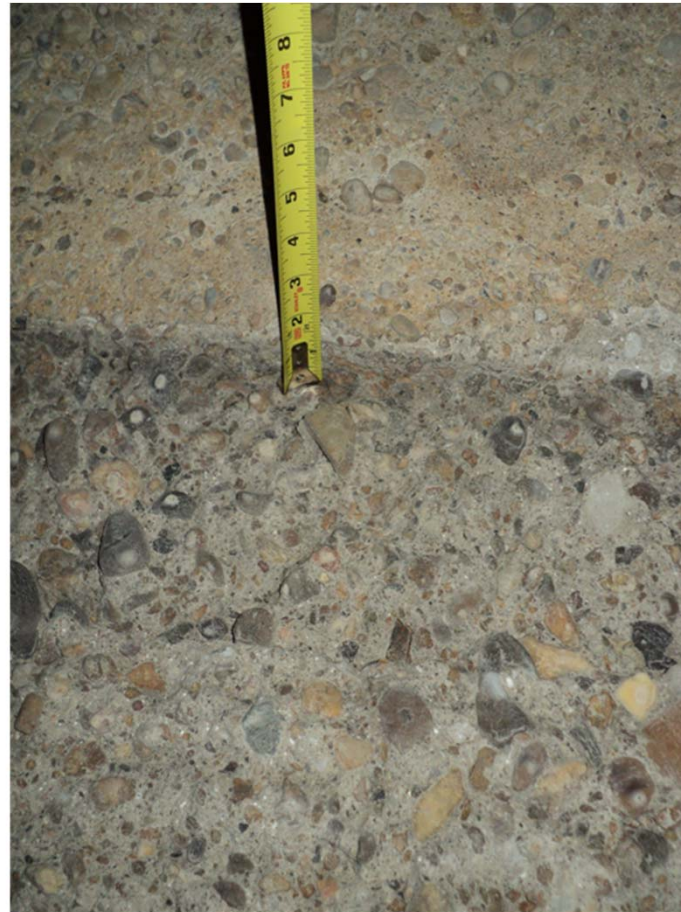
- Hydrodemolition and saw cut edge
