# 2018 ICRI Spring Convention Seismic Solutions

## Industrial Structure Column Repair

## Coker Unit at a Midwest Refinery

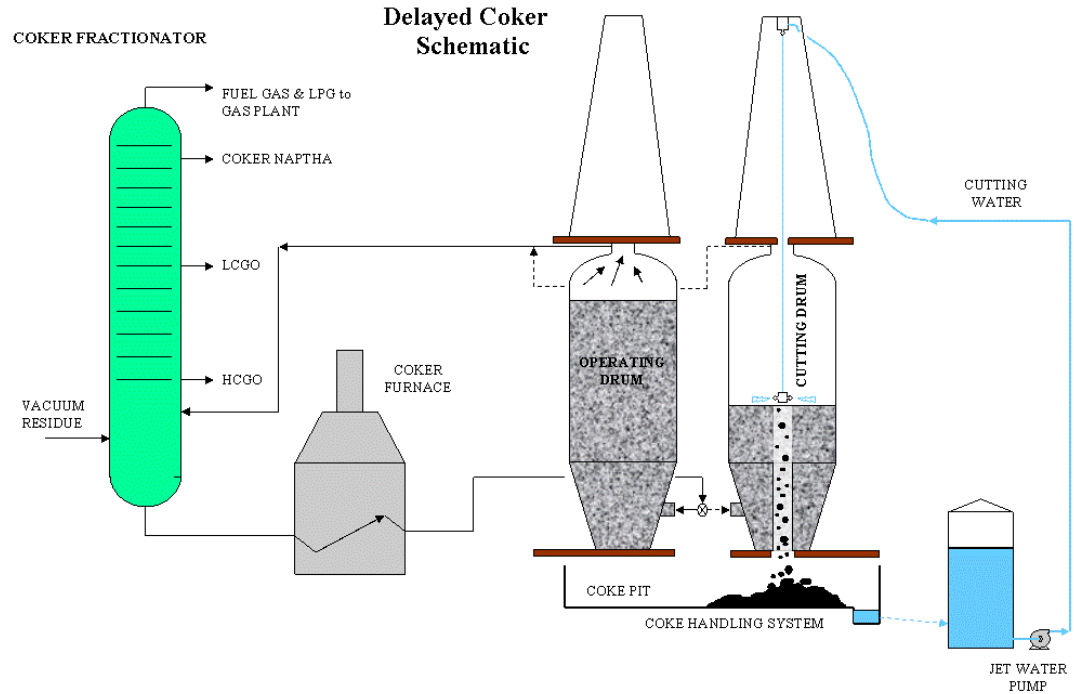
- Extremely heavy Operating Loads (full drums, proof loads)
- Comparatively light Dead Loads
- Resulted in full perimeter column repairs (instead of phased approach)

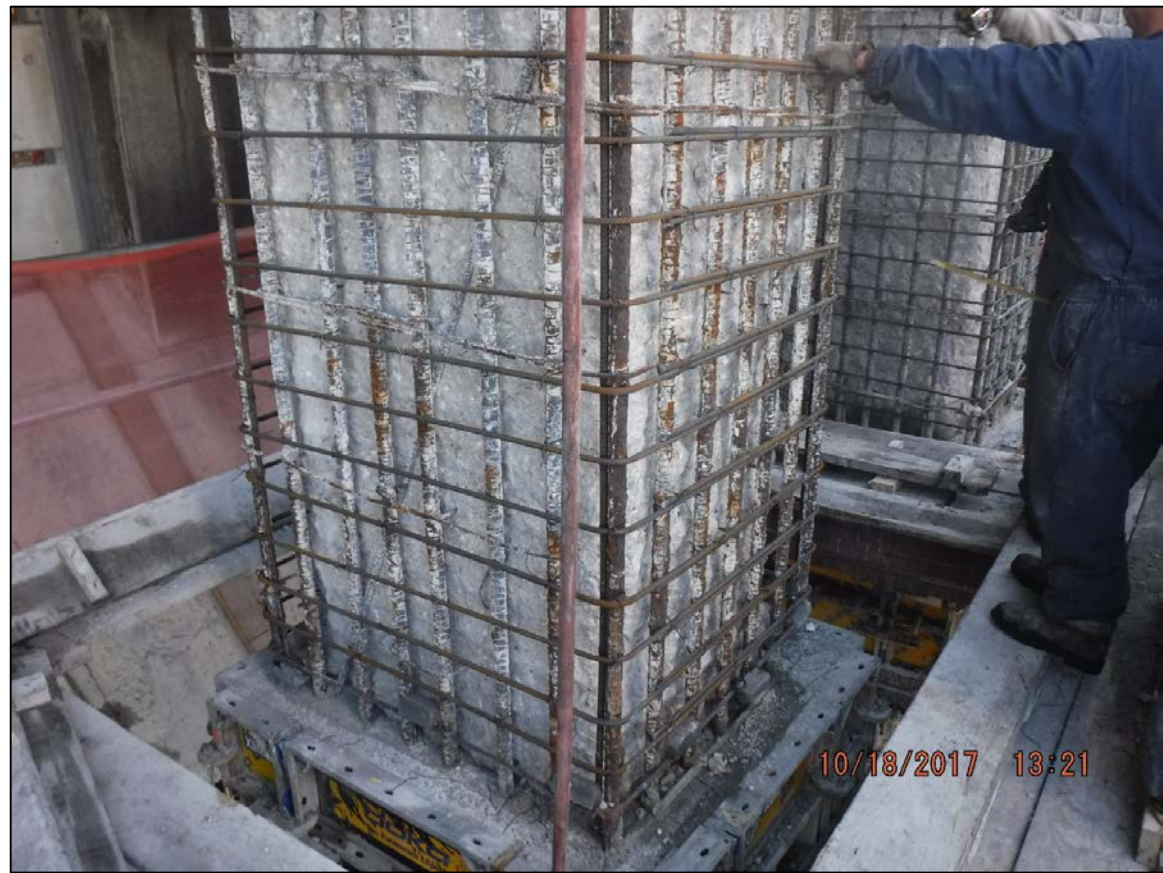
- #3 Stirrup spacing at 18" (many were damaged)
- Structure vulnerable to brittle column failure in seismic event
- Code requires 6"
- Heavy deterioration
- No concrete cover in many spots

- Stirrup spacing reduced from 18" to 6" to meet current seismic requirements and increase column ductility
- Vertical reinforcement augmented
- Cathodic protection installed
- Higher strength concrete
