October 16, 2023 ICRI 2023 Fall Convention

Nigel Parker, M.Eng, P.Eng, LEED® AP BD+C Associate RJC Engineers

## **Presentation Objectives**

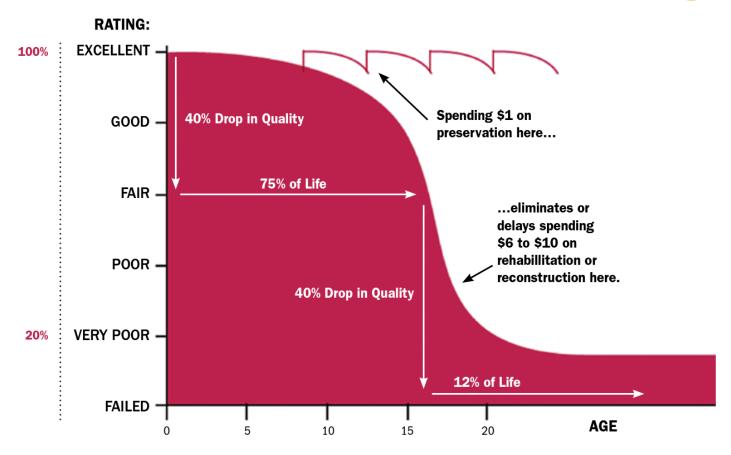
## AM 101 – Grading System<sup>2</sup>

<b>Condition Grade</b>	% of Estimated Service Life (ESL) Remaining
Very Good	80 to 100%
Good	60 to 79%
Fair	40 to 59%
Poor	20 to 39%
Very Poor	< 19%

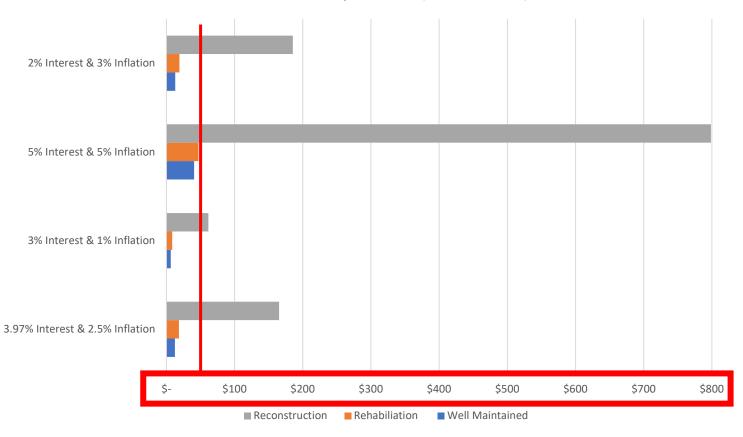
## **Theoretical Case Studies: TTDC Garage**

#### Well Maintained

Year 20 and 40 @ \$15/sq.ft.

### Major Rehabilitation Only

Year 35 @ \$40/sq.ft.

#### **Asset Replacement Cost**

Year 50 @ \$250/sq.ft.

50 Year Life Cycle Costs (FV in Millons)

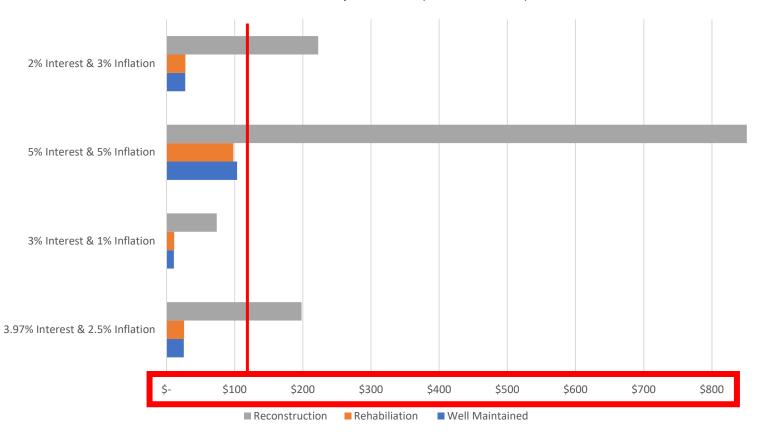
# Case Studies: Asphaltic Garage

#### Well Maintained

Year 25 and 50 @ \$25/sq.ft.

### Major Rehabilitation Only

Year 40 @ \$50/sq.ft.

#### **Asset Replacement Cost**

Year 50 @ \$300/sq.ft.

50 Year Life Cycle Costs (FV in Millons)

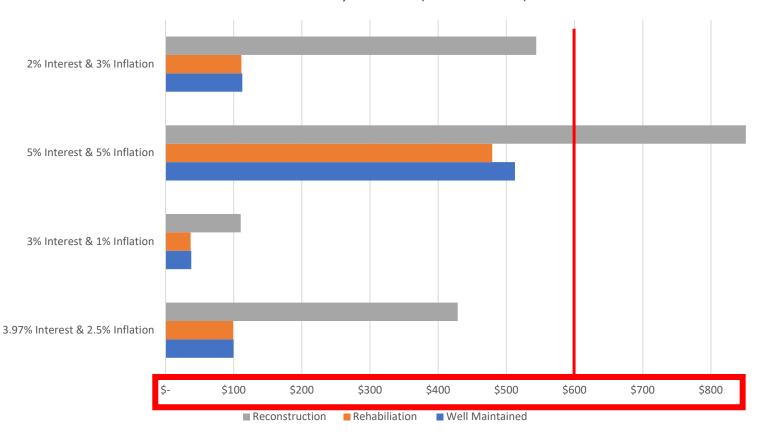
### Case Studies: Plaza Deck

#### Well Maintained

Year 30 and 60 @ \$80/sq.ft.

### Major Rehabilitation Only

Year 50 @ \$150/sq.ft.

#### Asset Replacement Cost

Year 75 @ \$350/sq.ft.

50 Year Life Cycle Costs (FV in Millons)
