# **Sustainable Concrete Repairs Using Surface Applied Organofunctional Silane Corrosion Inhibitors**

**Pete DeNicola-Evonik Industries  
Paul Tourney-Tourney Consulting  
Neal Berke-Tourney Consulting  
Brooks Bucher-Tourney Consulting**

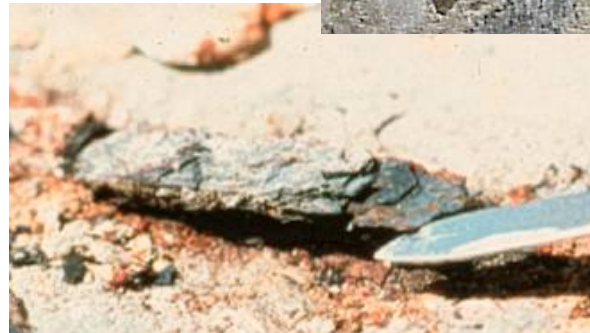
**Corrosion causes cross sectional loss of the steel which results in a loss of structural strength.**

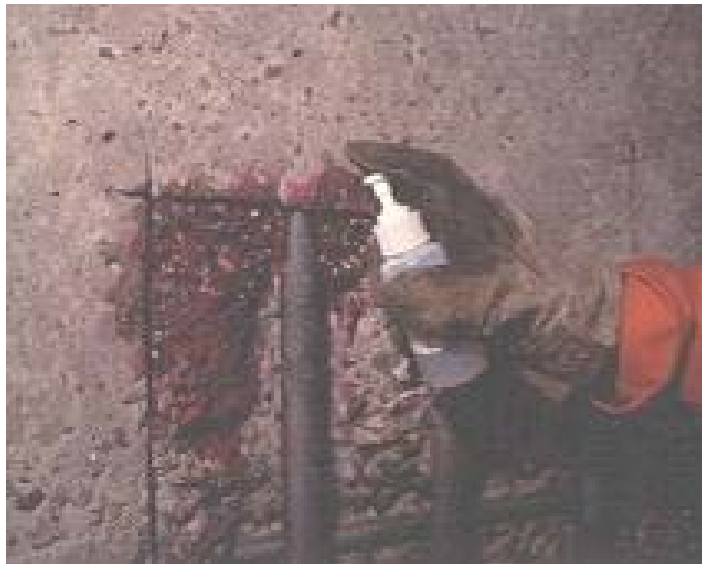
**Spraying pH Indicator**

# Measuring Carbonation and Chlorides

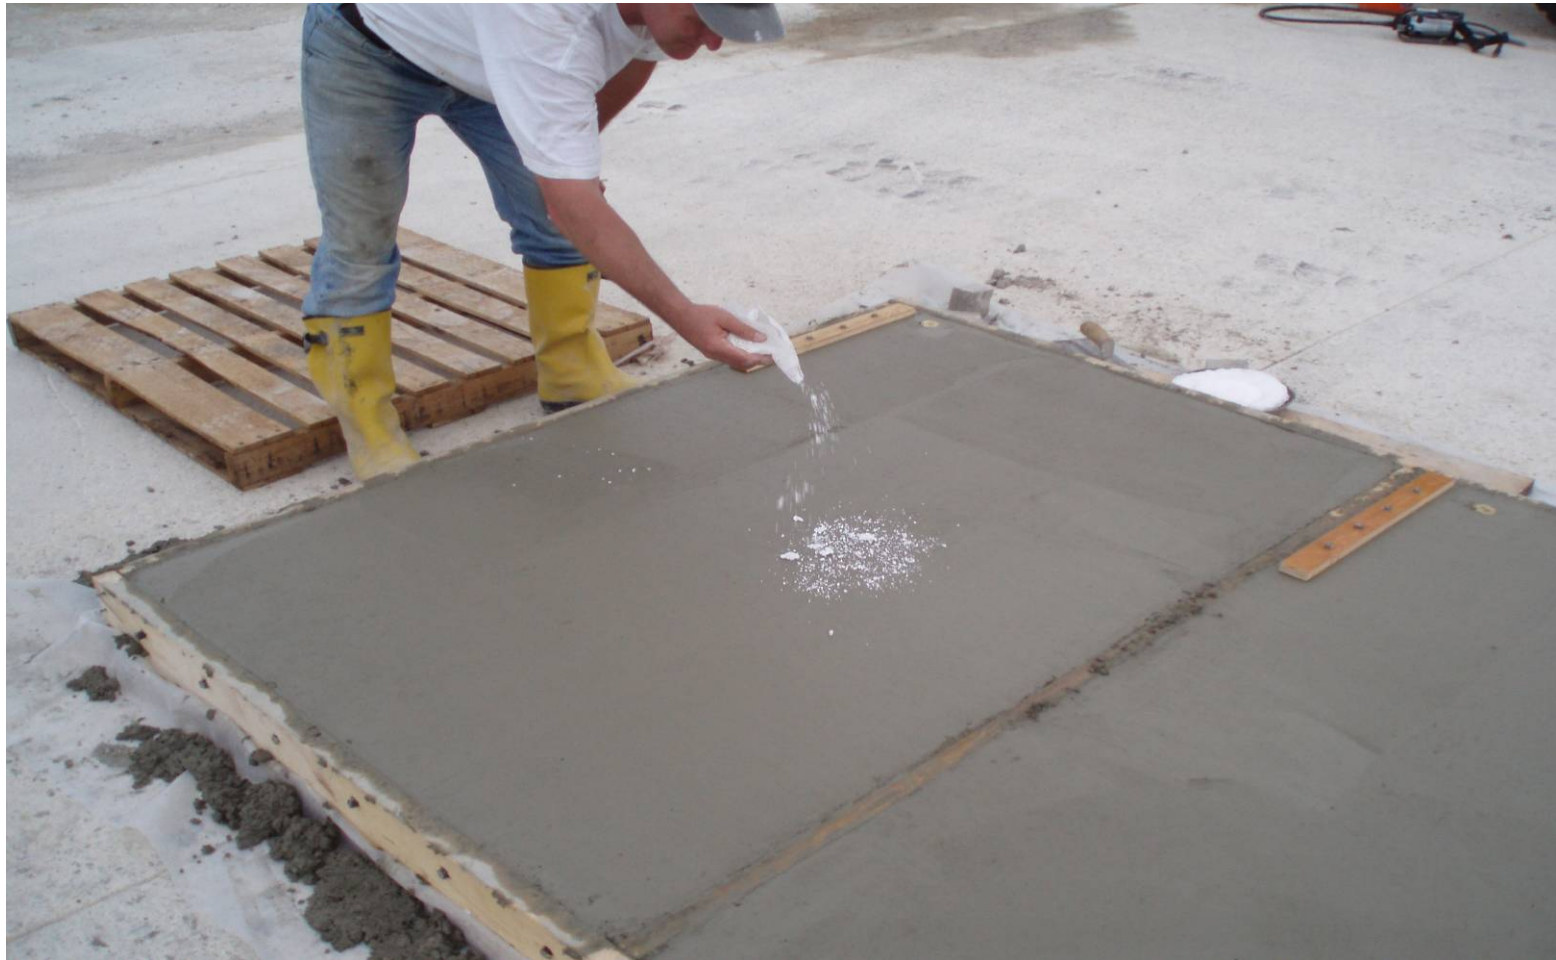
Top layer contains 2% admixed  $\text{CaCl}_2$   
Hot-spot started with extra (200g)  $\text{CaCl}_2$

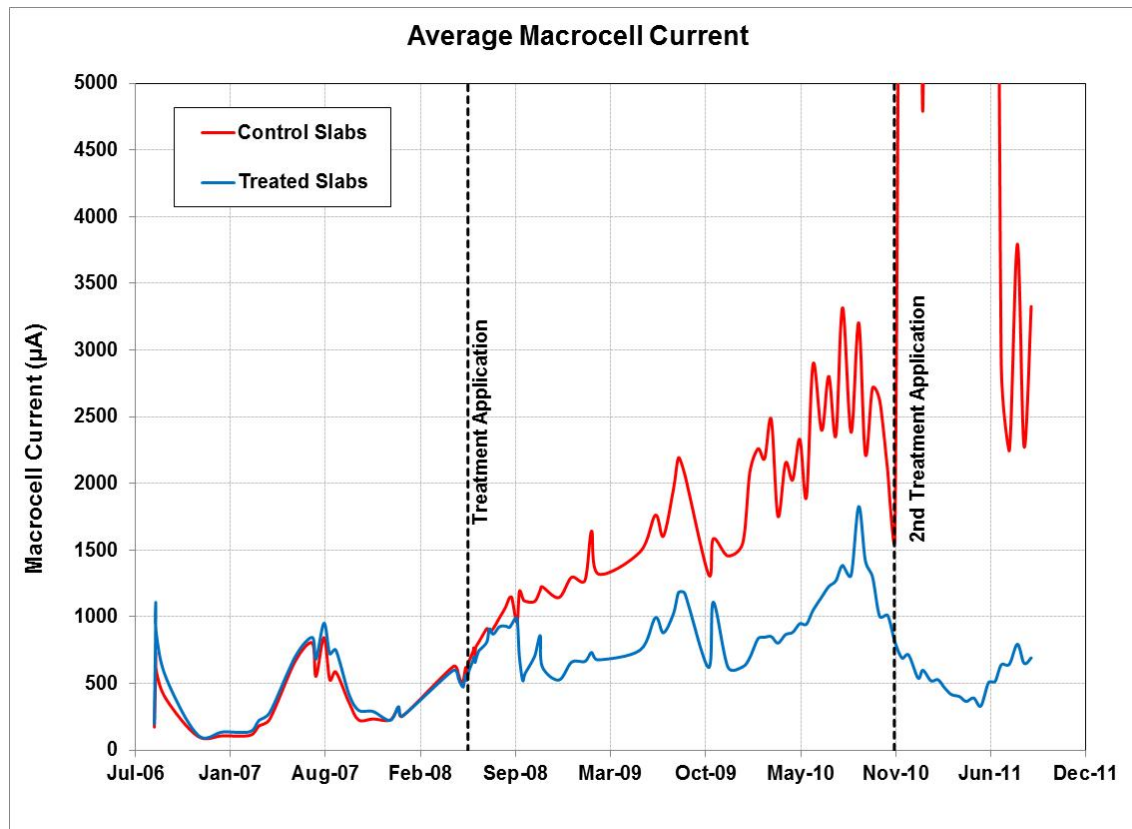
# Macrocell Current Results

The average total charge, from time of first treatment, passed for the controls was 412,843 C and the treated slabs were at 82,125 C for a 80.1% reduction.

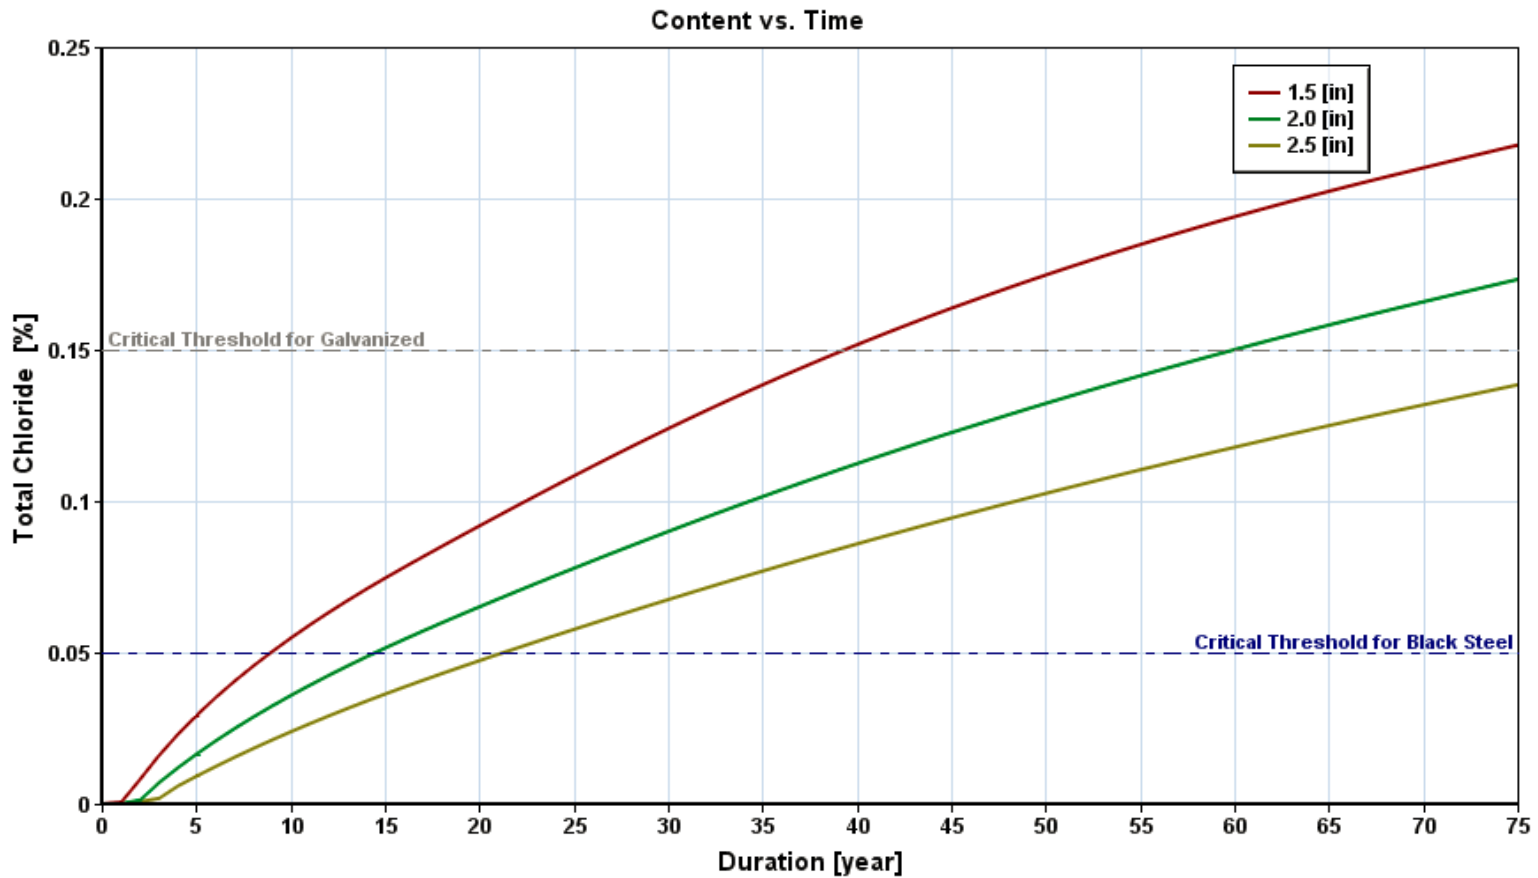
# Modeling Results for New Bridge Deck-Untreated

<b>Black Steel</b>	<b>Epoxy Coated</b>	<b>Galvanized</b>
	0.05 %	0.05%	0.15%
1.5 inch	8.9 years	8.9 years	39.3 years
2.0 inch	14.5 years	14.5 years	60.0 years
2.5 inch	21.3 years	21.3 years	> 75 years

Note: Water/cement ratio for model run was 0.5

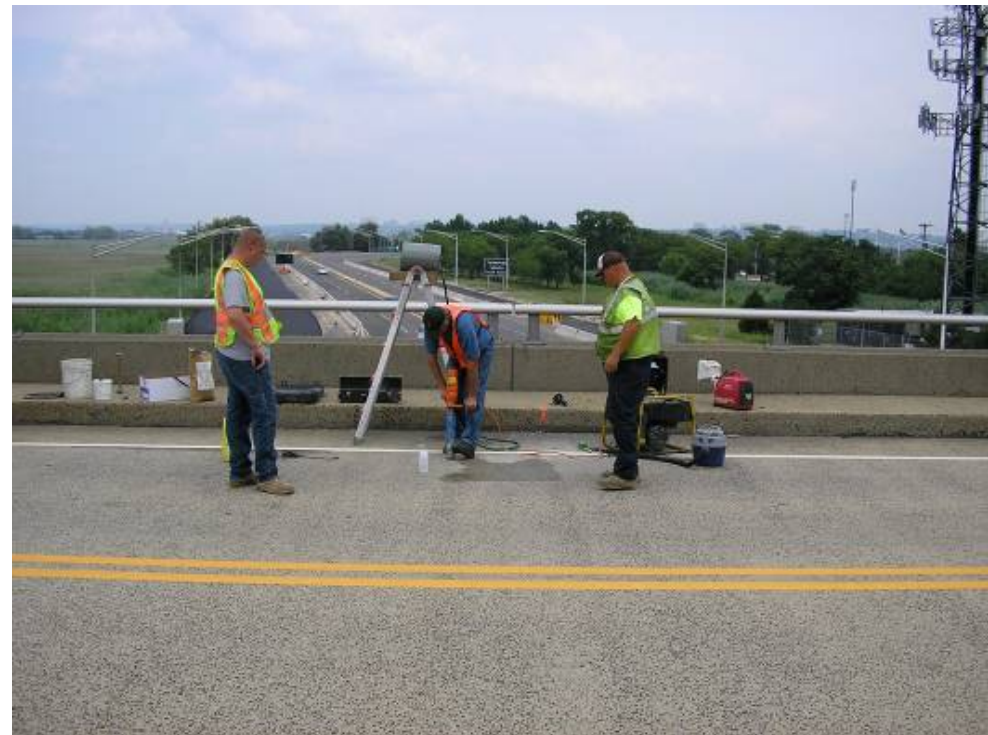
# Project Background

Concrete Core specimens were pulled from both bridge decks and corrosion rate testing was conducted on July 31, 2008

- Chloride ion content at 1.5 inch depth ranged from 2-8 times the threshold that steel becomes depassivated
- Average corrosion rates were considered to be in the moderate range with hot spots where the steel was corroding at rates of up to 329  $\mu\text{m}$  per year

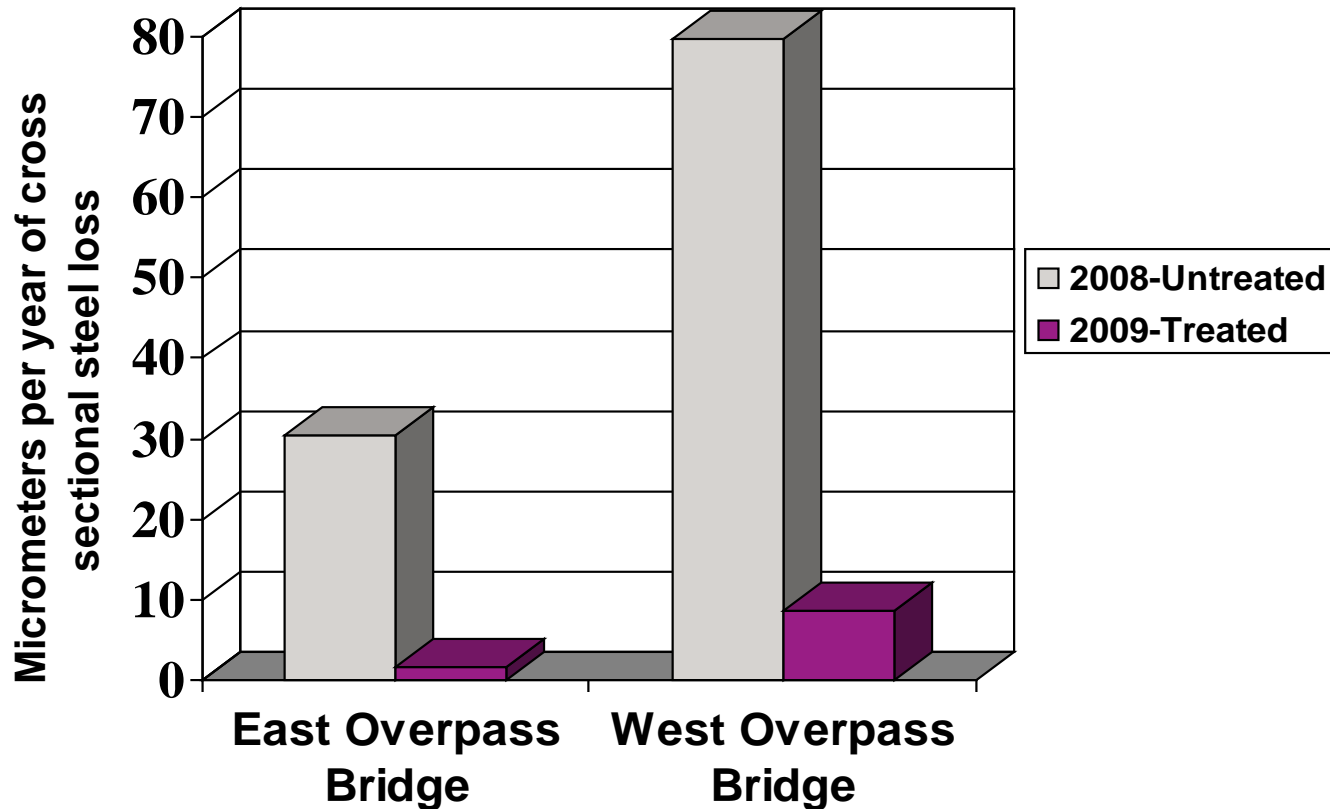
## Average Corrosion Rate Results for Both Overpass Bridges

# Corrosion Rate Monitoring Conducted 14 Months After Treatment

Product was applied to both bridge decks on August 14, 2008. Two applications were required to achieve the net coverage rate of 100 square feet per gallon.

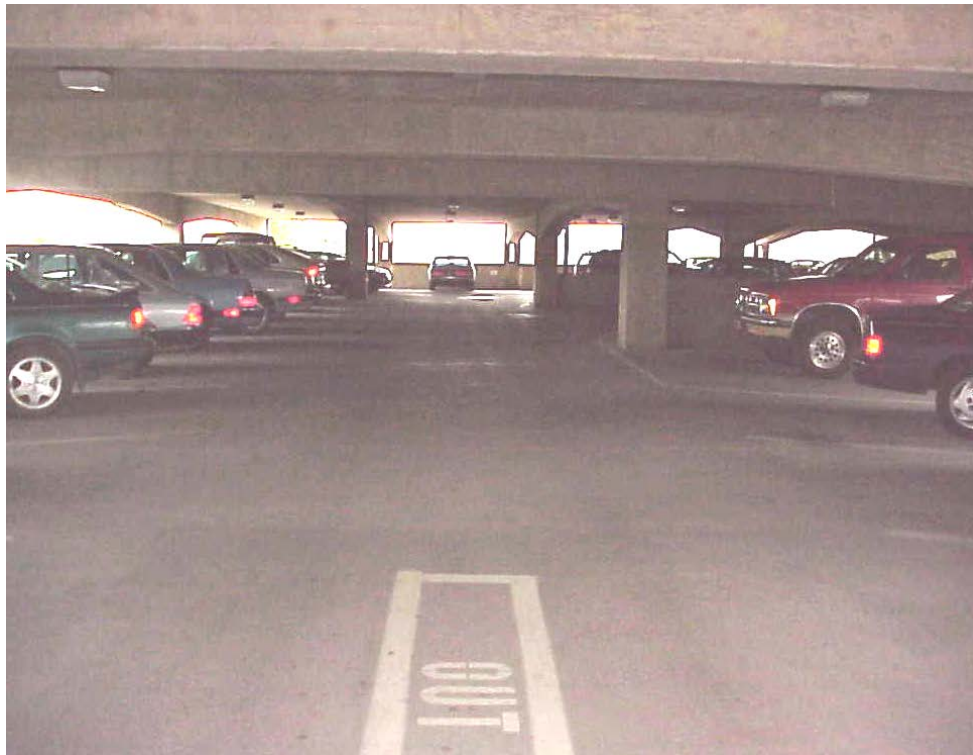
- 30 year old parking structure in PA, USA
- Exposed to snow and freezing rain
- Repairs made in 1996 at US \$850,000

- Spalls and Delaminations were repaired using standard methods
- Organofunctional Silane was applied to all the exposed concrete
- Corrosion testing was performed annually for 11 years to verify performance

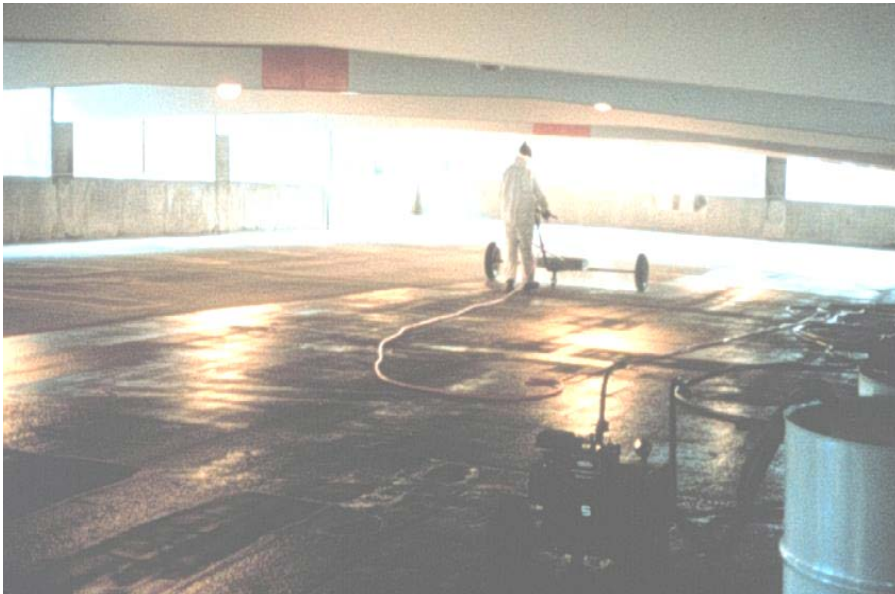
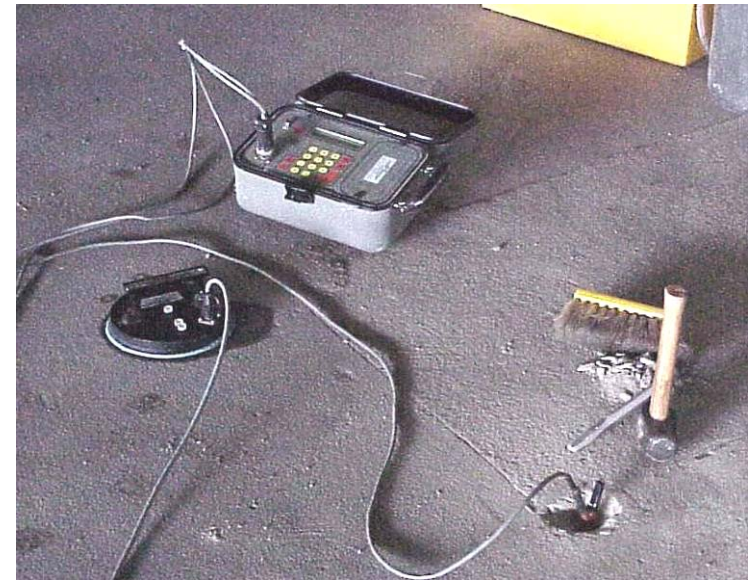
# Field Performance-Parking Structure Exposed to Deicer Salts
