March 26, 2015

High-Rise Roofing and Waterproofing

SUPERSTRUCTURES

Presented by:
Michael Stripunsky, RA & Barry Drogin

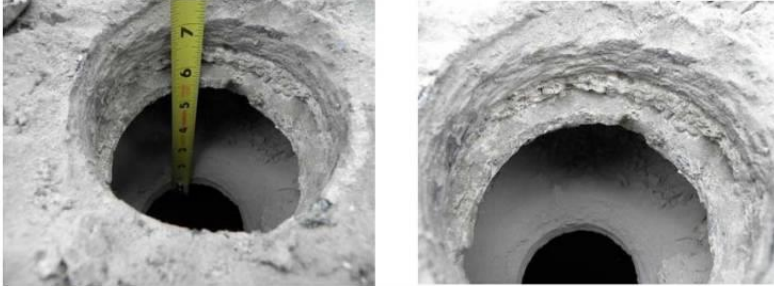
Probe 01

Adjacent to Roof Drain

- Complete through-panel core. Hollow panel is approximately 6" high with a 1" thick shell
- Sloped concrete fill appears to be near 0" in depth.

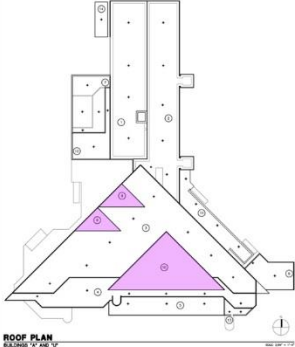
Item No.	Observed Conditions	Sketches / Representative Photographs	Recommendations
4	<p>Roof Areas 8, 9 and 10:</p> <p>Sloped lead coated copper batten seam roofing over slip paper, underlayment, and plywood secured to metal deck.</p>

<p>ROOF PLAN REVISION 17 AUG 17</p>	<p>The existing roofing system appears to be in good condition and requires only localized repairs including but not limited to:</p> <ul style="list-style-type: none"> Partial replacement of batten profile sheet metal (roof area 10) Localized sheet metal patching Installation of vented roofing assembly at roof base Installation of new ridge cap flashing system
5	<p>Roof Areas 11 and 13:</p> <p>Improper concrete terrace waterproofing assembly. Concrete topping slab is installed directly over built-up waterproofing membrane. This condition does not permit proper drainage. Standing water at waterproofing level was observed at probe areas.</p> <p>MEM 03</p>

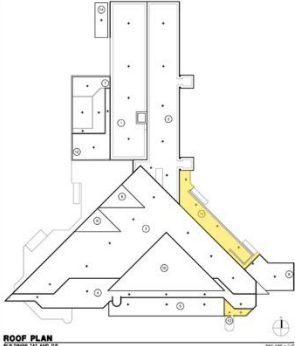
<p>ROOF PLAN REVISION 17 AUG 17</p>	<ul style="list-style-type: none"> Remove existing concrete topping slab and waterproofing membrane. Repair existing concrete structural deck. Install new liquid applied terrace system of the following composition: <ul style="list-style-type: none"> Reinforced liquid applied roof membrane over existing structural concrete Drainage mat New concrete topping slab matching existing configuration

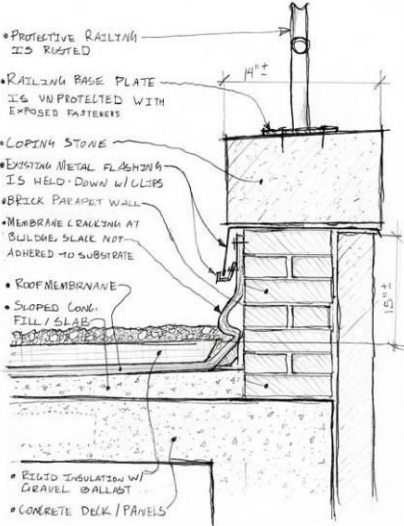
<p>Probe Sketch</p>

<ul style="list-style-type: none"> • PROTECTIVE RAILING IS RUSTED • RAILING BASE PLATE IS UNPROTECTED WITH EXPOSED FASTENERS • COPING STONE • EXISTING METAL FLASHING IS HELD DOWN WITH SLIPS • BRICK PARAPET WALL • MEMBRANE CRACKING AT BULGE/SLACK NOT ADHERED TO SUBSTRATE • ROOF MEMBRANE • SLOPED CONG. FILL / SLAB • BELTD INSULATION W/ GRAVEL BALLAST • CONCRETE DECK / PANELS
<p>Probe Observations & Results</p> <ul style="list-style-type: none"> • The height of the existing base flashing is approximately 15" • The vertical substrate / brick masonry appears to be in fair condition. • Roof membrane is cracked at bulge/excess slack on vertical surface. • Protective railing is rusted • Railing base plate is unprotected and has exposed fasteners.

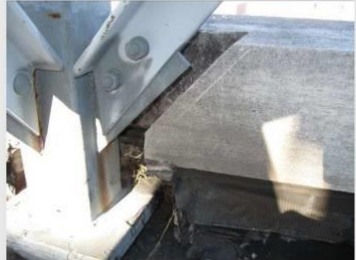
<p>Photo 1 Cut Coping at Dunnage</p>

<p>FLA 11 Adversely Altered Parapet & Coping</p>	
<p>Observations</p> <p>Altered coping stone and inner face of brick masonry at parapet. Missing base and counter flashing.</p>	
<p>Photographs</p>

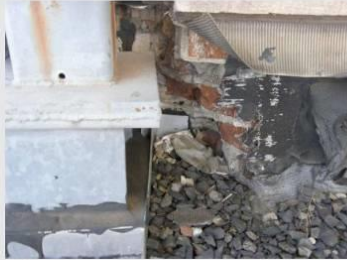
<p>Photo 2 Cut Parapet & Flashing</p>
<p>Analysis</p> <p>Damage and removal of the existing parapet assembly by the installation of dunnage steel supports allows for water infiltration into the wall and roofing systems.</p>

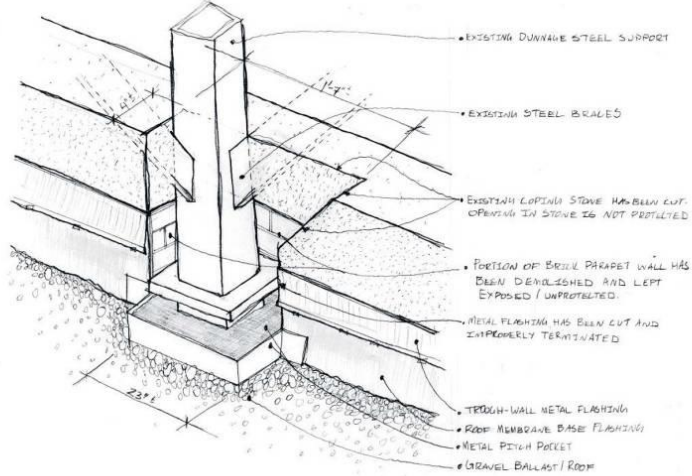
<ul style="list-style-type: none"> • EXISTING DUNNAGE STEEL SUPPORT • EXISTING STEEL BRACES • EXISTING COPING STONE HAS BEEN CUT. OPENING IN STONE IS NOT PROTECTED • PORTION OF BRICK PARAPET WALL HAS BEEN DEMOLISHED AND LEFT EXPOSED / UNPROTECTED • METAL FLASHING HAS BEEN CUT AND IMPROPERLY TERMINATED • TROUGH-WALL METAL FLASHING • ROOF MEMBRANE BASE FLASHING • METAL PITCH POCKET • GRAVEL BALLAST / ROOM 	
<p>Recommendations</p> <p>Repair and clean the substrate behind the steel dunnage. Install reinforcement / anchorage for the exterior face brick masonry. Provide proper base flashing and provide new counter flashing at post.</p>

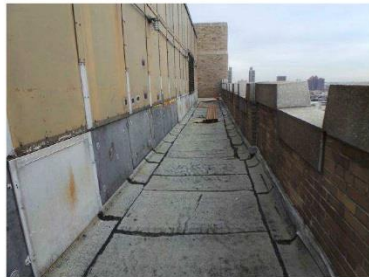
Representative Photo and Proposed Roof System:

Age of Roof (approx.): 20+ years
 Reported Leaks: Thermal imaging anomalies. Probes found water damaged insulation and wet deck.

Roof Replacement Priority: 1 (see legend below)
 Proposed Roofing System: Protected Liquid-Applied Membrane
 Asbestos Containing Materials (ACM): Present (confirmed by testing)
 Extended Construction Cost: \$88,270 (including ACM abatement)
