STRENGTHENING HIGH-RISE STRUCTURES USING FRP COMPOSITE MATERIALS

DAVID WHITE, P.E.
SIKA CORPORATION

ICRI 2015 SPRING CONVENTION - NYC

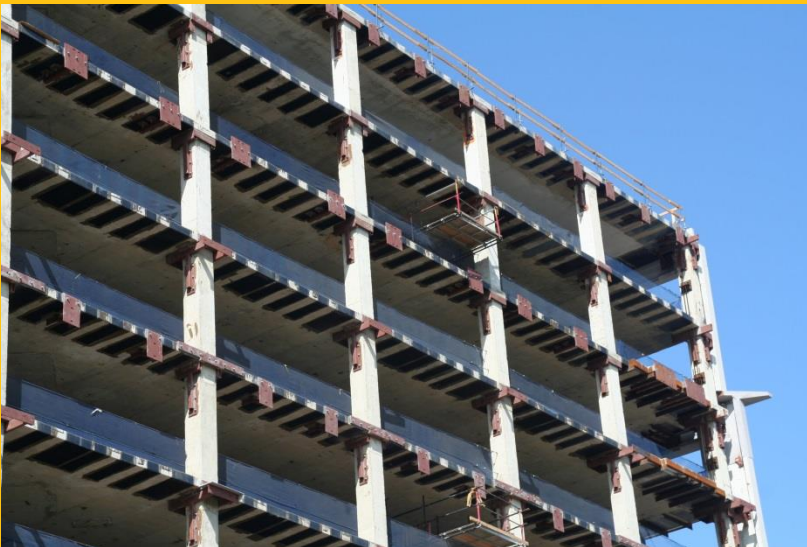
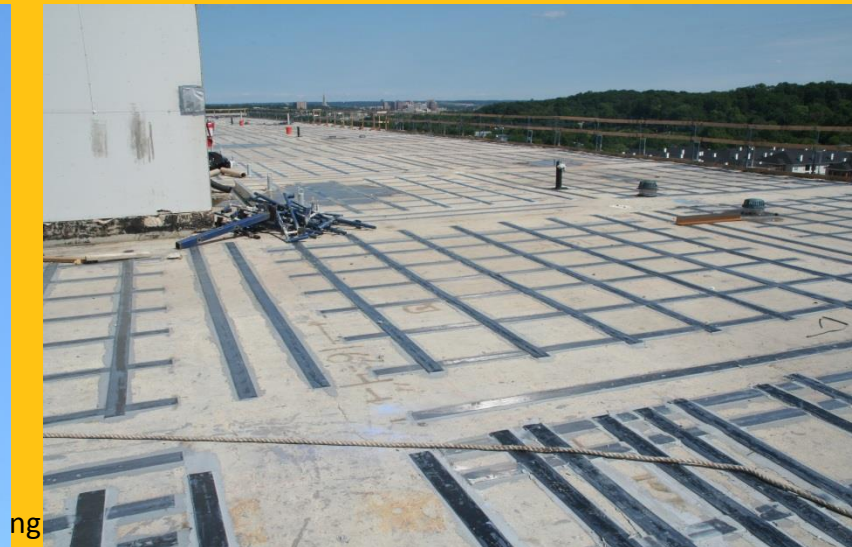
OFFICE BUILDING – METRO DC

- 600,000 sf building gutted to its core
- **Blast hardening** existing concrete frame bldg.
- Slab edge protection before curtain wall installed
- Roof/slab strengthened with carbon fiber plates for uplift pressure
- Column perimeter strengthened for punch through forces
- Renovated to LEED certification
- Blast proof per D.O.D. requirements

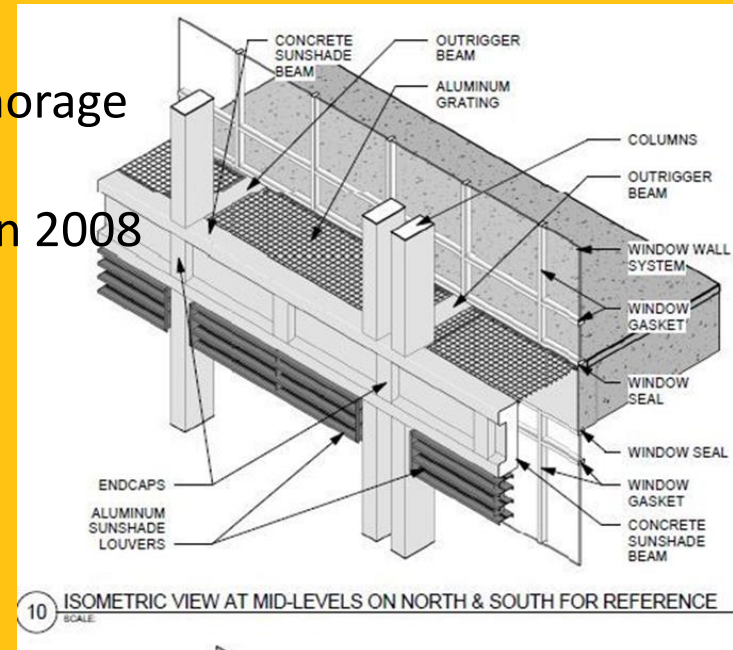
HARRIS COUNTY ADMINISTRATION BUILDING

- Government building constructed in 1978
- One floor basement – 9 floors above grade – mechanical penthouse on roof
- Reinforced concrete slab supported on PT concrete beams and spandrel beams
- “Sunshade” beams line perimeter of building
- “Outrigger” beams cantilever beyond window wall perimeter to support sunshade beams
- Precast concrete caps protect button-head anchorage system of PT outrigger beams
- Loose concrete pieces starting falling off HCAB in 2008
- Other problems included:
 - Concrete spalling
 - Cracking
 - Honeycombing
 - Deteriorated concrete

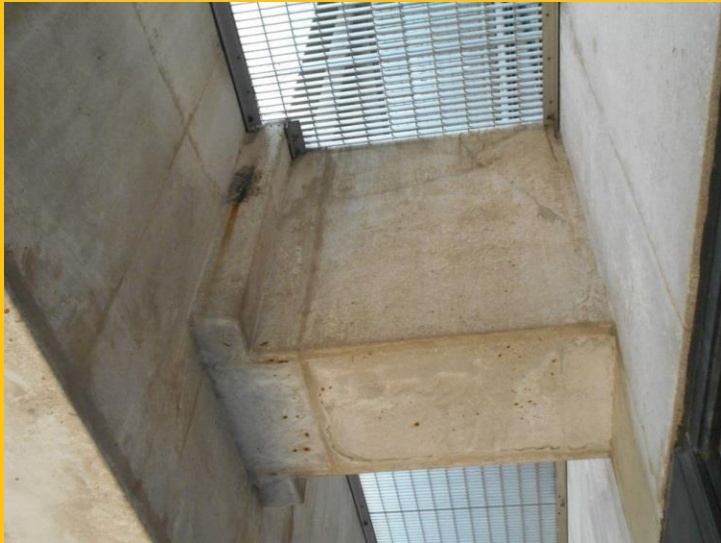
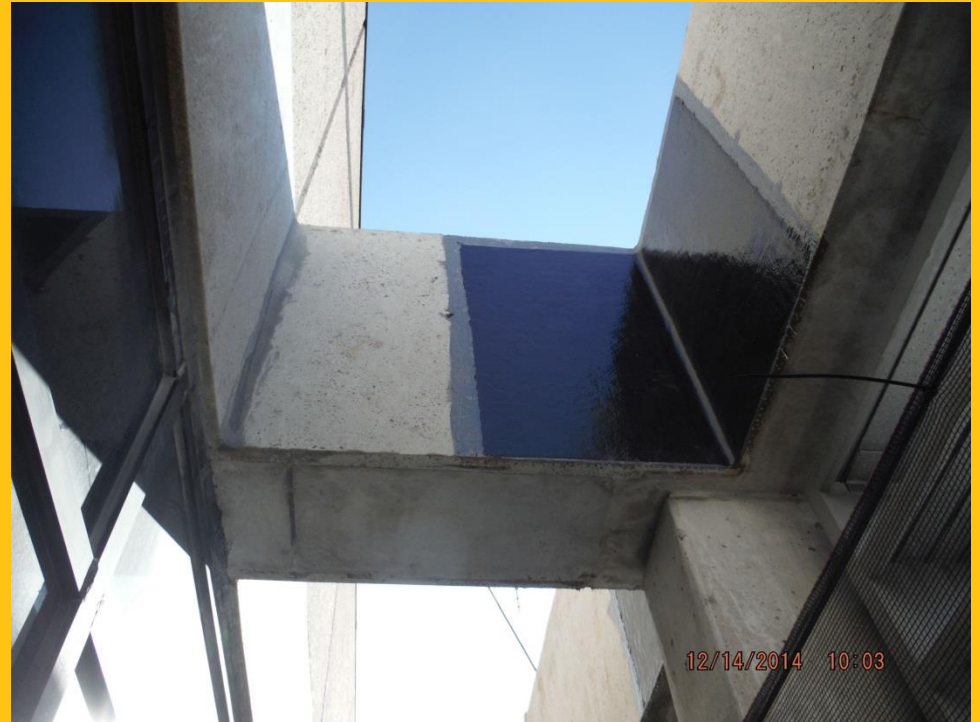
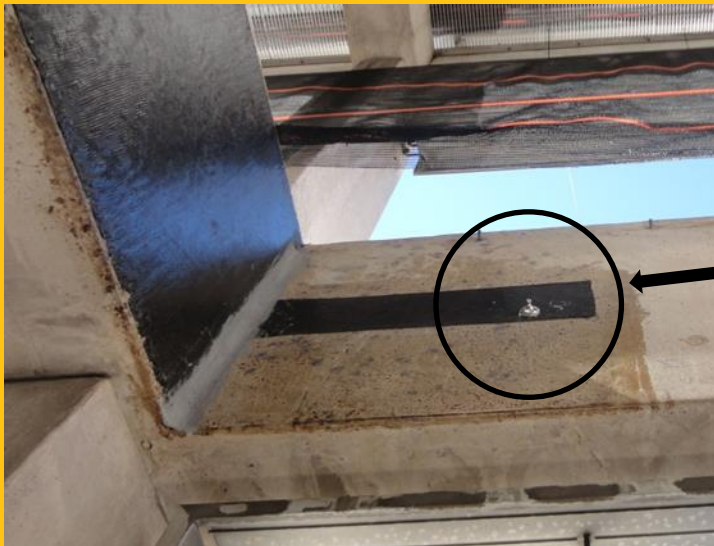
FRP REPAIRS

Bond strength testing

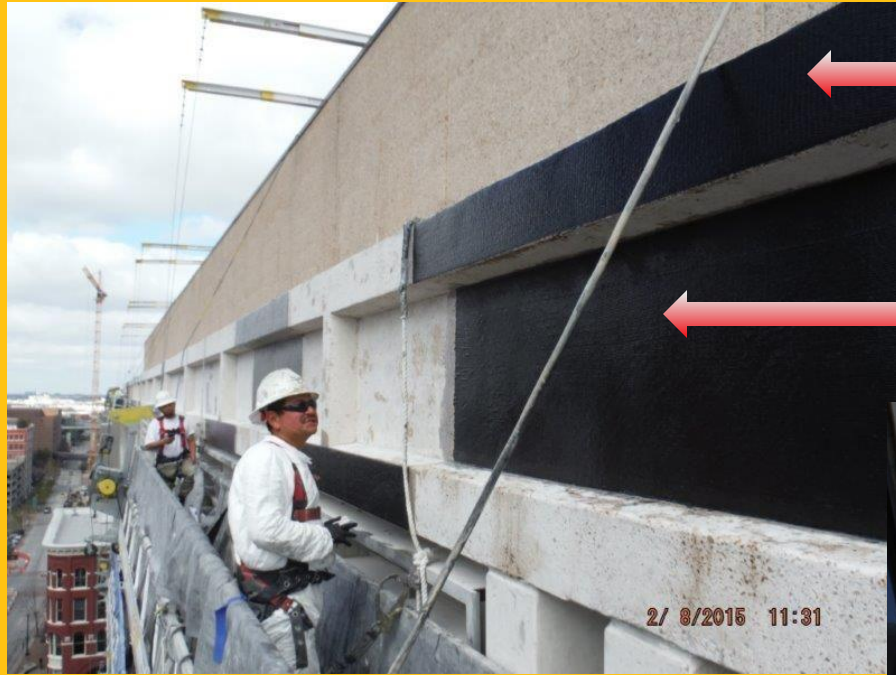
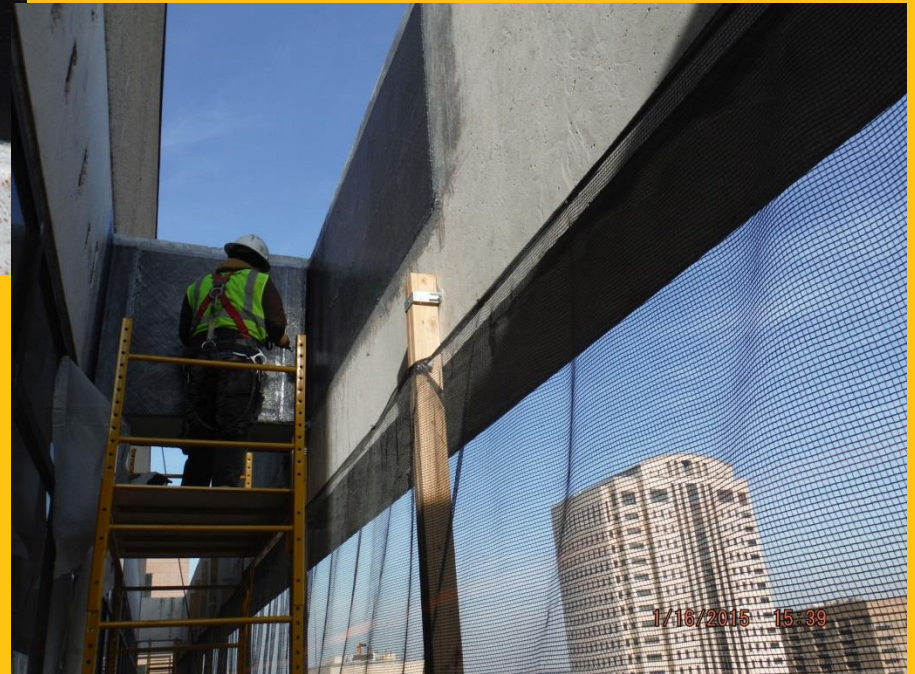
SUNSHADE BEAM FRP REPAIRS

Uni-directional CFRP fabric

+/- 45° Bi-directional CFRP fabric

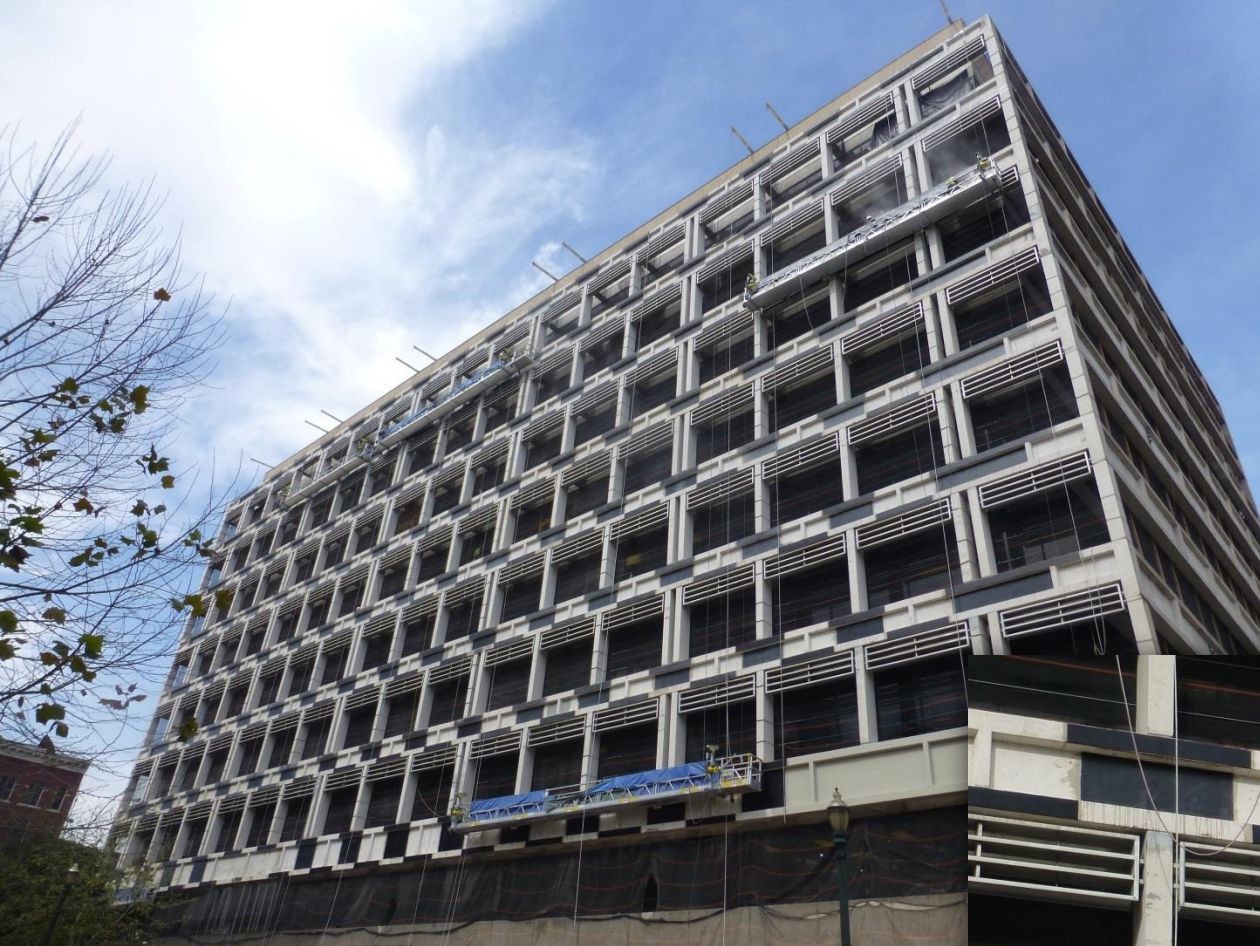
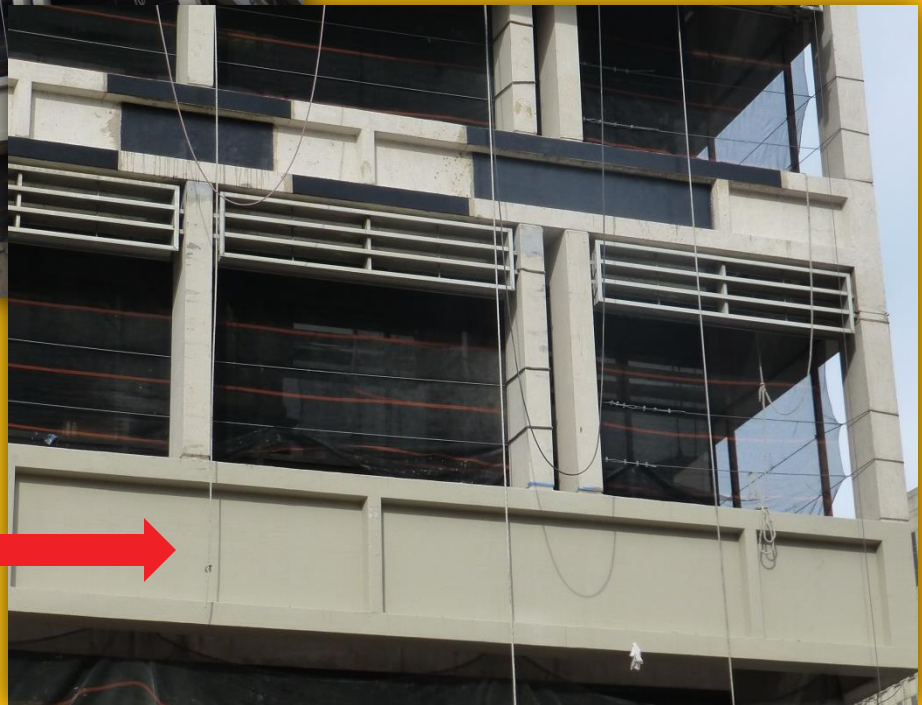
Mock-up Area

- FRP Repairs
- Skim Coat
- Façade Coating

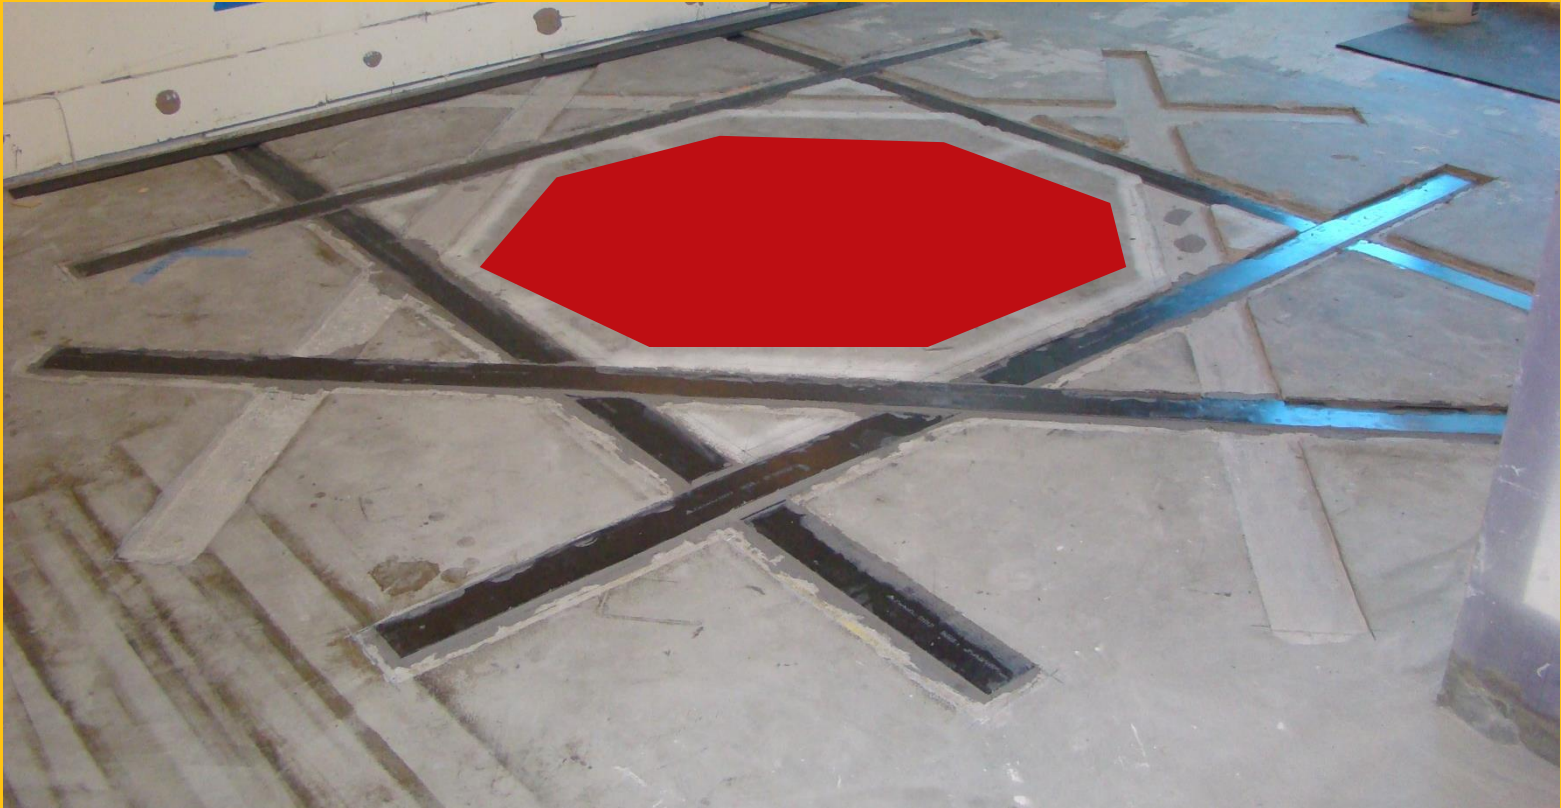
CENTRAL PARK WEST CONDO

- New octagon shaped staircase cut into reinforced concrete slab
- Carbon fiber plates inserted into grooves cut into concrete on top and bottom of slab

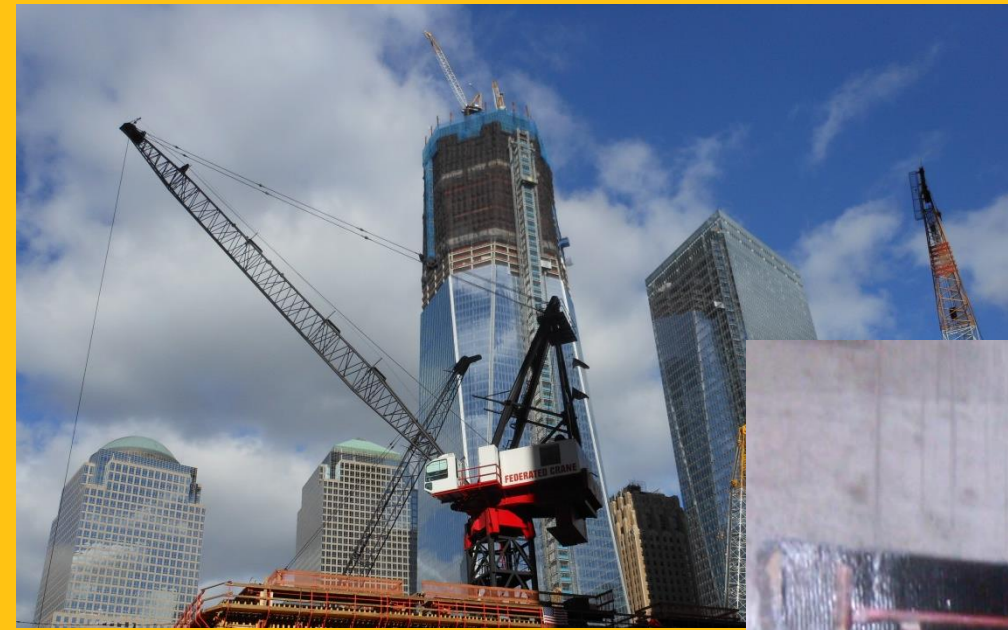
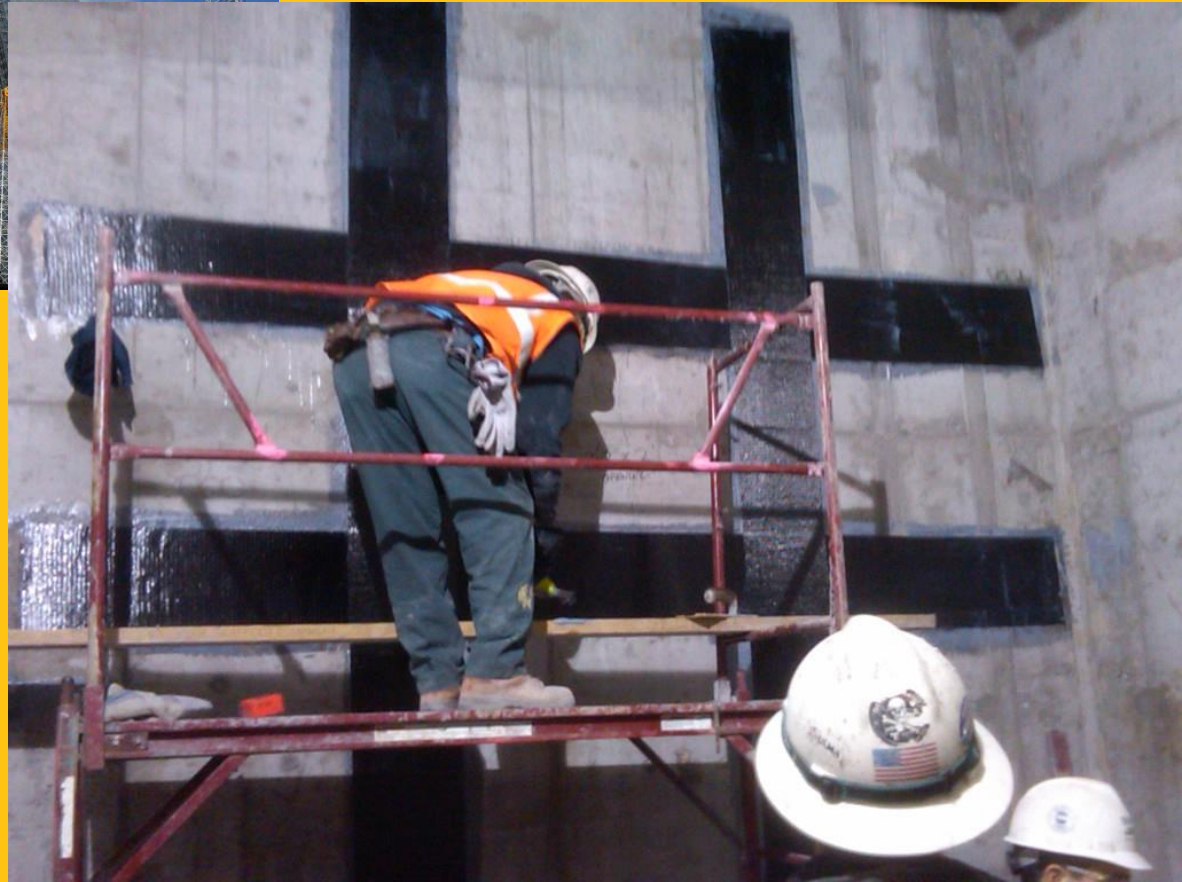
WORLD TRADE CENTER COMPLEX

- Foundation wall strengthening during construction
- Modifications for mechanical cores

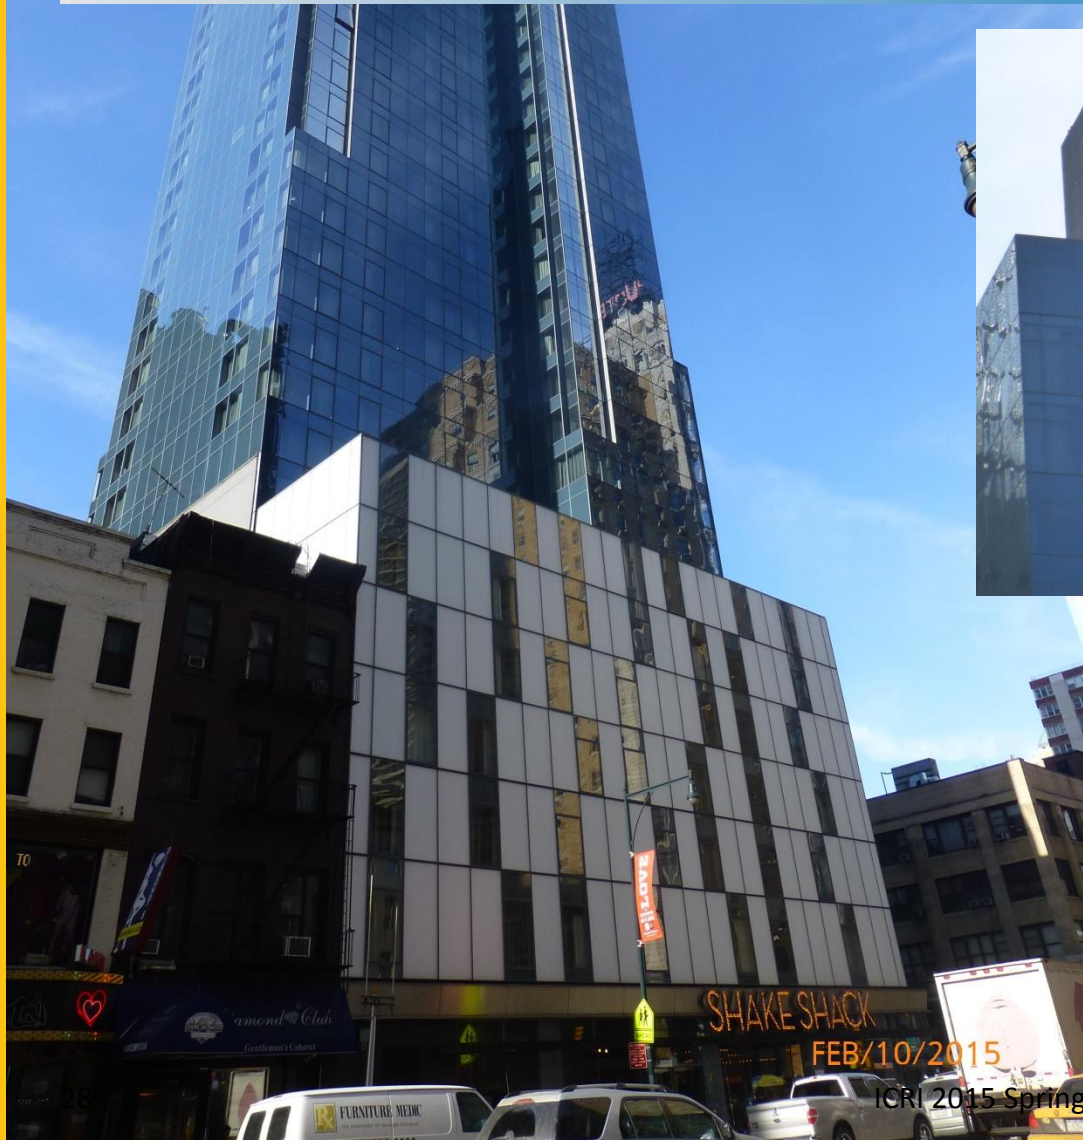
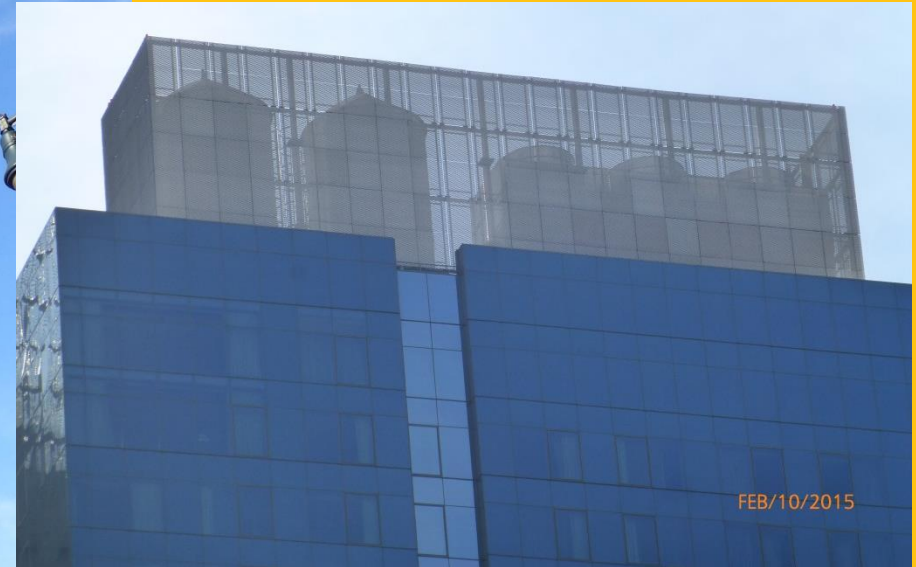
INTERCONTINENTAL HOTEL, W. 44TH ST. – NYC

- Large screens added to roof to hide water tanks
- Roof not designed to carry heavier loads

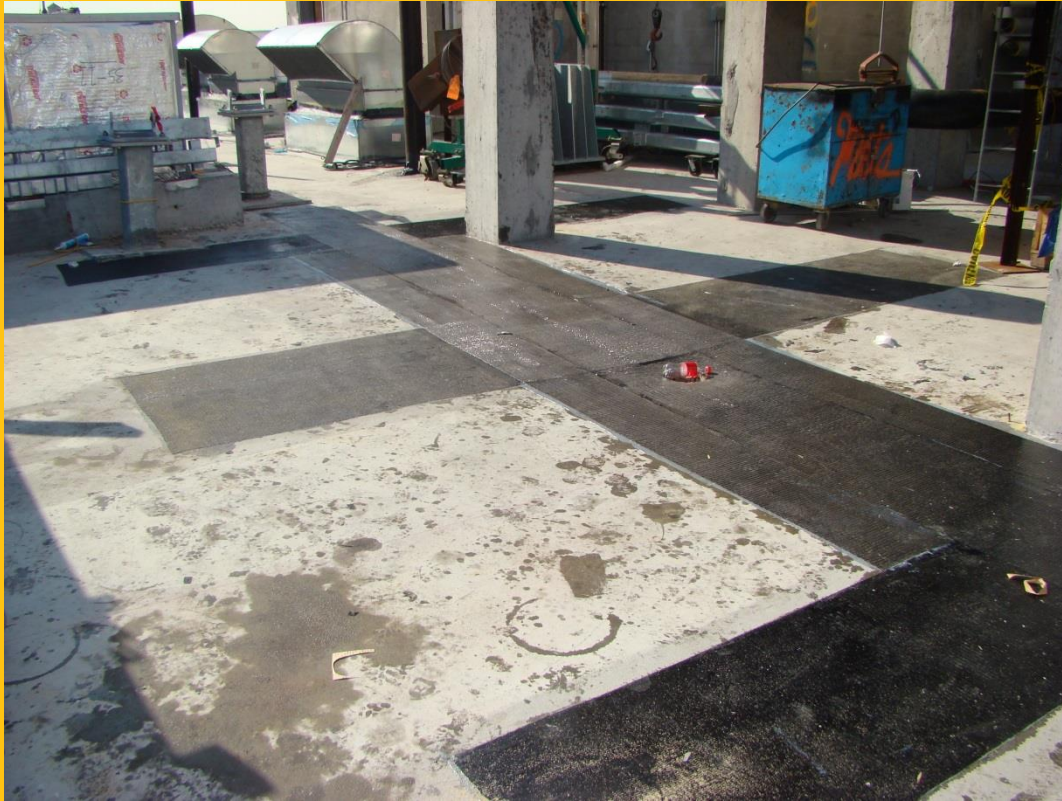
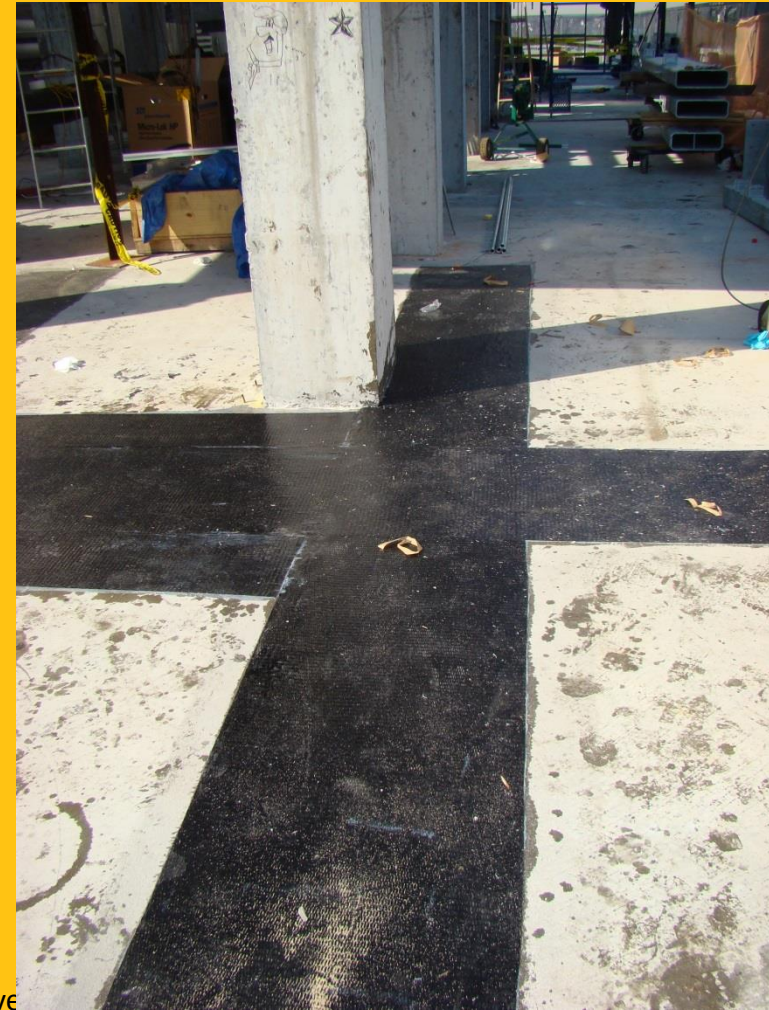
INTERCONTINENTAL HOTEL, W. 44TH ST. - NYC

- Carbon fiber fabrics bonded to roof slab to carry additional loads

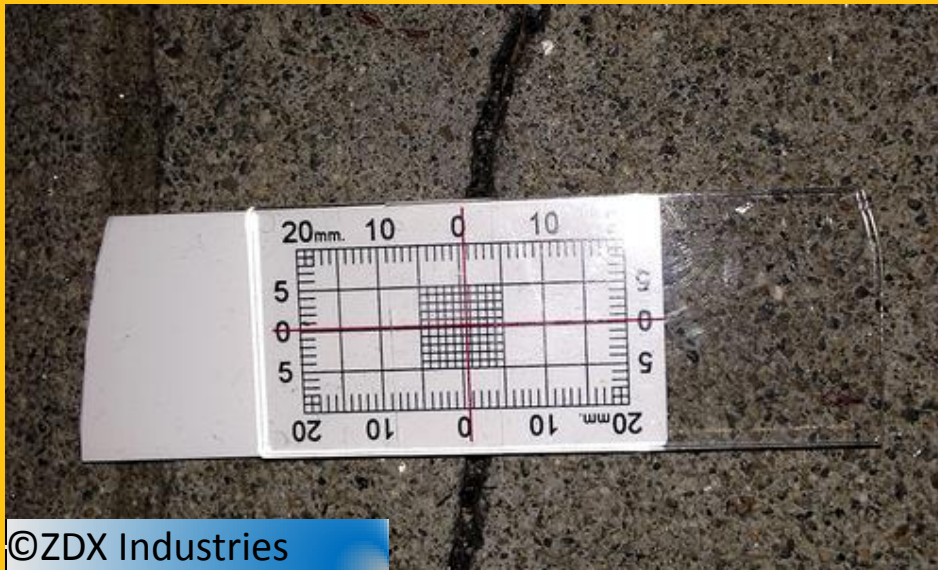
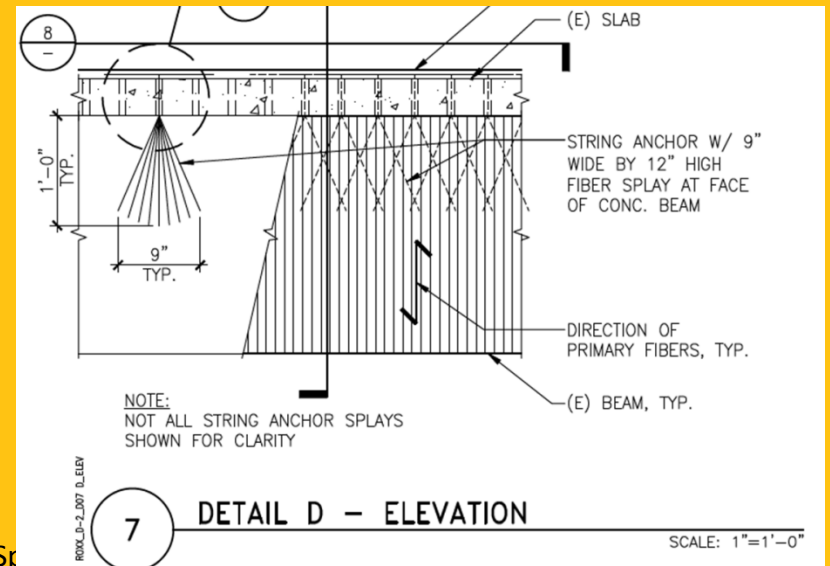
ROX-SAN MEDICAL TOWER

- Seismic retrofit of office building in Southern California
- Shear cracks identified in critical support beams
- Crack monitors installed to measure movement over extended period of time
- Structural analysis performed by structural engineers identified deficiency in concrete members
- Cracks injected with epoxy resin to stabilize movement
- New reinforced concrete shear walls added to stabilize building
- Concrete beams wrapped with CFRP fabrics for seismic strengthening
- CFRP fiber anchors installed to enhance “through-slab” connections

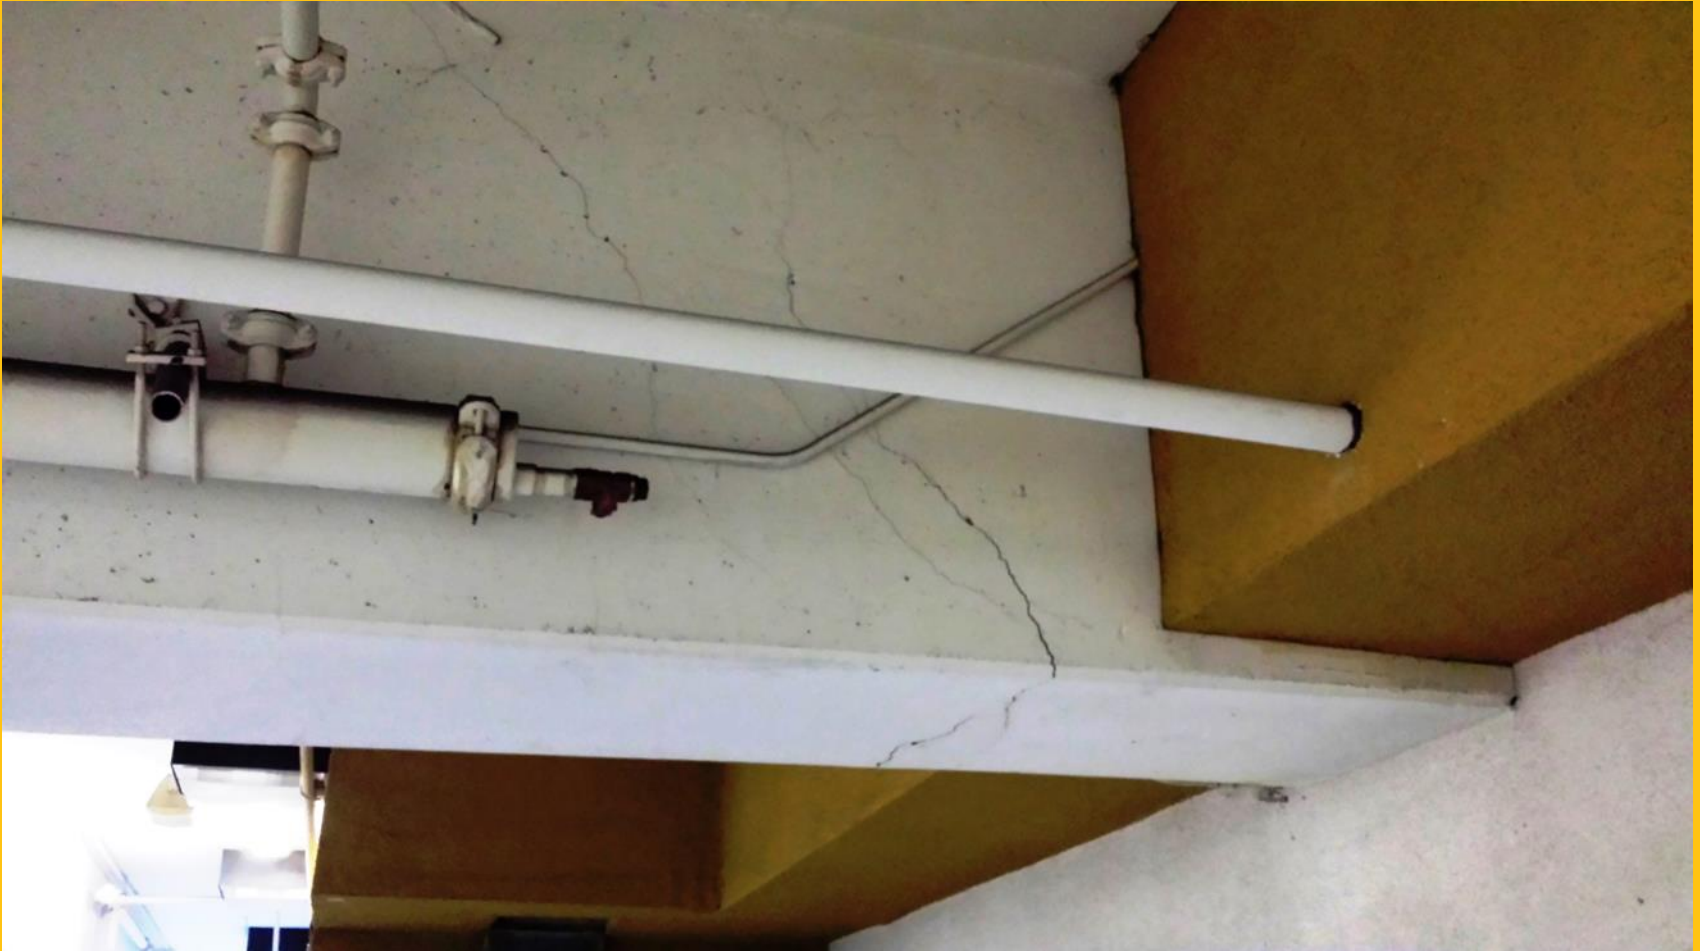
SHEAR CRACKS IN CRITICAL SUPPORT BEAMS

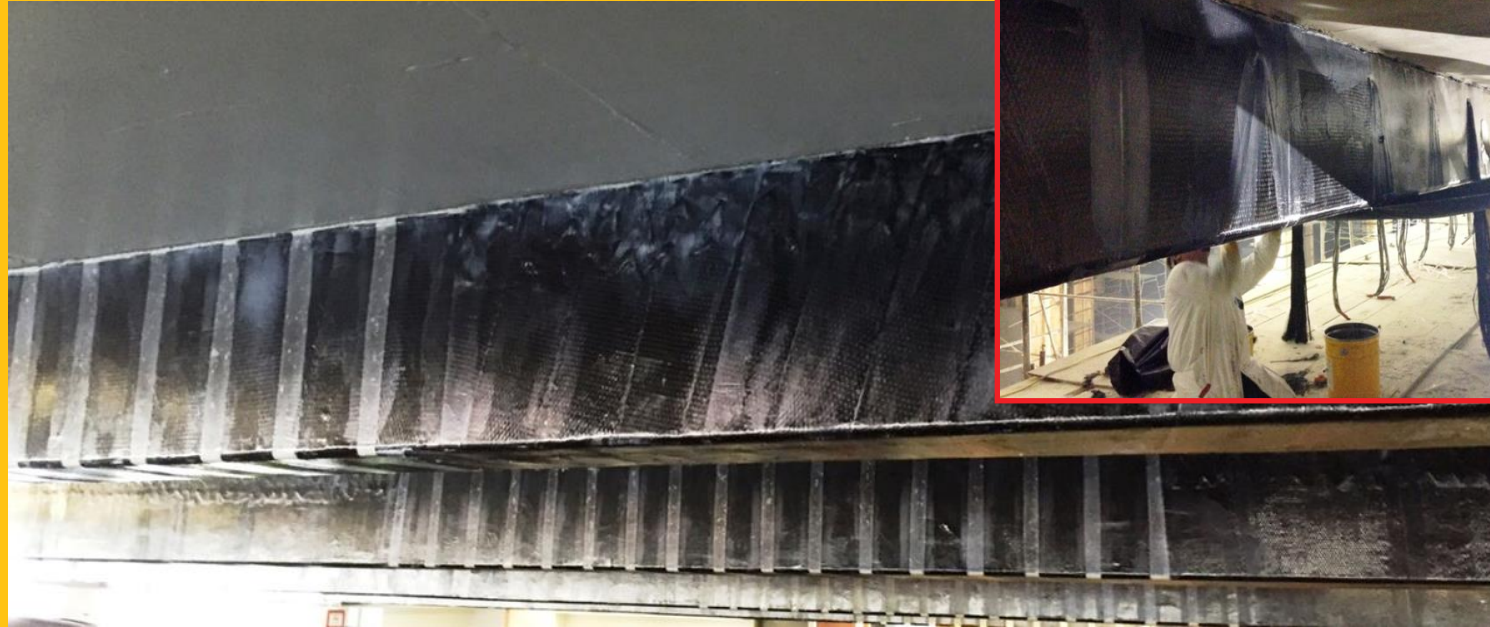
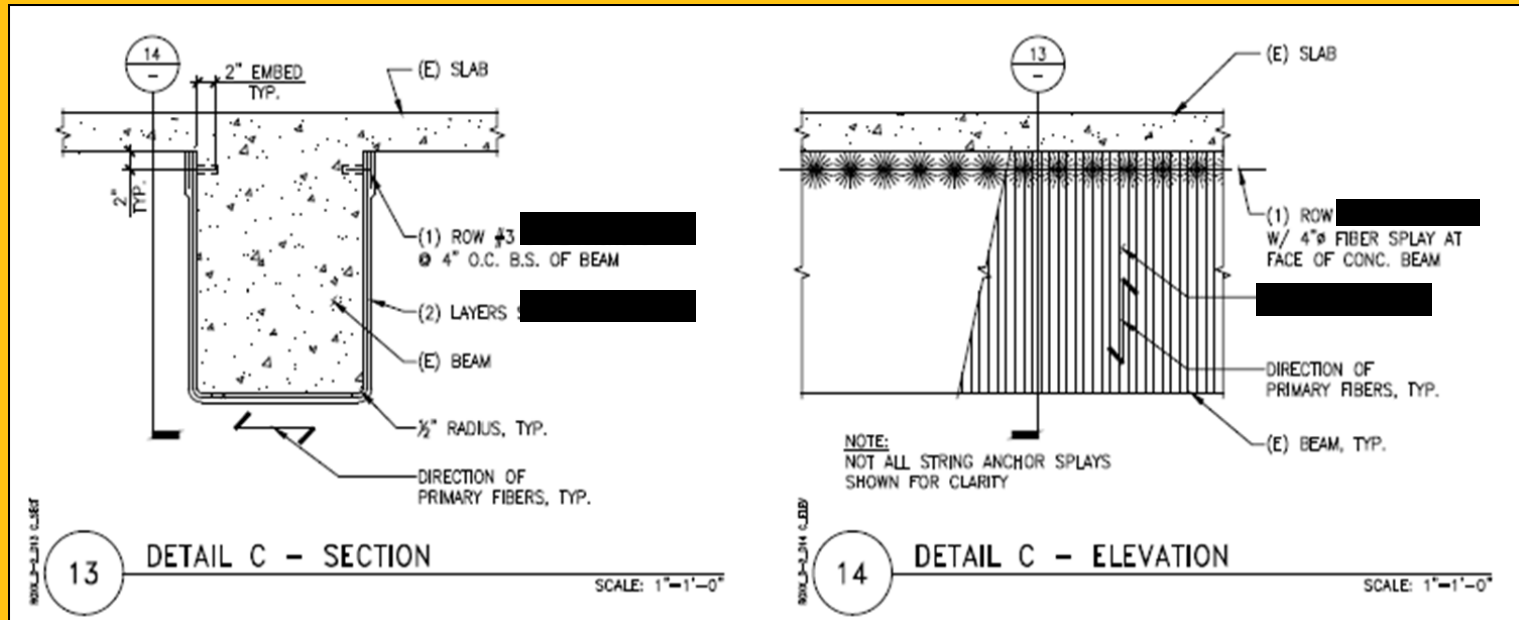
FRP REPAIRS
