**ICRI National
Convention**

Repair and Protection of Concrete Subject to Harsh Abuse in Mines and Elsewhere

- Physical Abuse
- Thermal Shock
- Chemical Attack
- Dynamic Loading

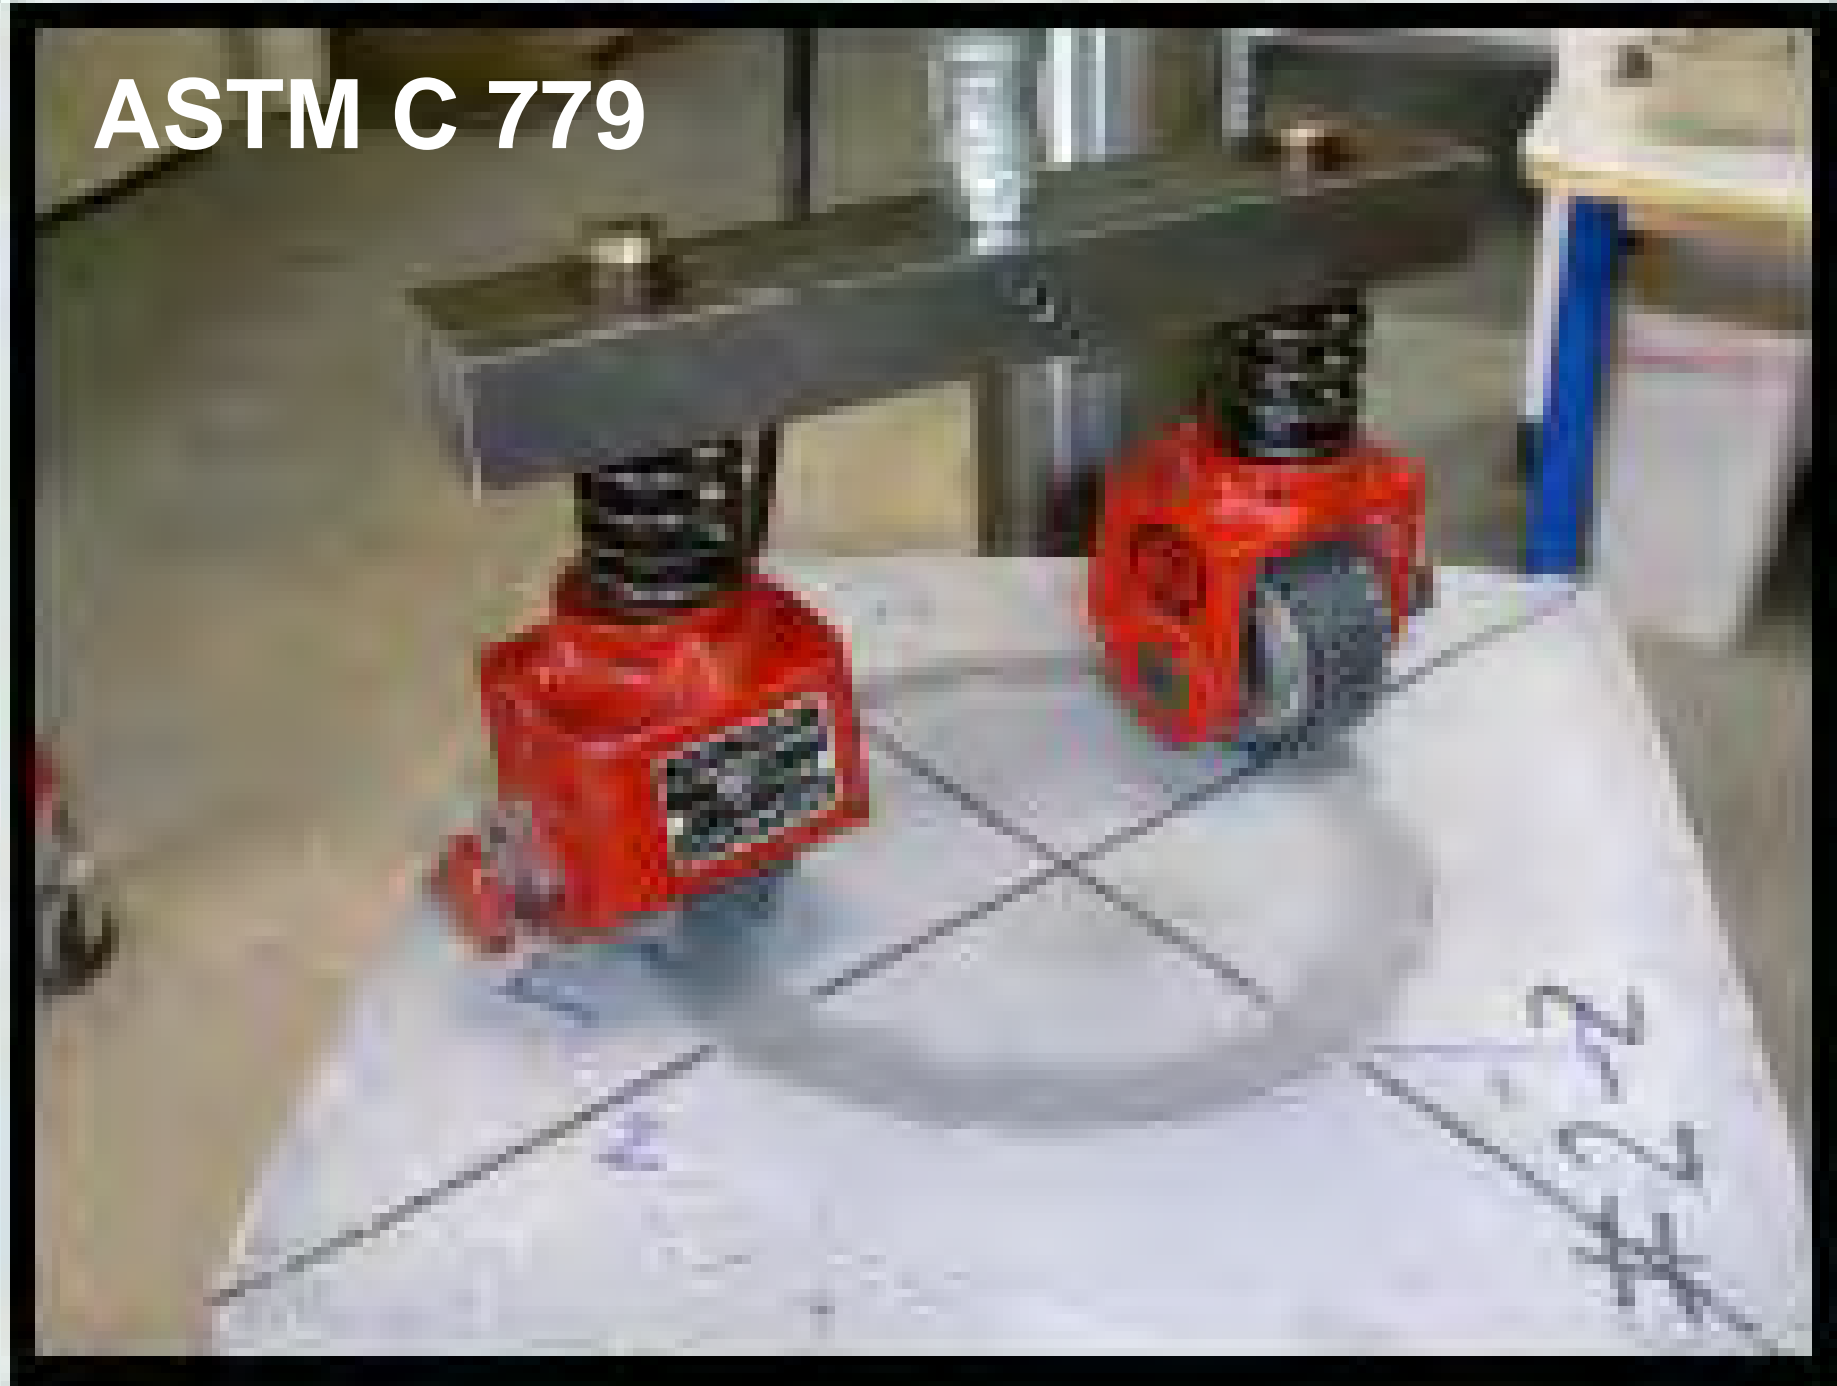
ABRASION RESISTANCE

ASTM C 779

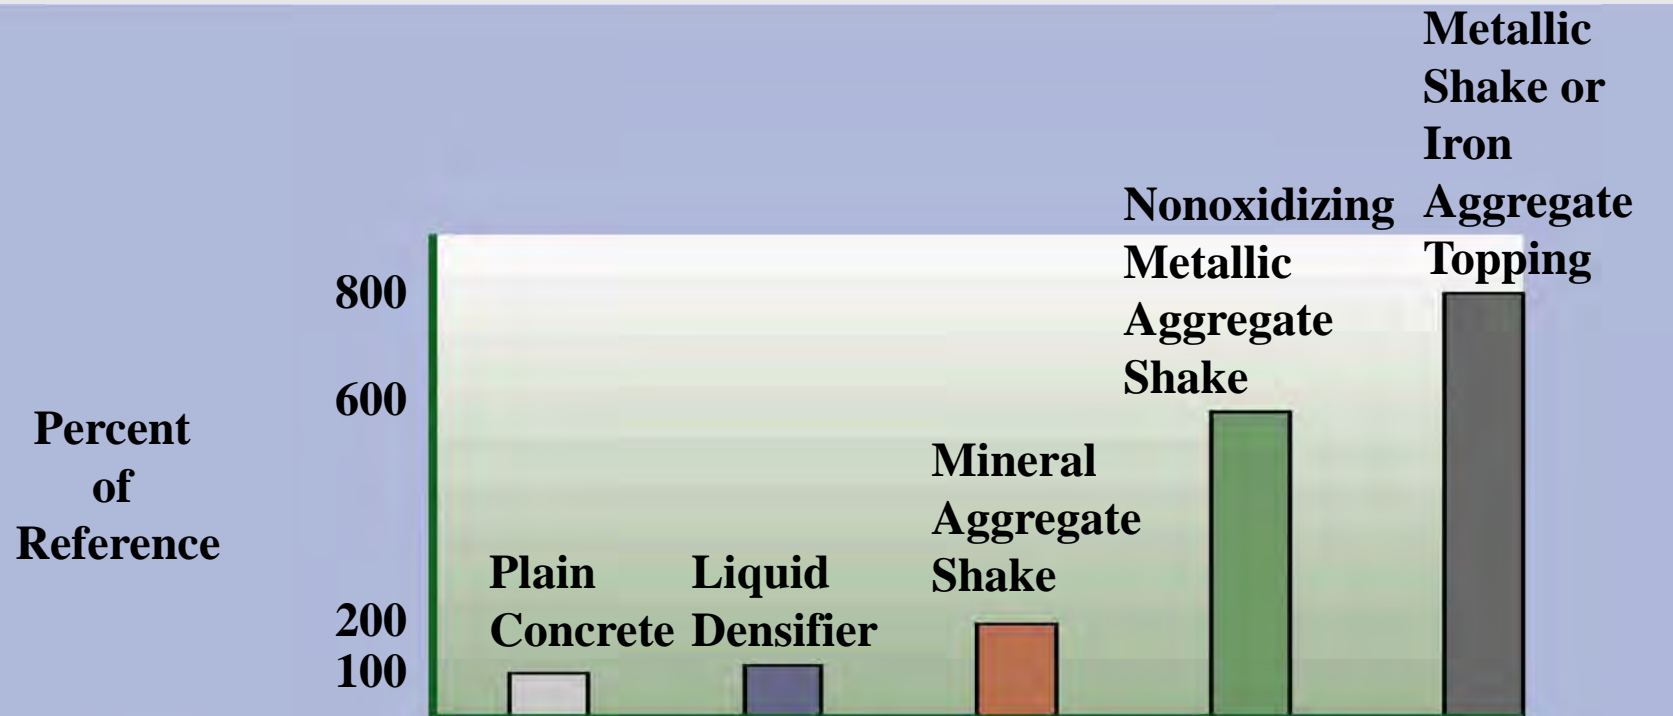
Relative Abrasion Resistance ASTM C 779

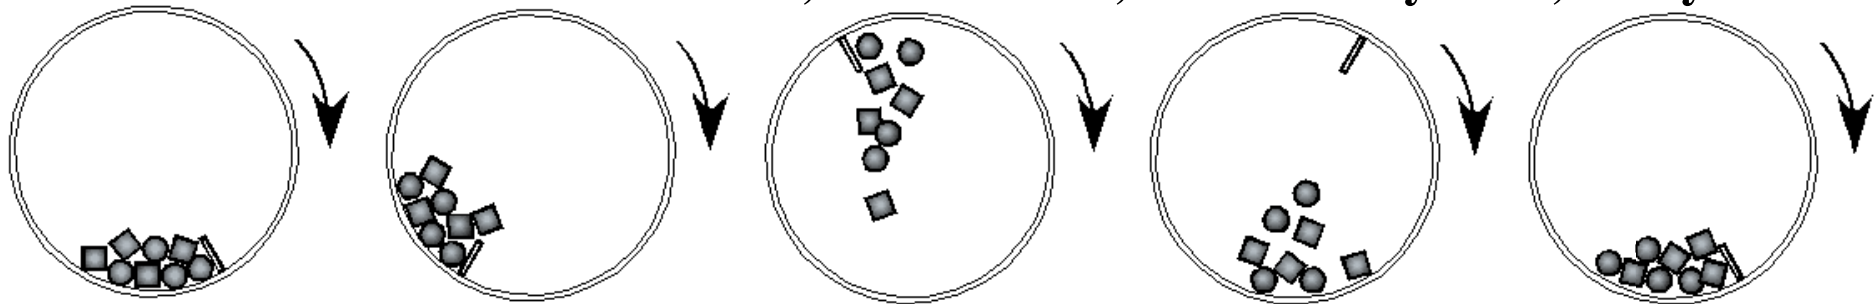
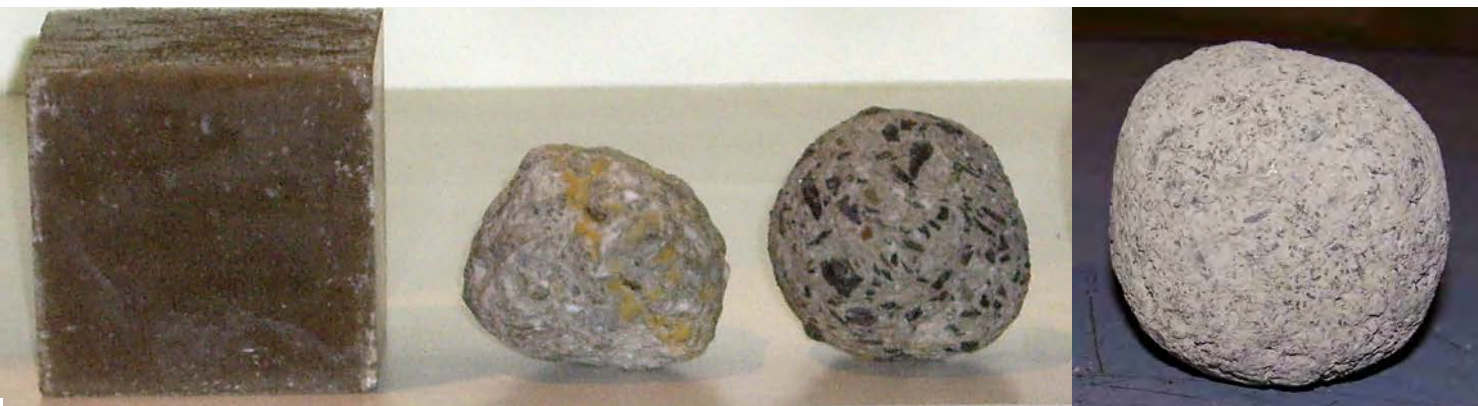
IMPACT RESISTANCE

LA Rattler: 2" cubes of material, 2" steel balls, rotate slowly for 2,000 cycles

2" cube

**4,000 psi
concrete**

**10,000 psi
concrete
with emery**

**12,000 psi
cementitious
topping
with iron
aggregate**

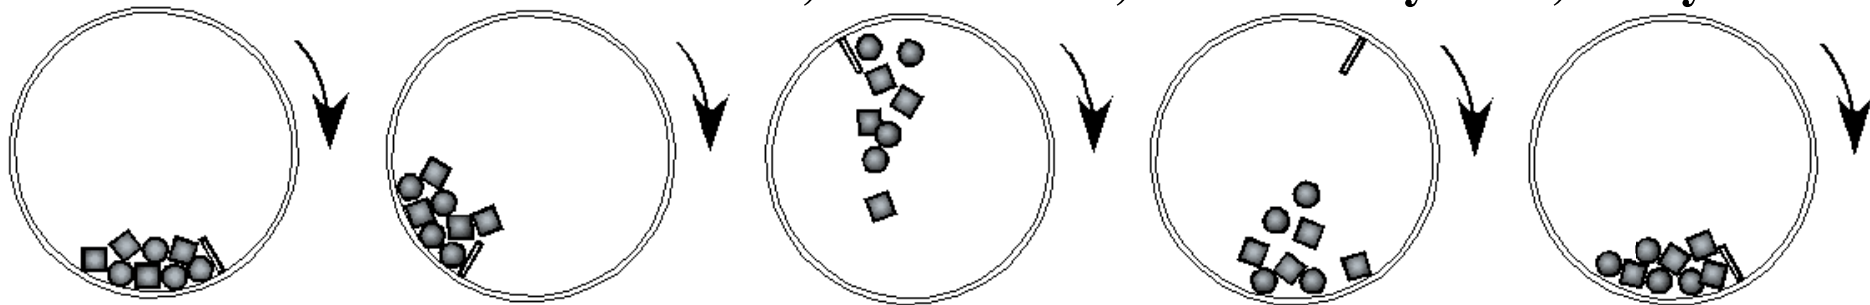
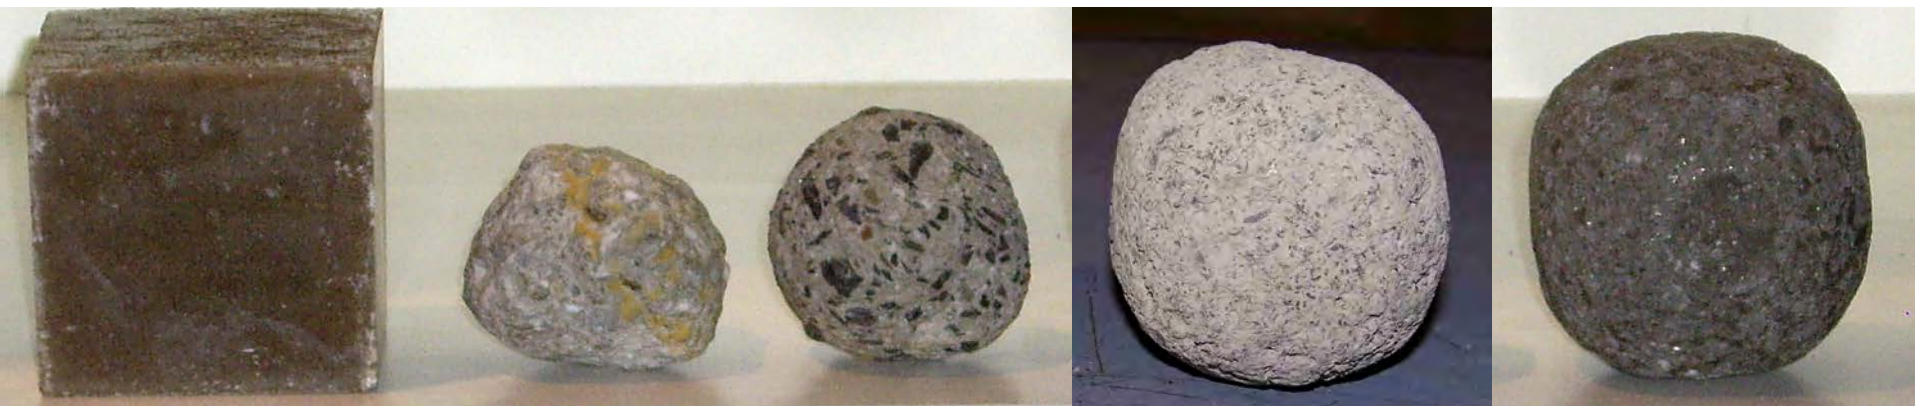
LA Rattler: 2" cubes of material, 2" steel balls, rotate slowly for 2,000 cycles

2" cube

**4,000 psi
concrete**

**10,000 psi
concrete
with emery**

**12,000 psi
cementitious
topping
with iron
aggregate**

**18,000 psi
cementitious
topping
with iron and
natural
aggregate**

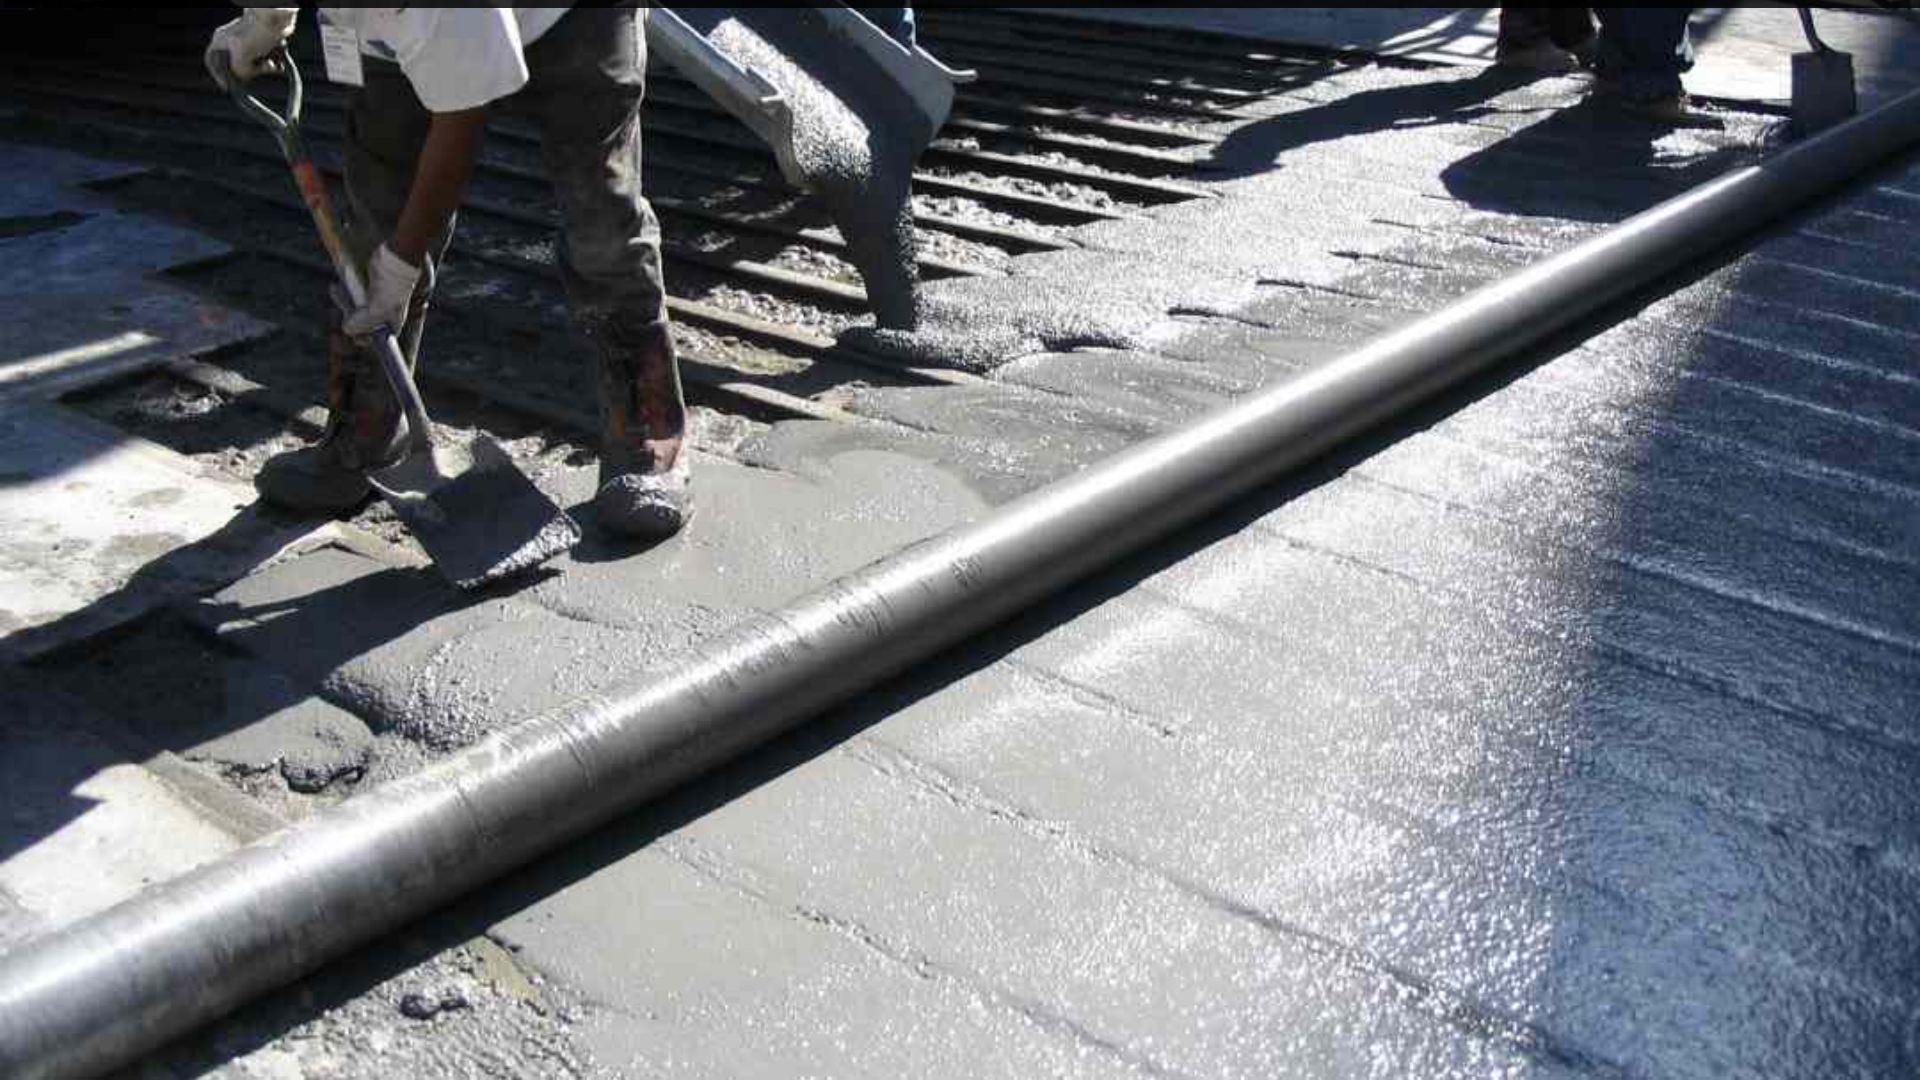
The concrete between the rails kept chipping out because every rail created two more joints in the slab and joints are problems.

Using iron aggregate topping to infill the damage between rails finally solved their problems.

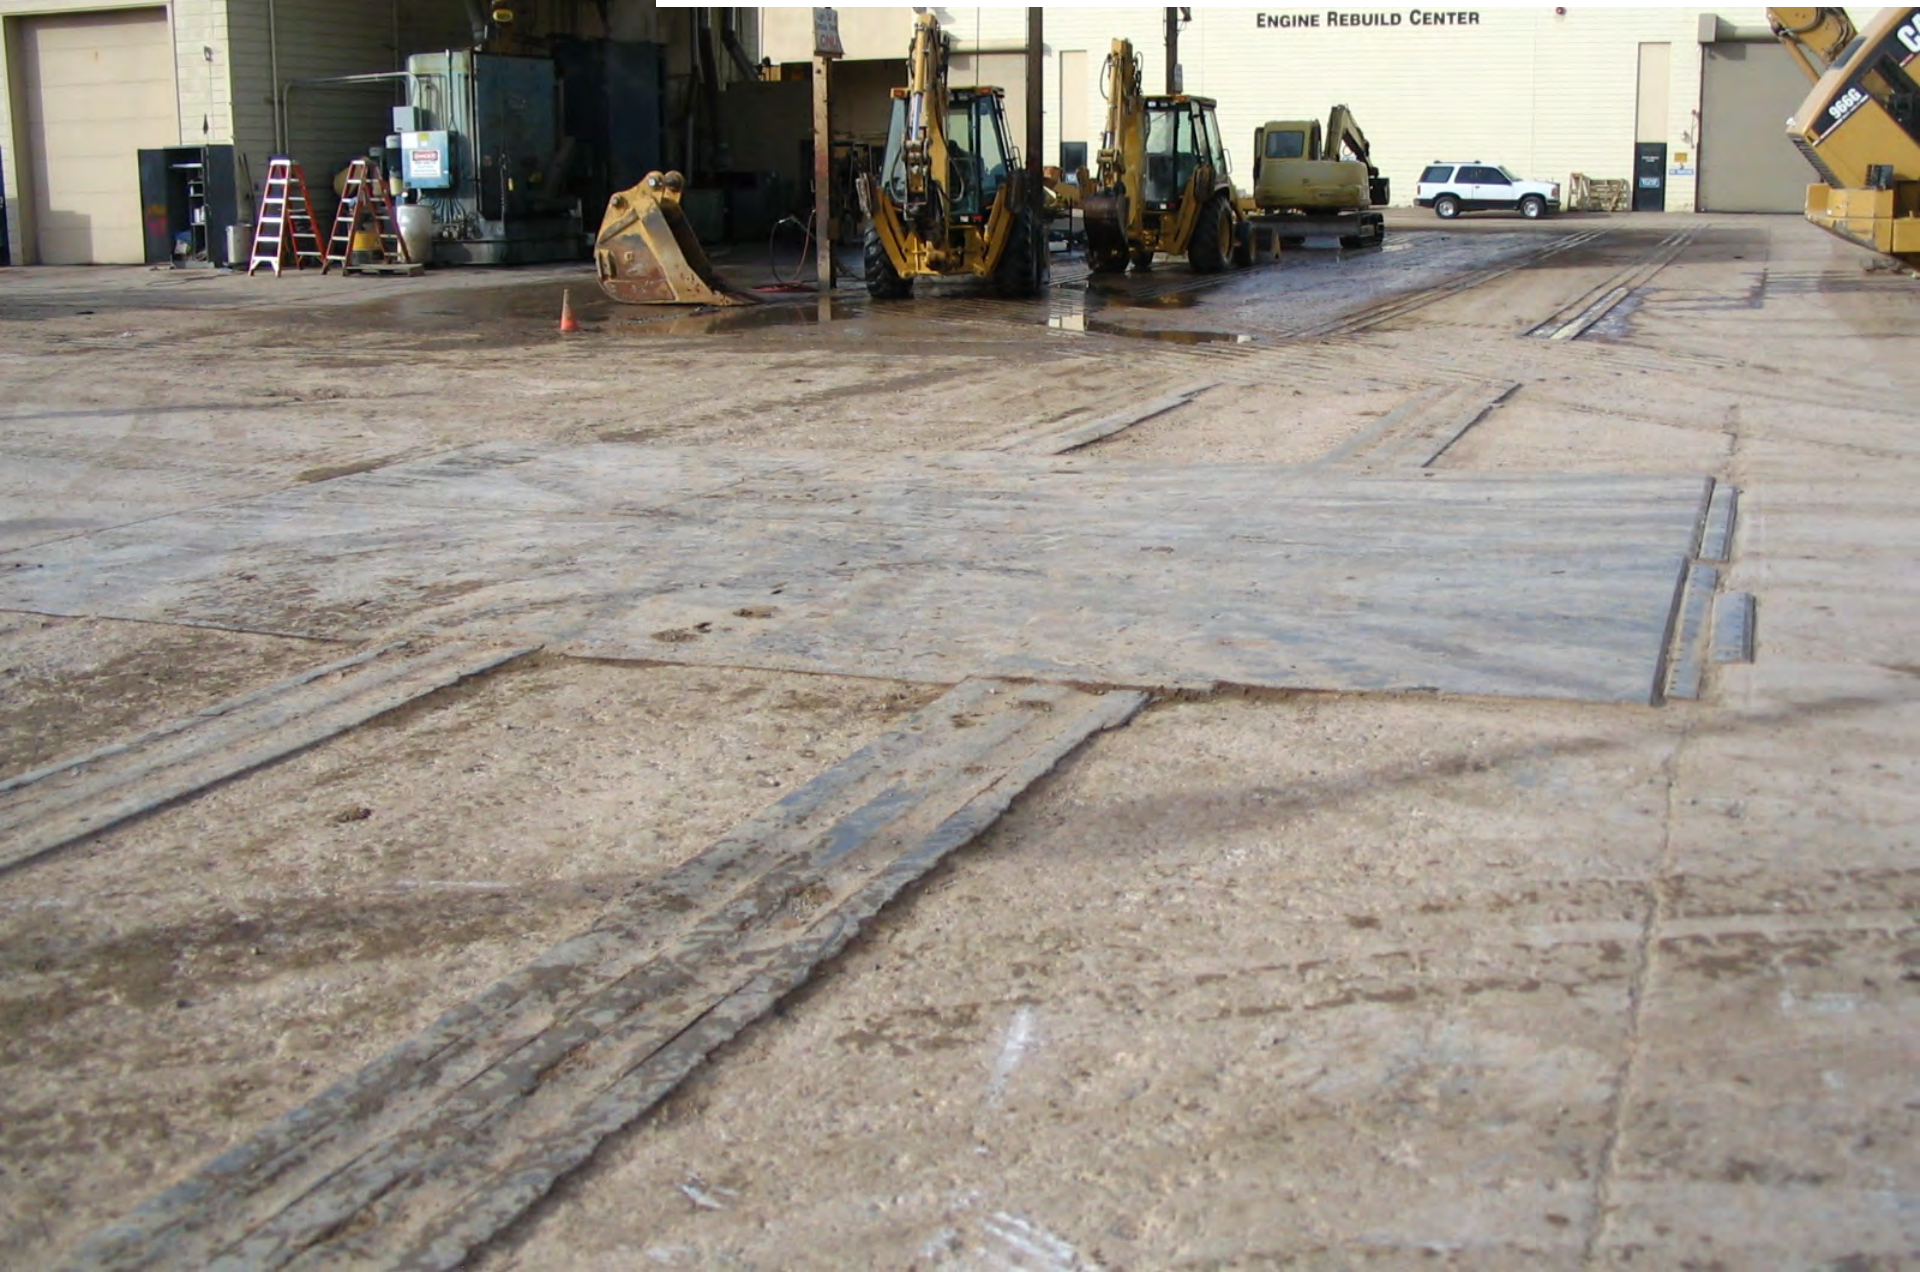
Wear between steel rails and around steel plates turned their yard into a washboard.

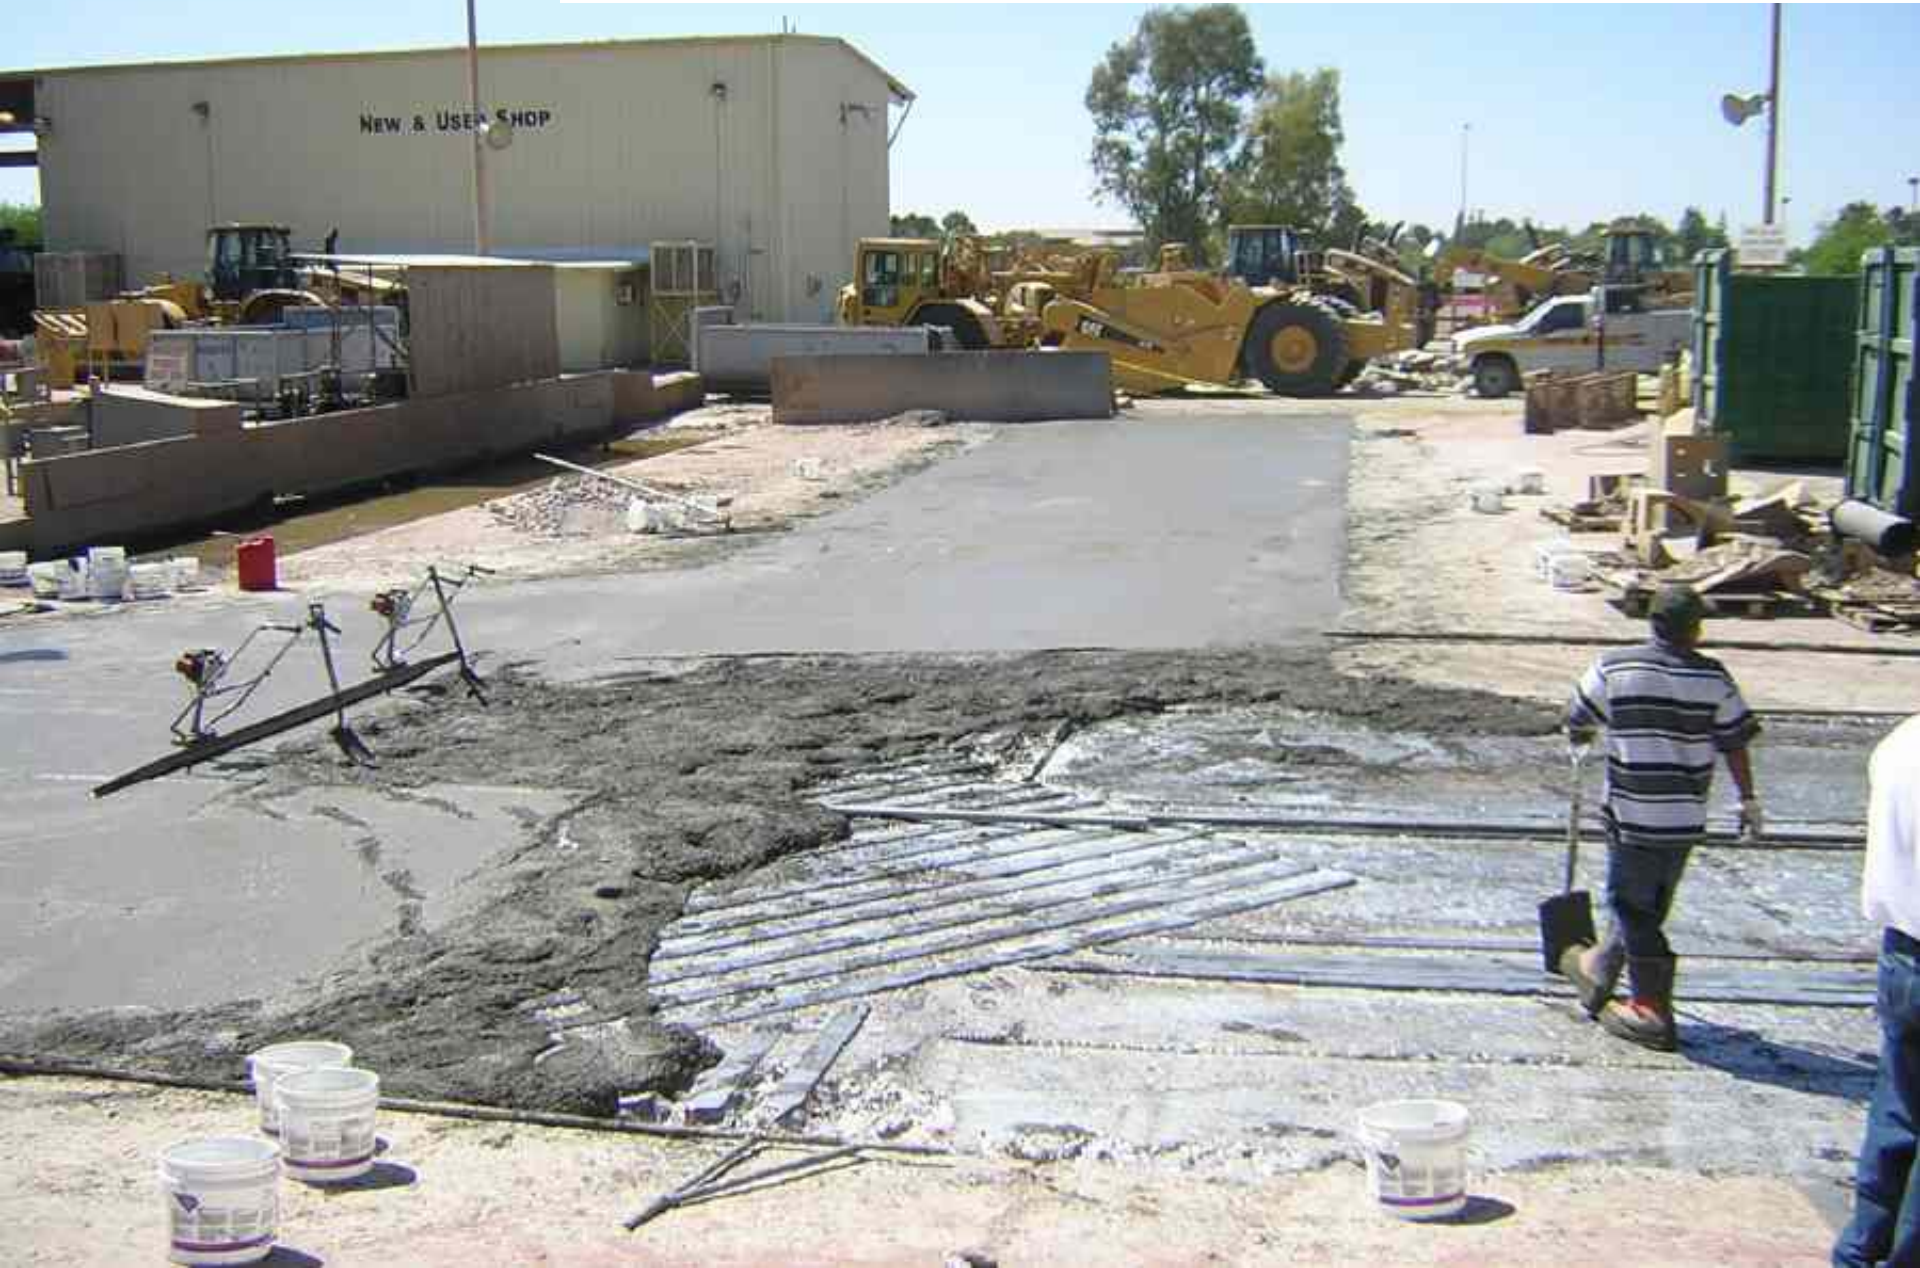
It was such a maintenance problem for them, they covered it all with iron aggregate topping.

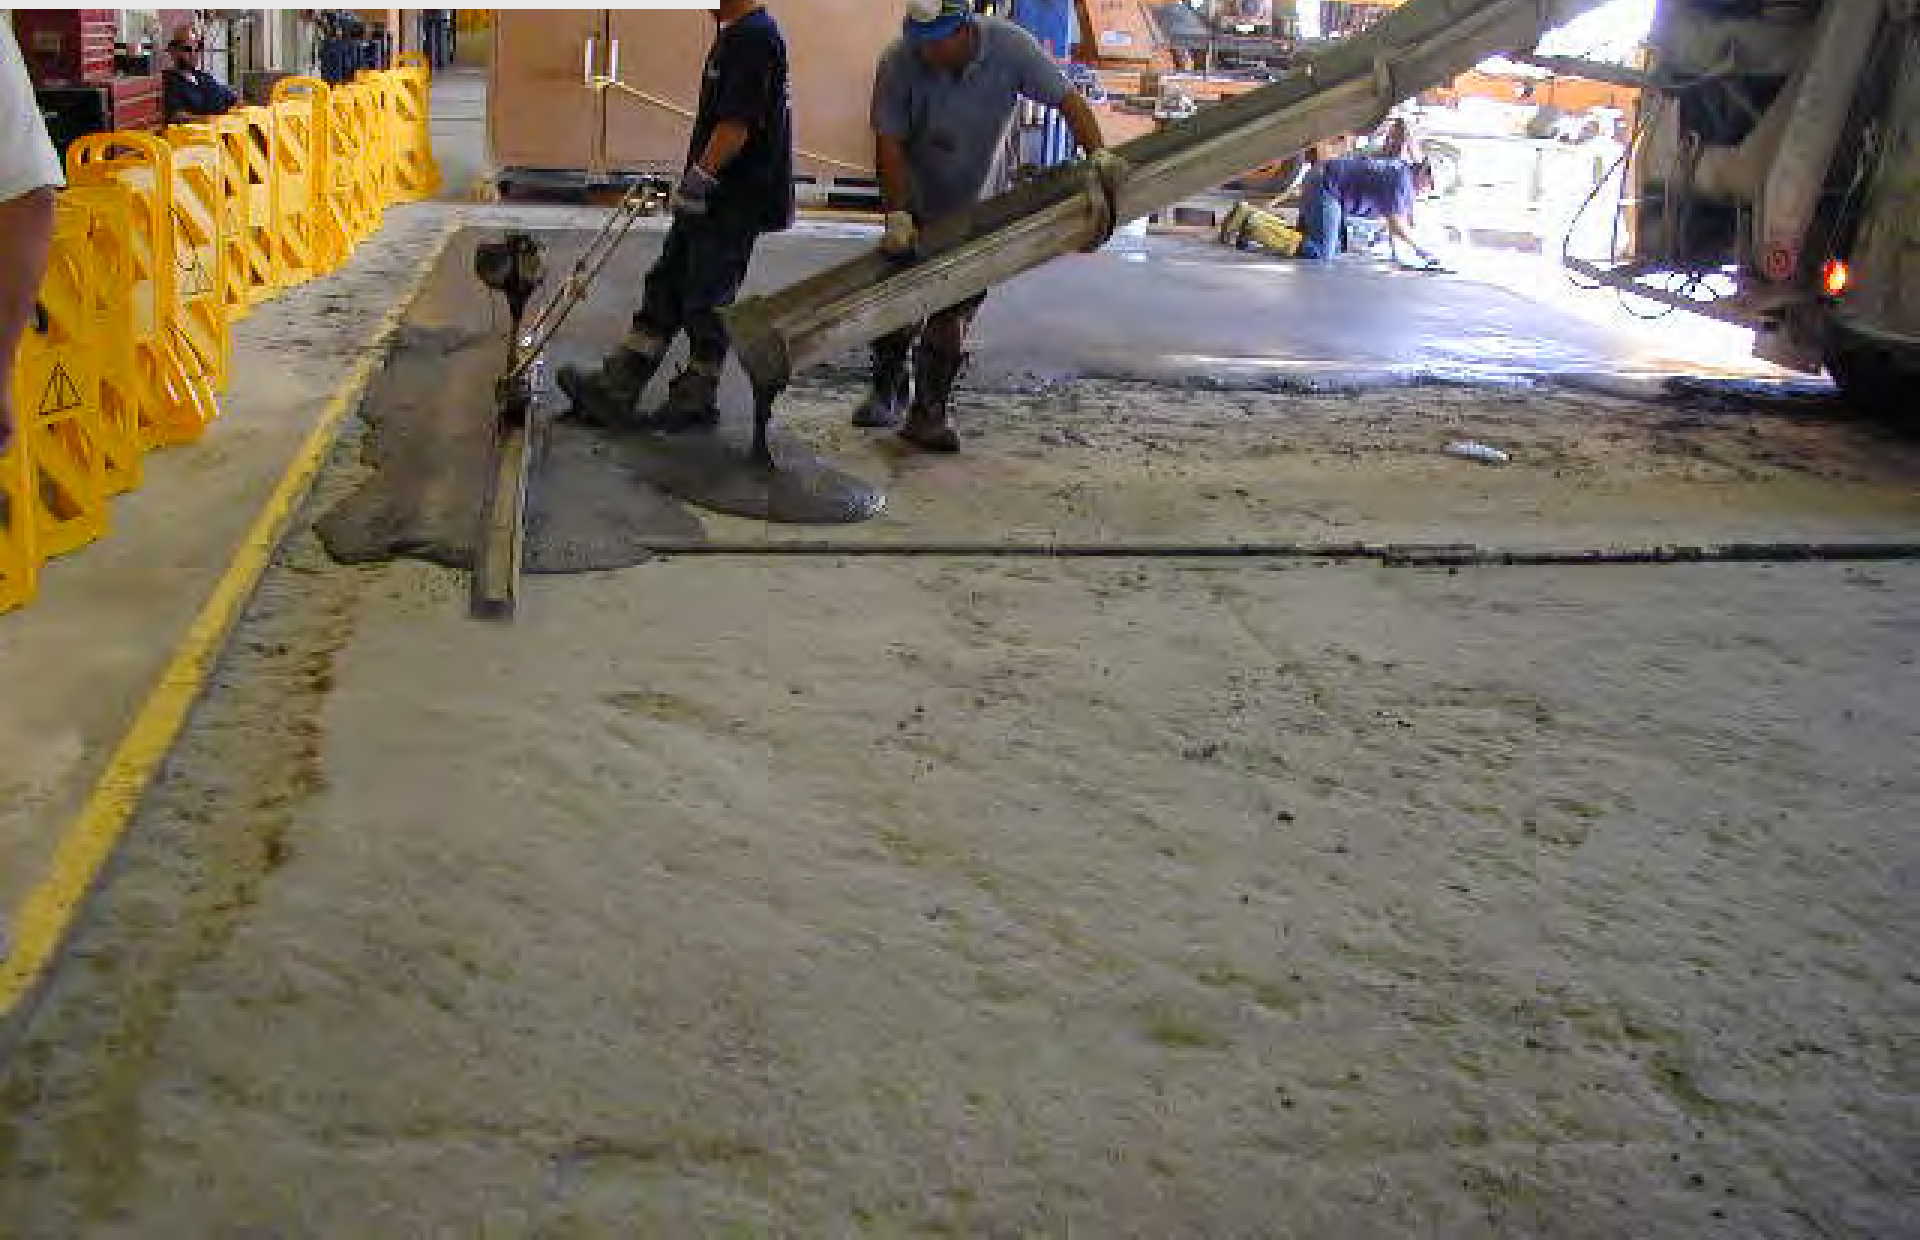
Proper Surface Preparation
Keyed Edges
Bonding

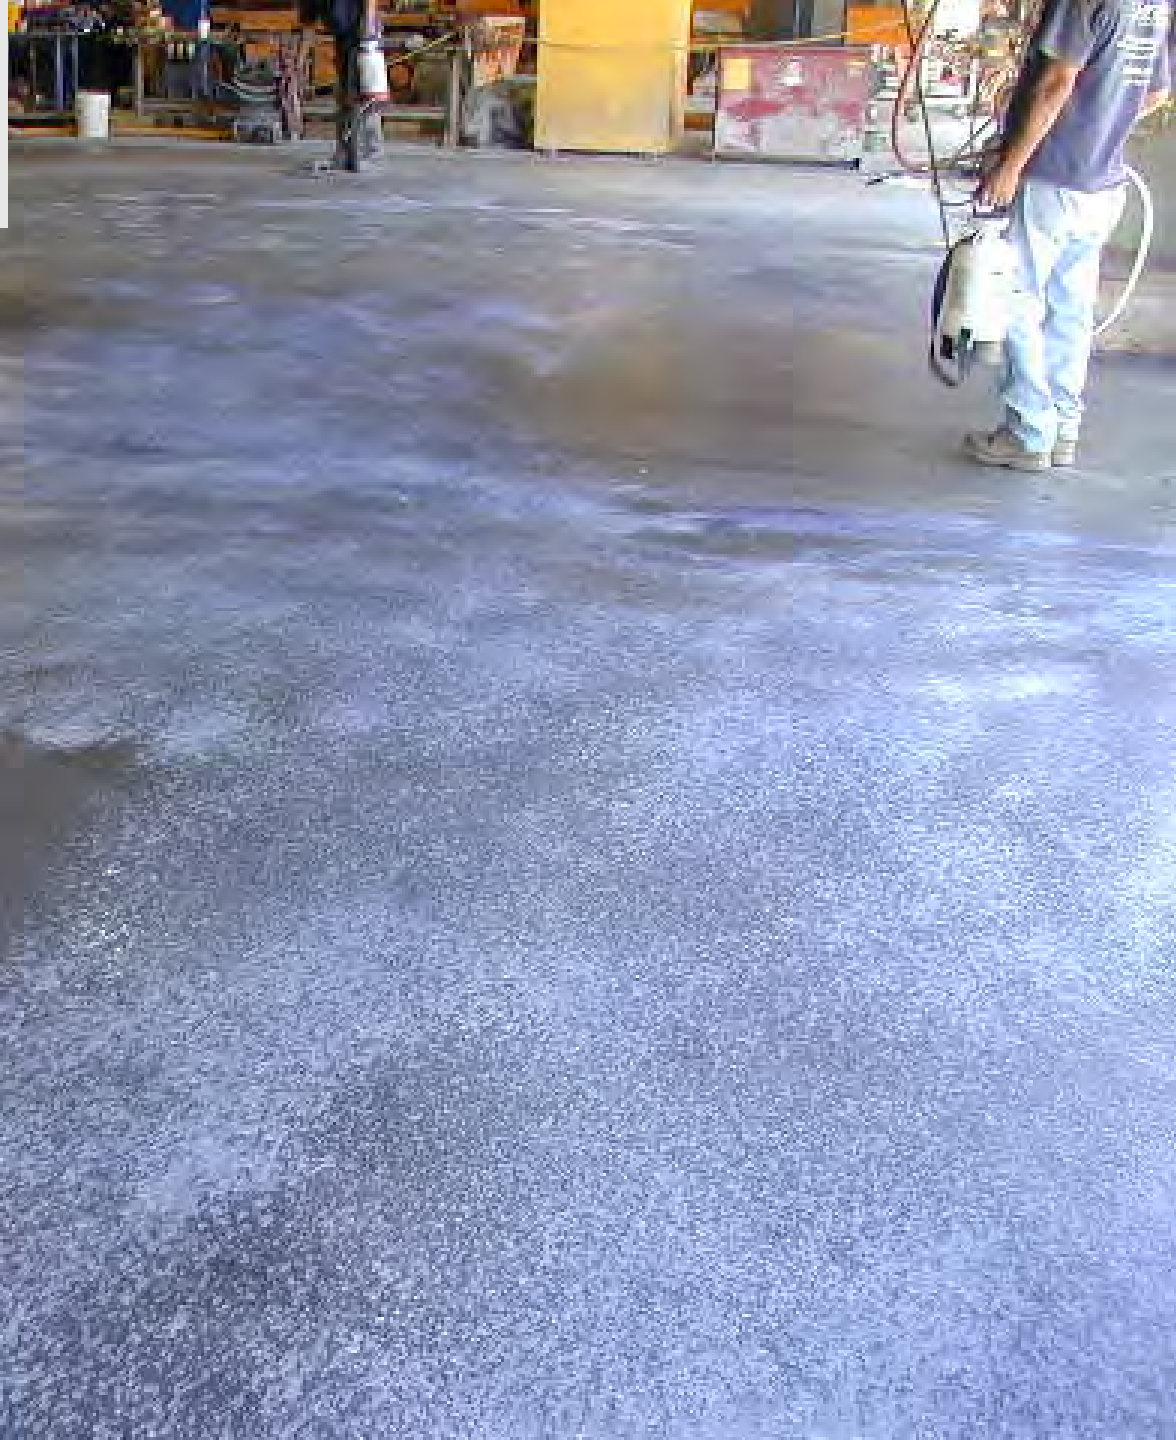
**SPEC NEEDS TO SAY:
“Backroll with short nap roller.”
This makes the coverage uniform.**

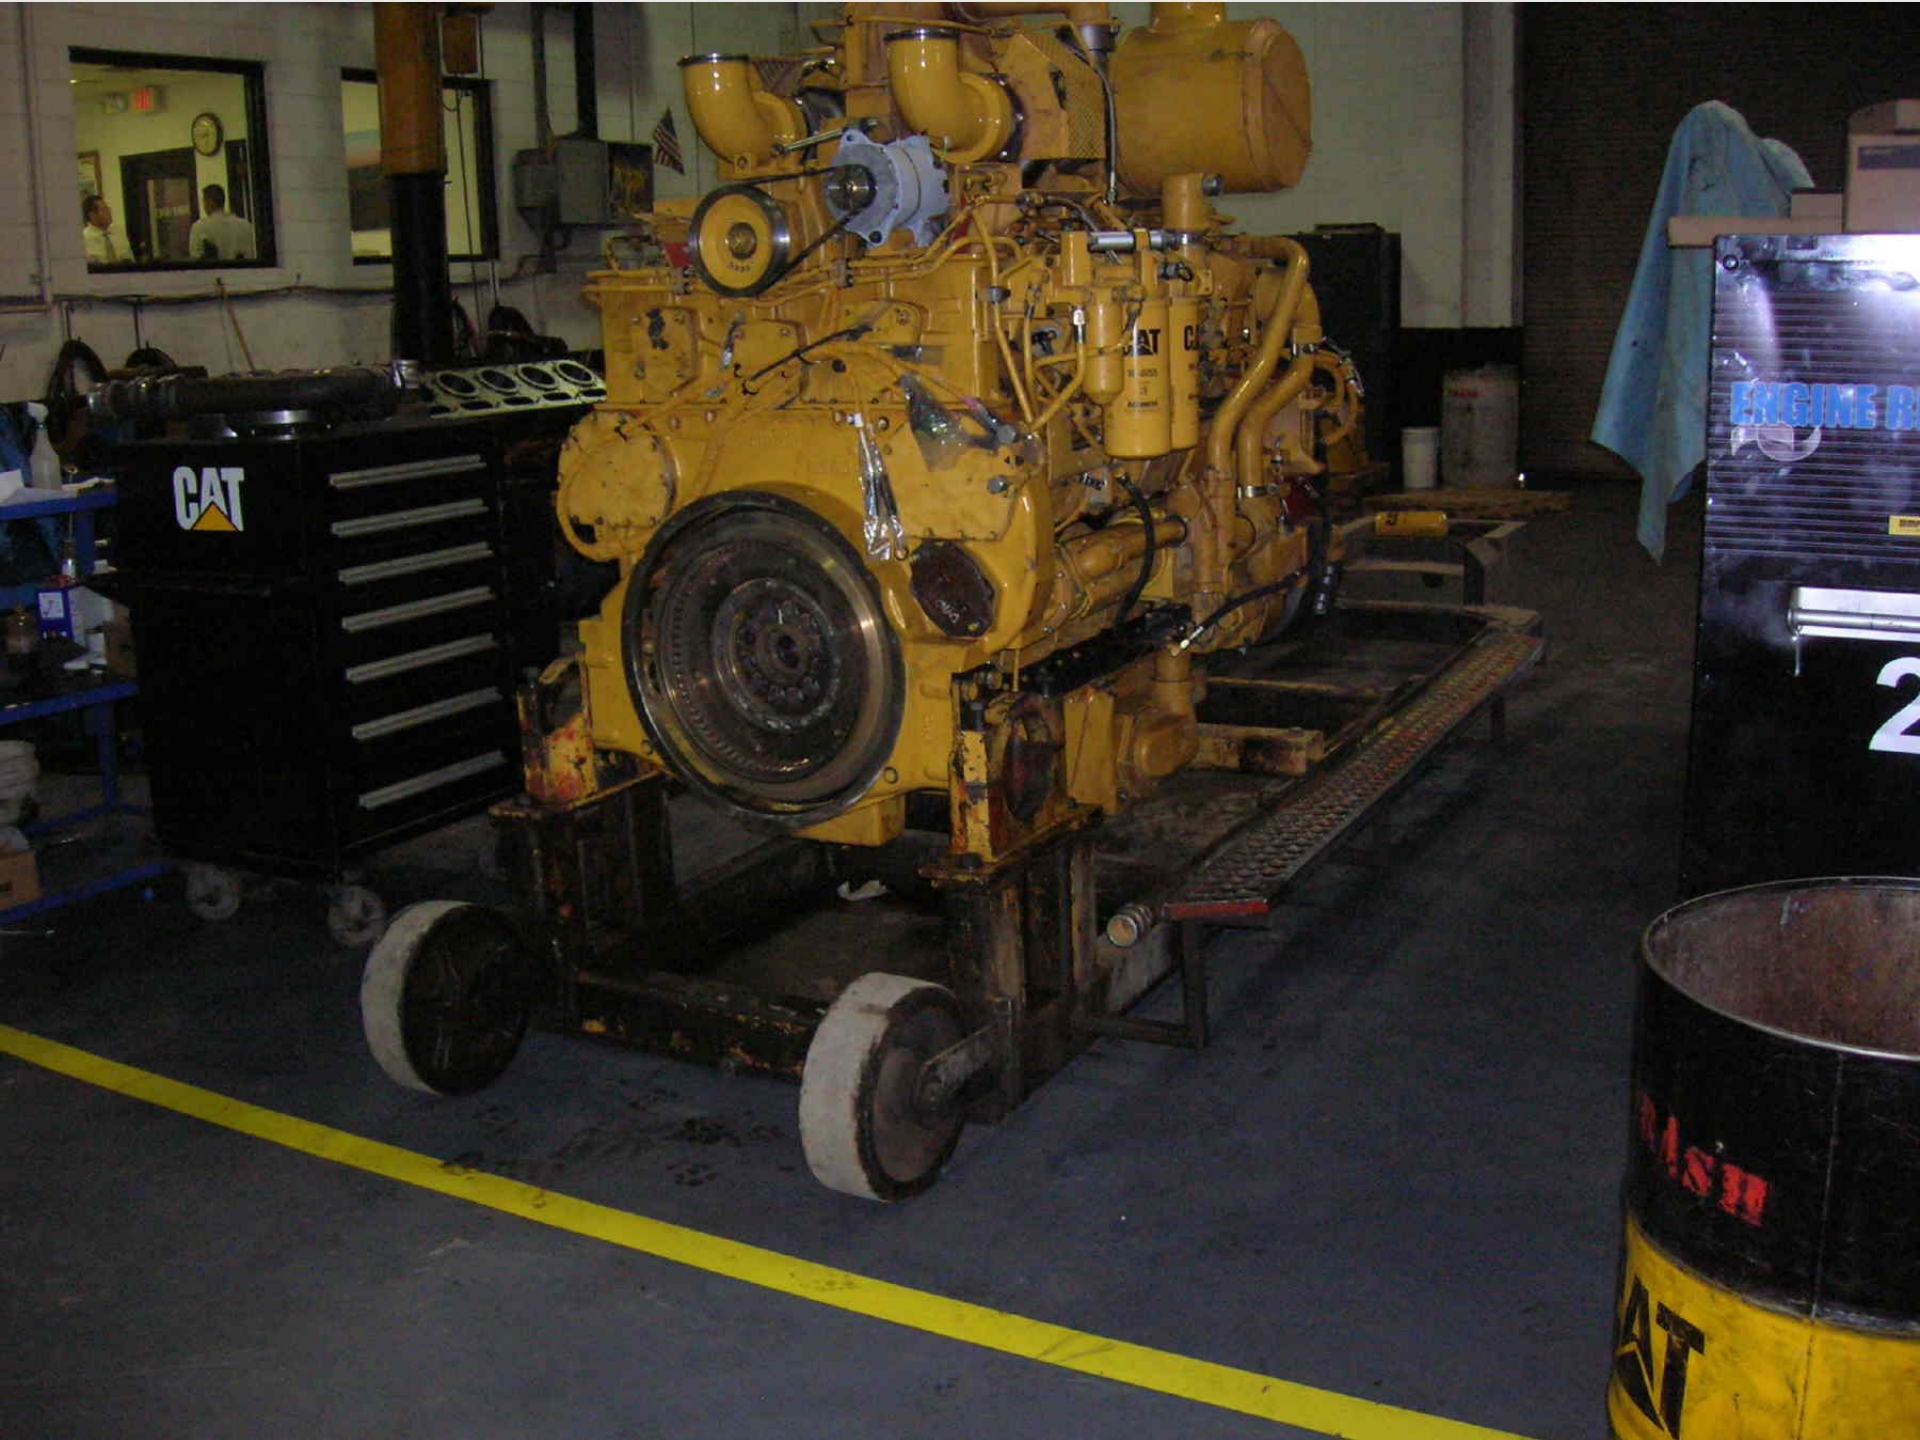
1/4" Trowel Down

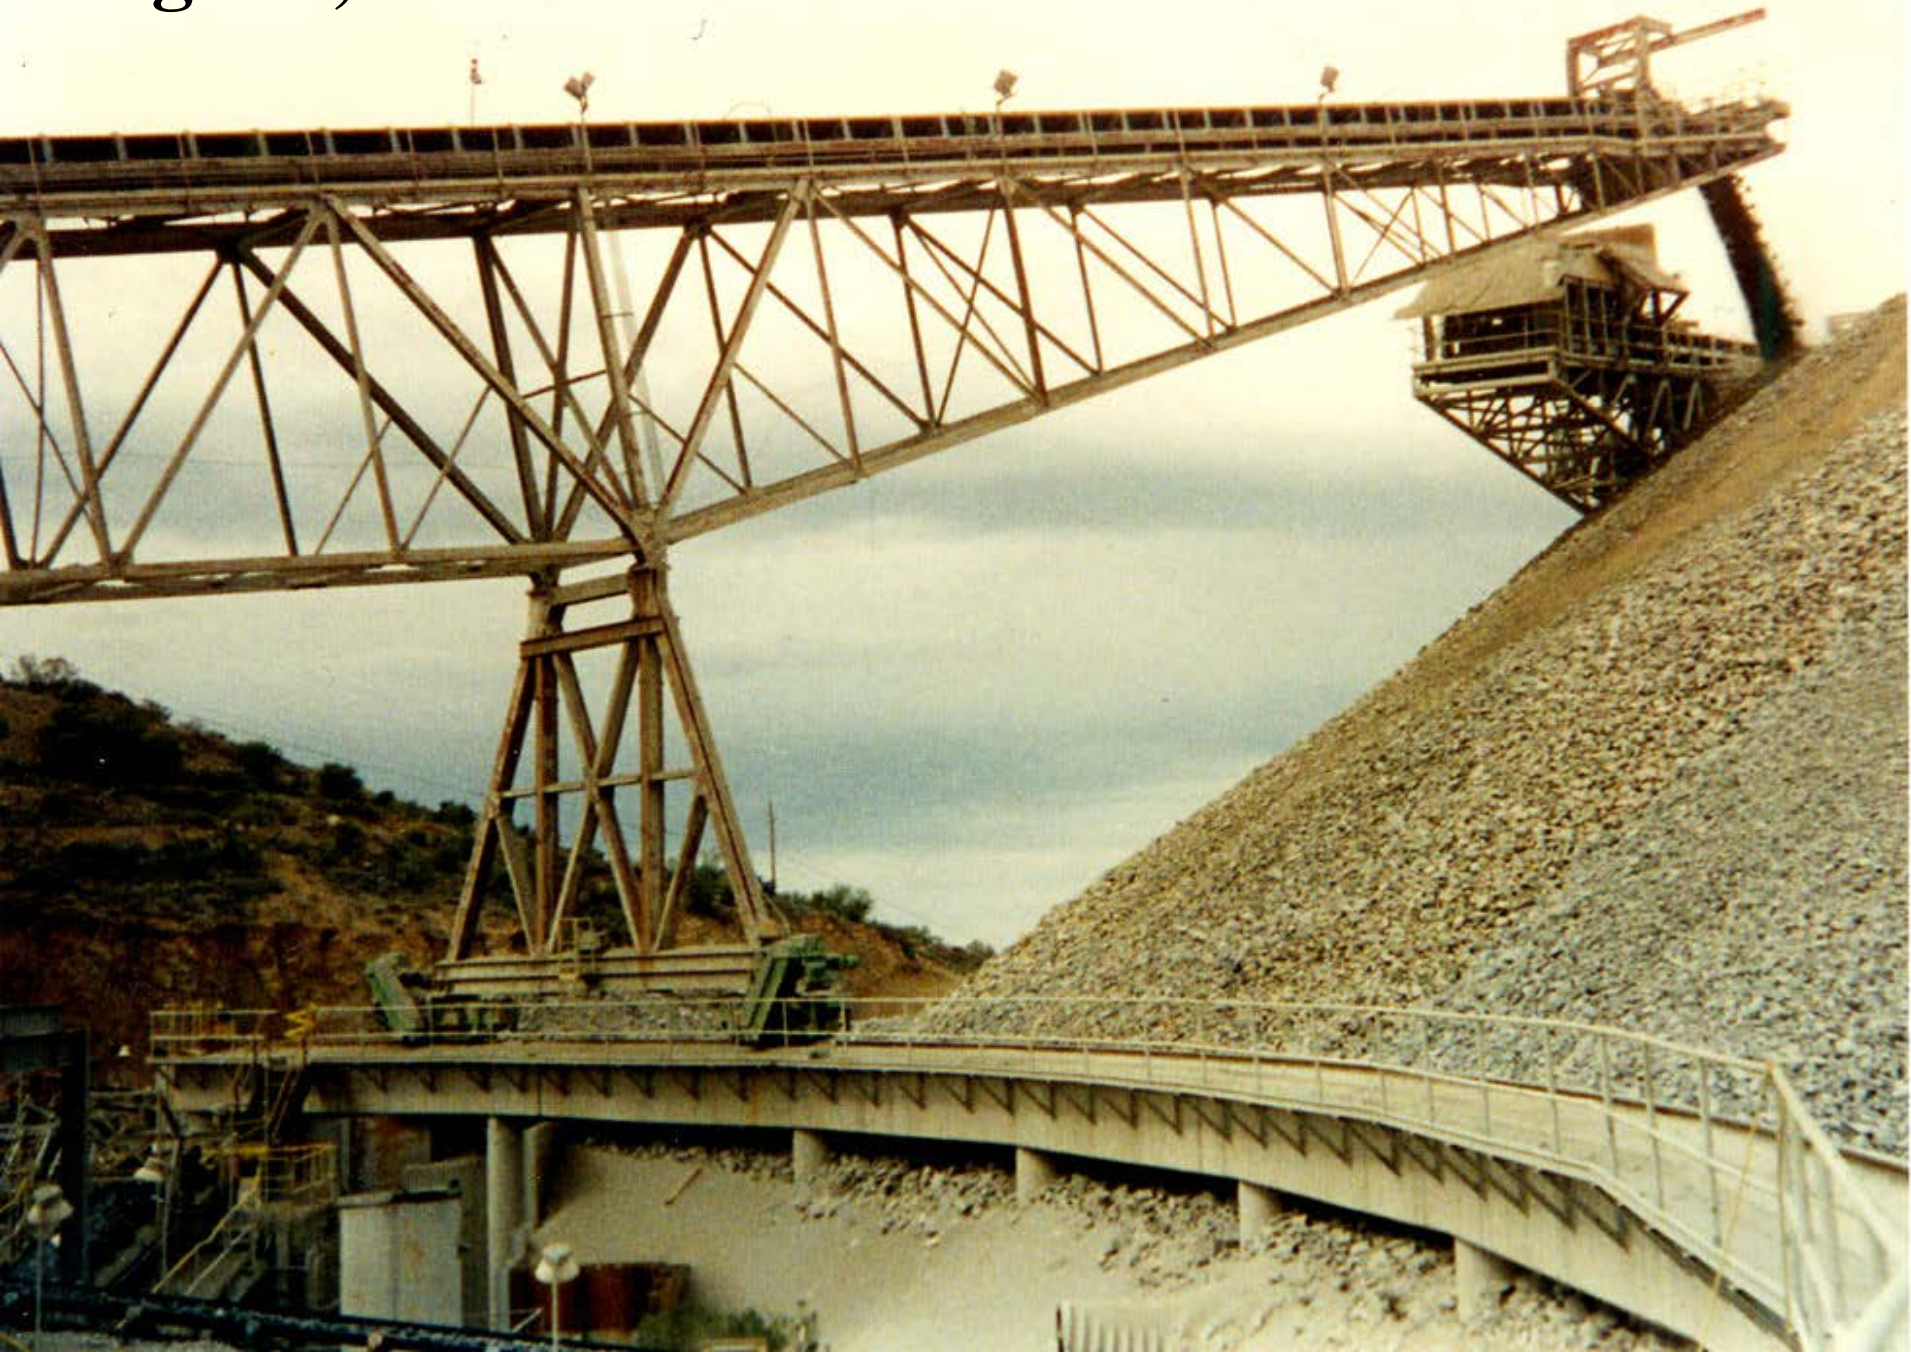
CEMENTITIOUS GROUT

Bagdad, AZ
