**ICRI National
Convention**

Repair and Protection of Concrete Subject to Harsh Abuse in Mines and Elsewhere

- Physical Abuse
- Thermal Shock
- Chemical Attack
- Dynamic Loading

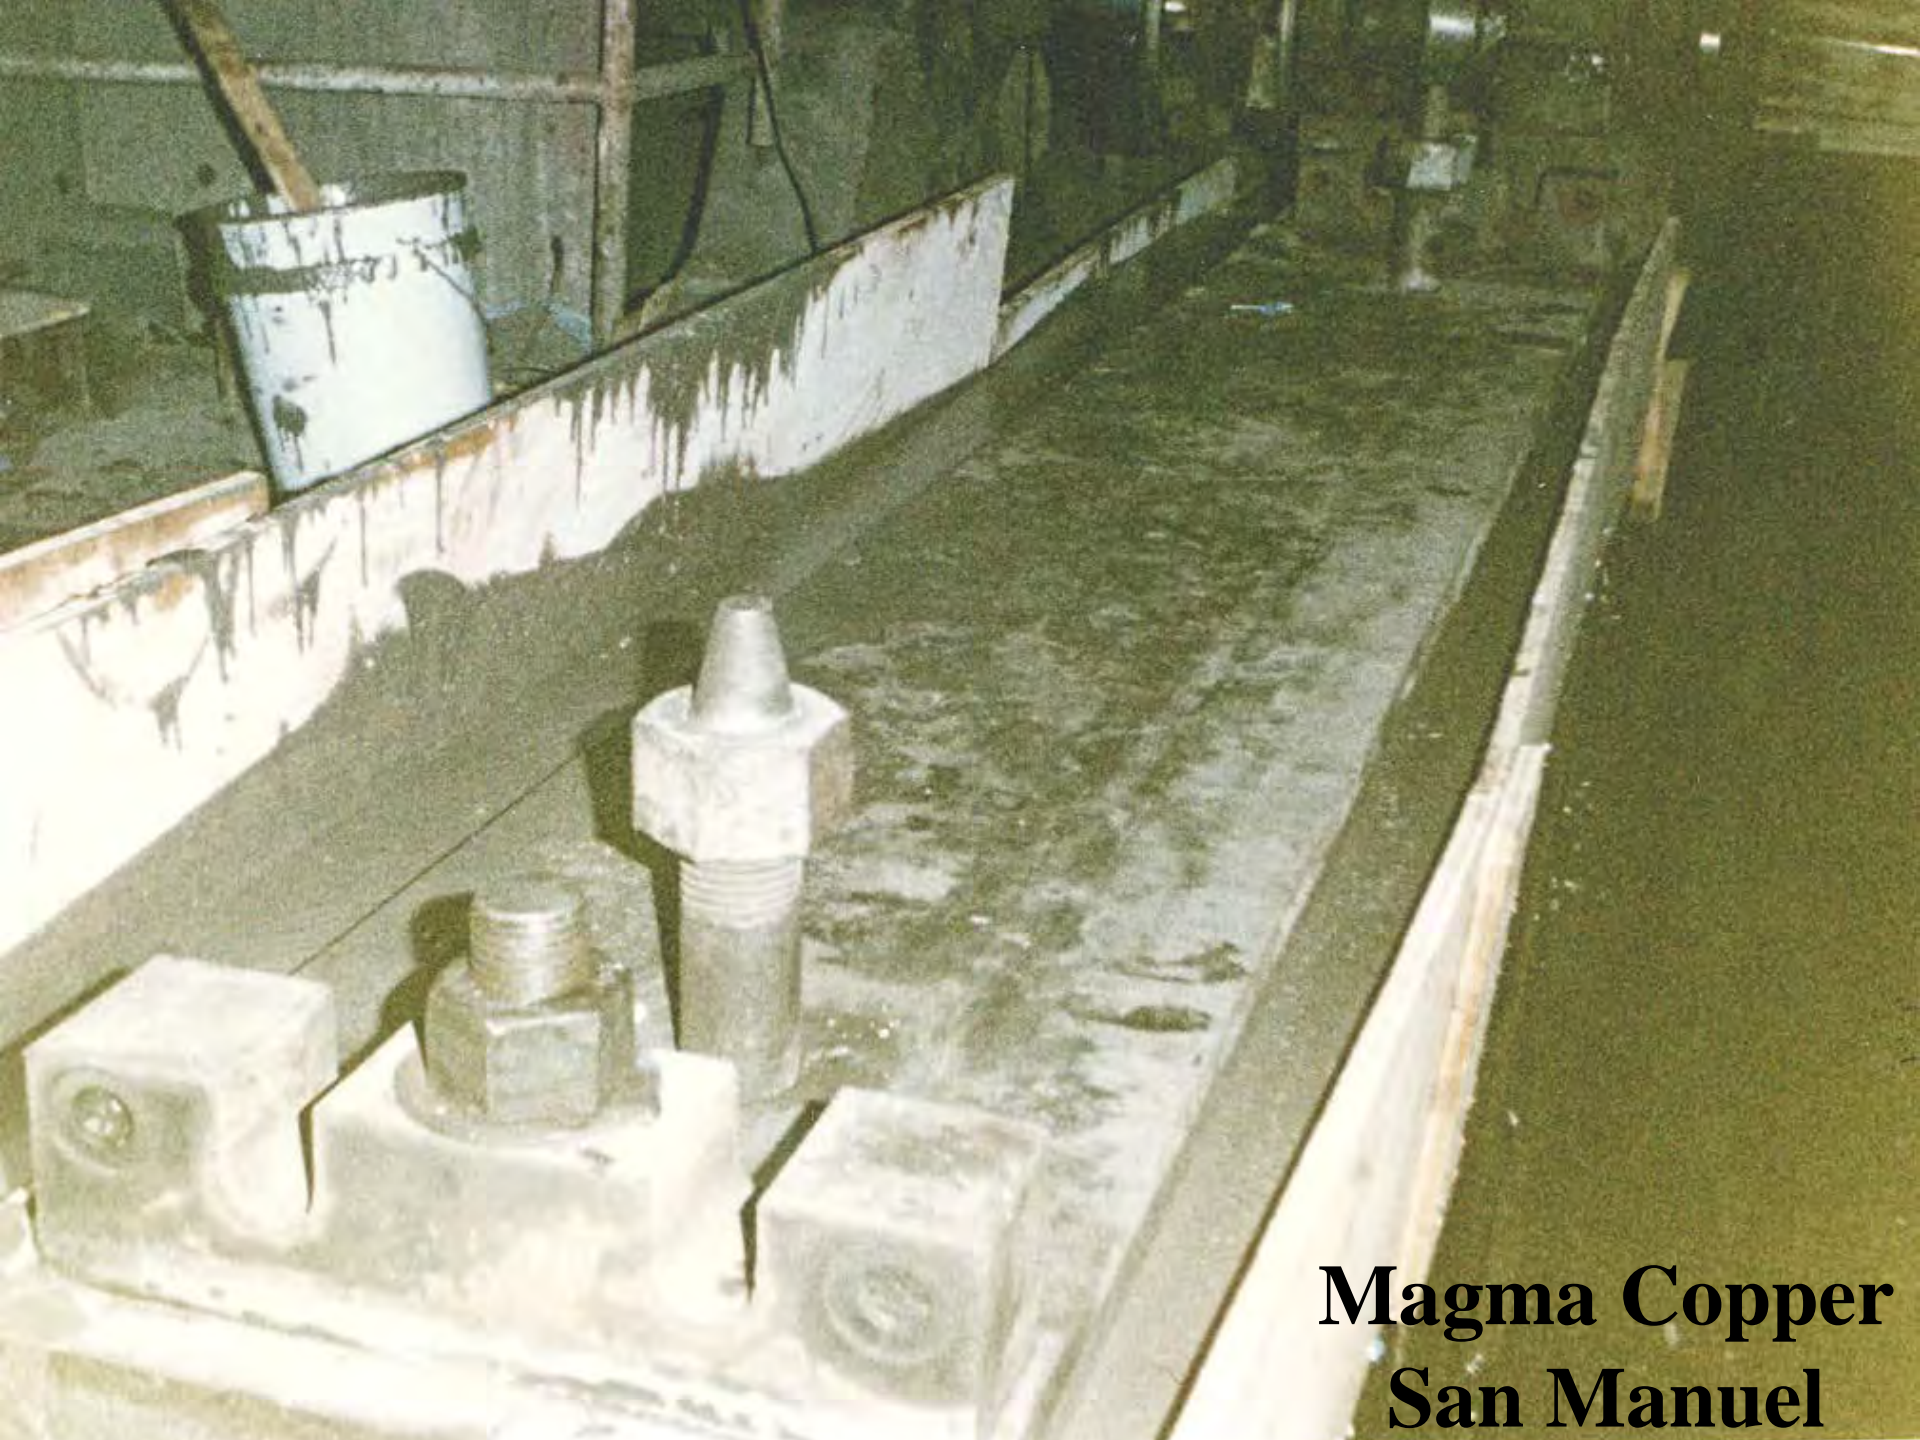
EPOXY GROUT

DIFFERENCES BETWEEN CEMENTITIOUS AND EPOXY GROUTS
