ASSESSMENT AND RESTORATION OF POST-TENSIONED PARKING RAMP STRUCTURES

BY GABRIEL A. JIMENEZ

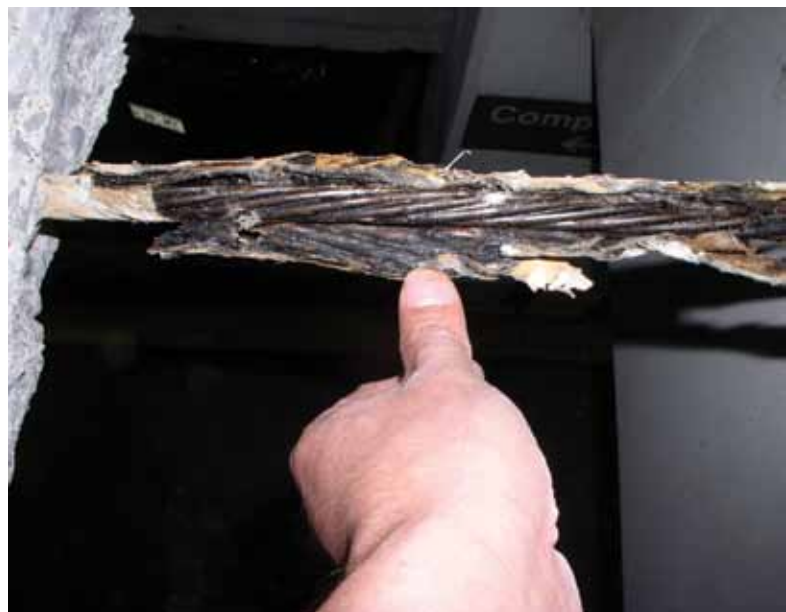
Fig. 4: Emulsified PT coating (grease) from a paper-wrapped system

The corrosion performance of paper-wrapped button-headed wire tendons has had many problems, particularly in the past 25 to 30 years. The paper wrapping inevitably provides minimal protection against moisture and chloride ion intrusion. The paper was easily damaged during concrete placement, which was exacerbated by inadequate cover, low quality concrete, and concrete cracking (refer to Fig. 4).

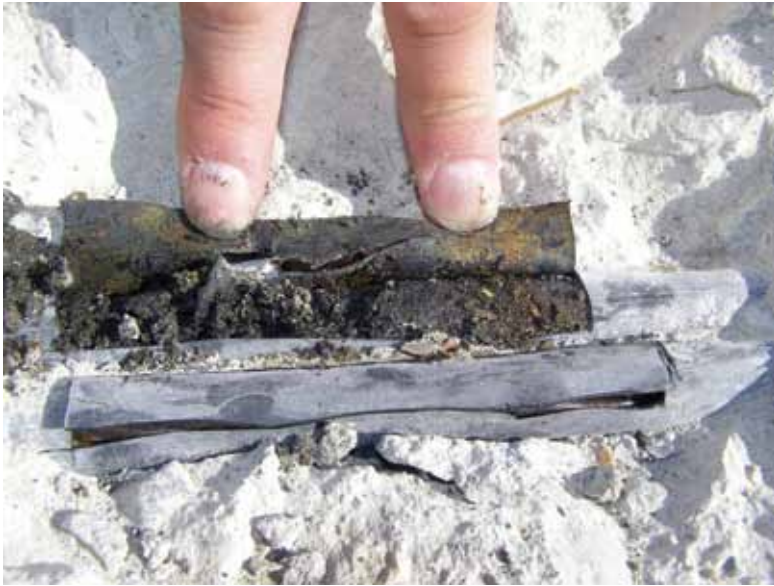
Fig. 5: Exposed strand with severe corrosion and wire section loss for a push-through system

In the push-through system, the coated strand was pushed into a preformed plastic tube. The push-through heat-sealed plastic sheathings were loose-fitting, and the extruded type was tight-fitting. Both the push-through and the heat-sealed sheathing left a large void around the tendon where the unfilled, or partially filled, annular space was susceptible to moisture intrusion. In addition, the lap weld was poorly performed on many occasions and would open during handling and installation; this allowed moisture to penetrate and the grease to leak out. The loss of grease, or coating, made the strand more susceptible to corrosion damage as well as increased the friction during stressing (refer to Fig. 5).

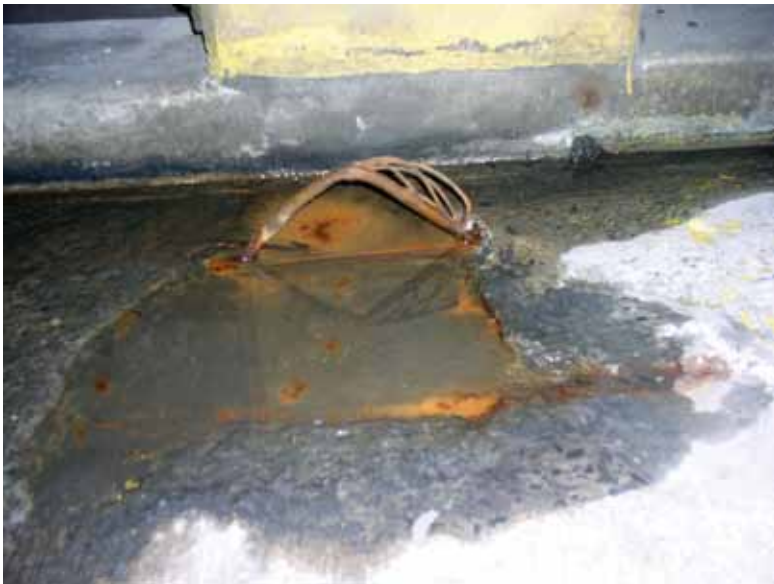
Fig. 6: Post-tensioning tendon failure due to corrosion

Cross-sectional loss of prestressing tendons due to corrosion has a significant impact on the load-carrying capacity and integrity of the parking ramp structure itself. Release of the post-tensioning force due to tendon failure sometimes causes the tendon to break the surface of the slab (refer to Fig. 6).

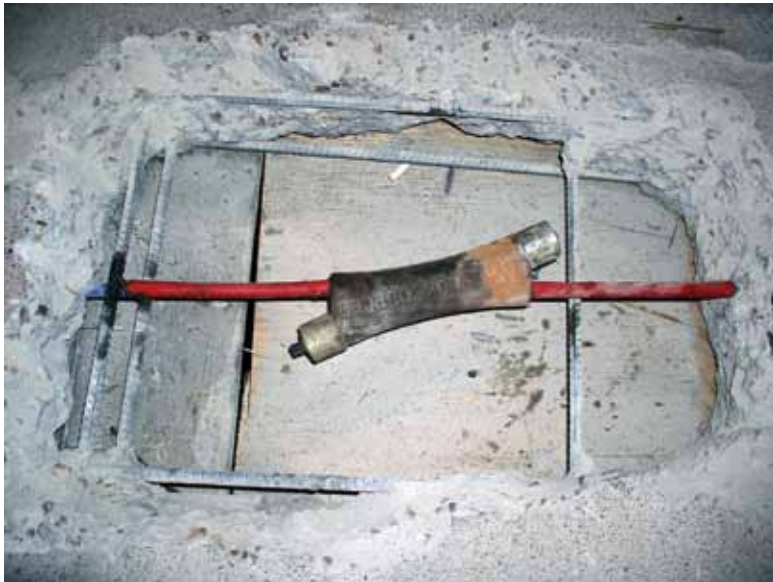
Fig. 7: Center stressing splice for monostrand system

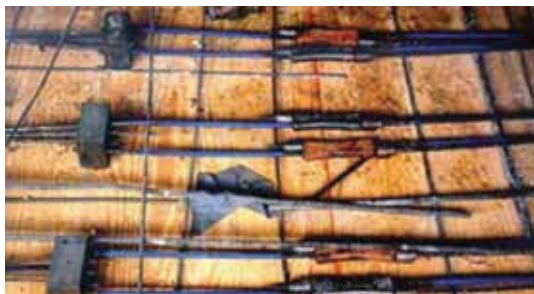
Fig. 8: Monostrand to wire system splice (after VanOcker [2005])

The technique of partial tendon replacement is recommended in slab tendons where the corrosion or deterioration is localized. Representative areas for this repair are high points of tendons and construction joints. The affected section of the tendon is replaced by a new section attached to the existing tendon by couplers (refer to Fig. 7). In the case of a button-headed system, the repair follows a similar procedure, using threaded rods, wire splices, and a combination of button-headed hardware with monostrand replacement tendons. Successful repairs using the combined system have been reported (VanOcker 2005) (refer to Fig. 8).
