# TROUBLESHOOTING CONCRETE FLOORS WITH PETROGRAPHY

BY GERARD MOULZOLF

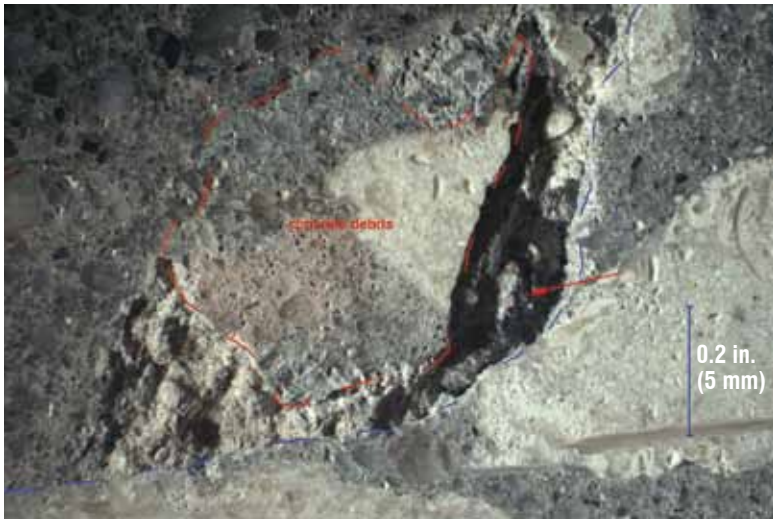
Fig. 6: Large, up to 0.4 in. (10 mm) diameter, concrete debris (outlined in red-dashed line) at contact between deeply recessed, hydrodemolitioned concrete surface and shotcrete repair, separated by blue-dashed line

Surface cleanliness after floor slab preparation can also be assessed under a microscope. Deep recesses in the prepared surfaces can hold large amounts of debris—especially high-/ultra-high-pressure water-jetted surfaces (Fig. 6). Failed repairs and overlays/underlays often exhibit debris adhered to their undersides. This petrographer has found many materials other than concrete debris at failed contacts, including steel shot, steel shavings, and sawdust. Other trades working on a project can affect previously cleaned surfaces. Protrusions in vinyl sheet goods or vinyl composite tile (VCT) have commonly been identified as construction debris and splatters of spackle or mortars. In certain geographical locations, however, especially in some parts of the Midwest, alkali-silica reactive (ASR) coarse and fine aggregate particles in the concrete expand beneath moisture-sensitive coatings and flooring (Fig. 7). These impervious coverings trap moisture and concentrate alkalis, providing a perfect environment for these expansive reactions. Alkalis can also have a negative effect on adhesives used to bond the flooring material to the concrete substrate.

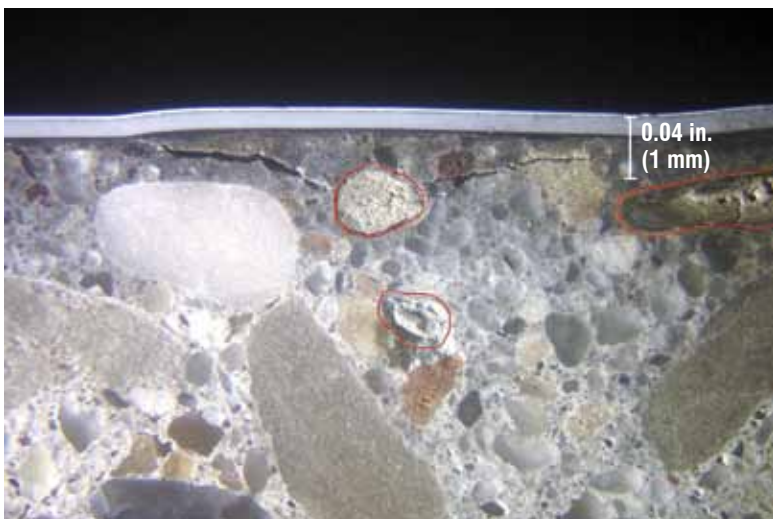
Fig. 7: ASR shale fine aggregate particles have formed protrusions in the coating system

delaminations that appear during grinding/polishing procedures (Fig. 2) or shortly after the slab is put in service. This type of delamination differs from a more common phenomenon that occurs upon planes of bleedwater trapped by delayed bleeding/premature finishing. This petrographer has also documented heavily burnished surface profiles up to 0.24 in. (6 mm) depth that have had water or a finishing aid added late in the troweling procedure—producing soft, dusting surfaces. This floor required unplanned grinding/polishing and the application of a hardener—at the finisher’s expense—to produce the specified surface finish. Hardeners must be selected and tested carefully to avoid other issues such as alkali-silica reactivity (pop-outs), described further in the article.
