Infrastructure Case Study: Concrete Column Rehabilitation

Interstates 30 and 45, near downtown Dallas, Texas, are two of the most heavily traveled interstates in the state. Because these highways are such important links to the city, any work completed on them would have to be very sensitive to the traveling public.

Dallas Interstates 30 and 45

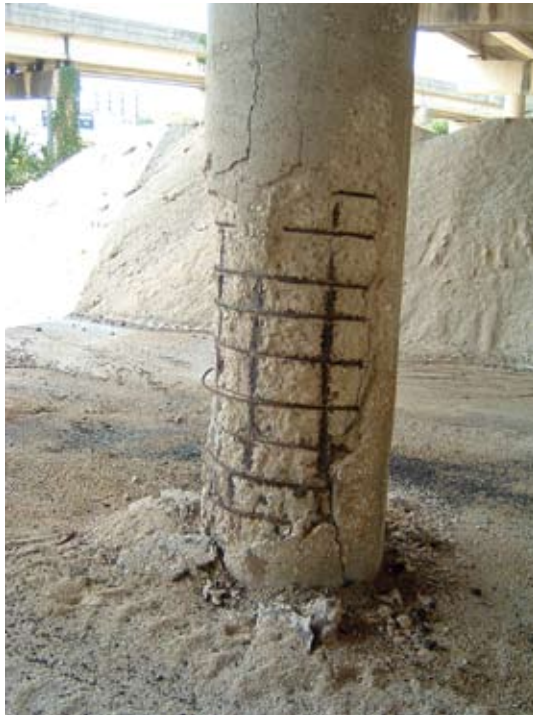
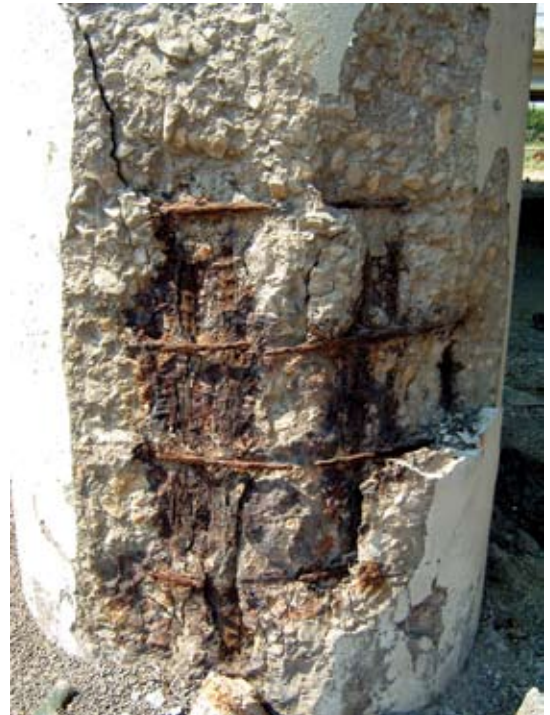
It has been standard practice for the city of Dallas to stockpile its deicing materials for bridge decks under the bridges along Interstates 30 and 45. The chloride in the deicing agent, which has surrounded the bridge columns over the years, has caused severe corrosion of the concrete and steel, undermining the integrity of the columns. Once the deicing material was removed from around the columns, the extent of the damage to the columns was noted. These columns had to be repaired before any further section loss occurred and undermined the stability of the bridges. The Texas Department of Transportation (TxDOT) put the project out to bid with a plan of action for the repairs. Due to the high volume of traffic along these bridges, the project would be very sensitive to the traveling public and any support system installed to repair these columns would have to withstand live and dead loads.

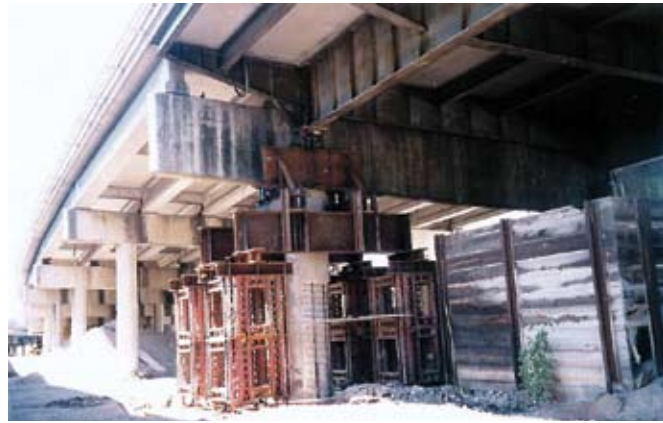
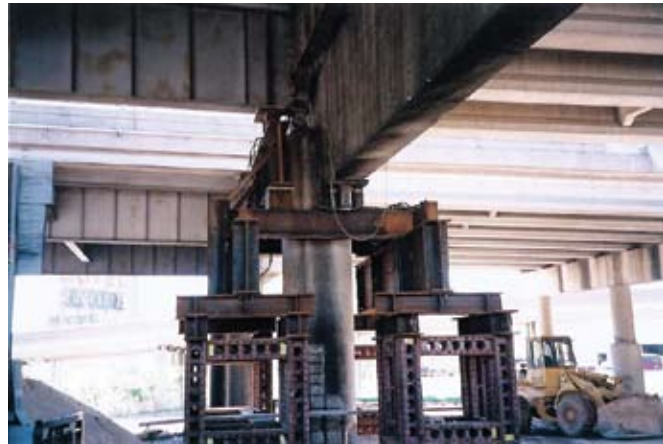
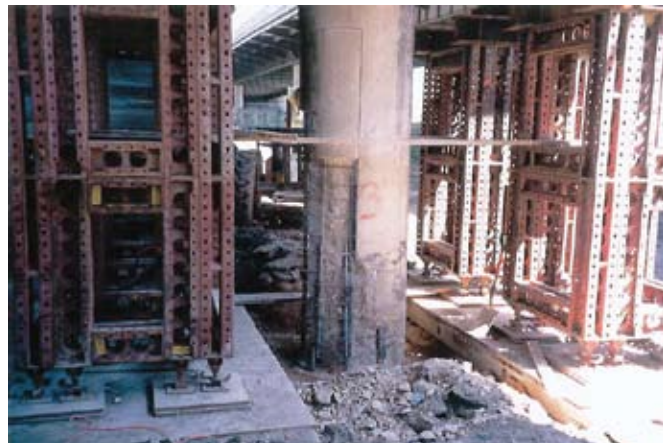
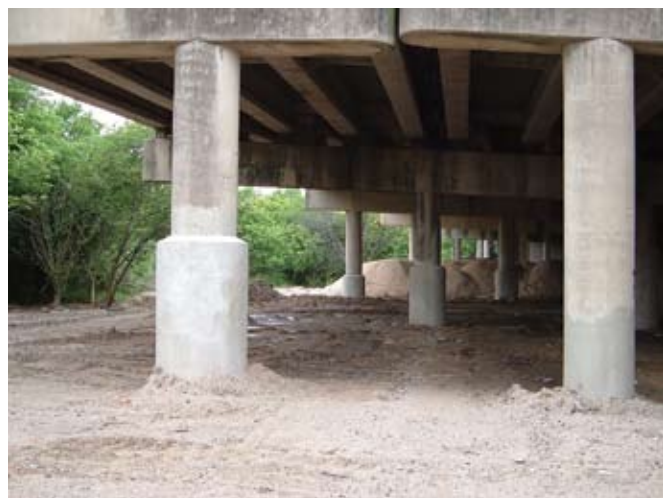
There were a number of different types of temporary support systems that had to be used to accommodate the various cap and beam configurations on the existing structure. Also, live loads required complex support structures and intensified the difficulty of the project. The shoring systems involved the use of four 200 kip (90,000 kg) shore towers, a series of beams, stiffeners, and pedestals. It also included the use of 100 ton (90,000 kg) hydraulic jacks, which required close monitoring of the pressure used.

The columns with significant section loss were encased with 6 in. of concrete using the following procedure. The area was sounded and then the limits of the area to be removed were score cut. The deteriorated concrete was removed to sound

concrete using hand-held pneumatic chipping hammers. The concrete was then sandblasted to achieve a fractured face and to remove any laitance and rust on the steel. A supplemental steel cage was then tied in place and a spray-applied corrosion inhibitor bonding agent was added. Sacrificial galvanic anodes were then placed in an effort to prevent future corrosion. Forms were then set and a DOT-approved concrete mixture was poured. Once the concrete reached its design strength, the shoring was removed. A similar process was used for isolated spalls using a prebagged rapid-setting repair mortar, except no shoring or forms were required.
