April 5, 2022
ICRI 2022 Spring Convention

Repair of Architectural Terra Cotta

Michael P. Edison
President
Edison Coatings, Inc.

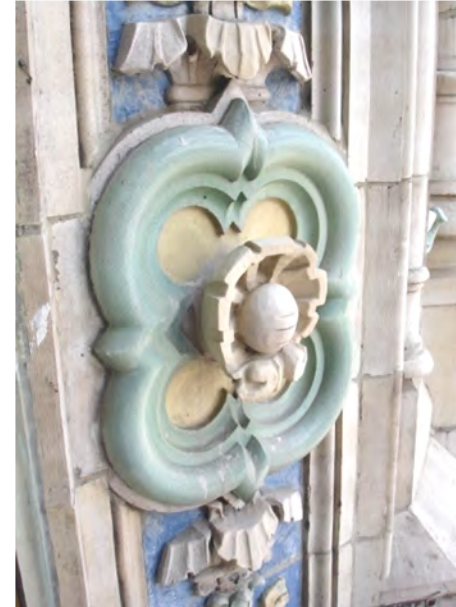
Polychrome Glaze
90 West Street, NYC
1910

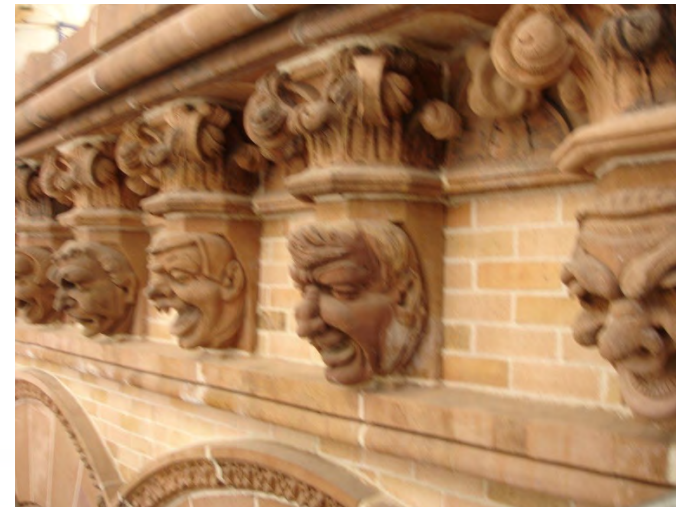
Unglazed or Slip Glaze
700 Broadway, NYC
1891

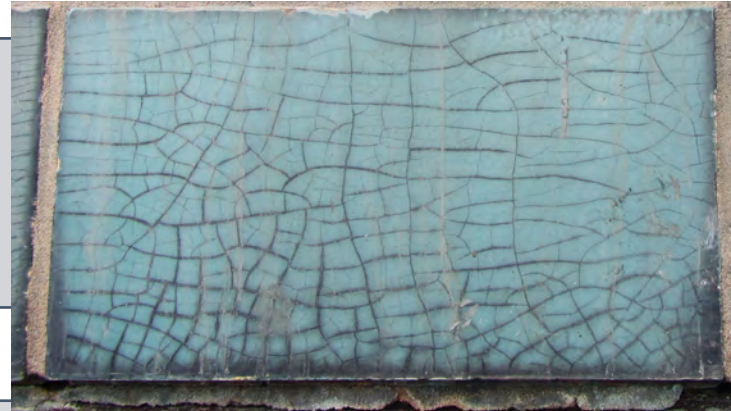
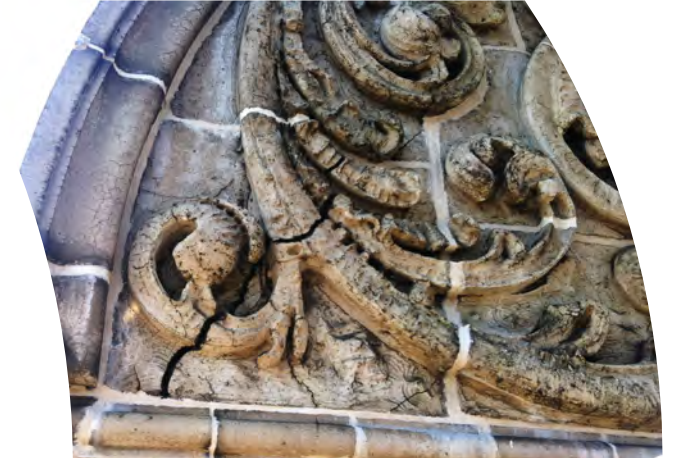
Glaze Cracking

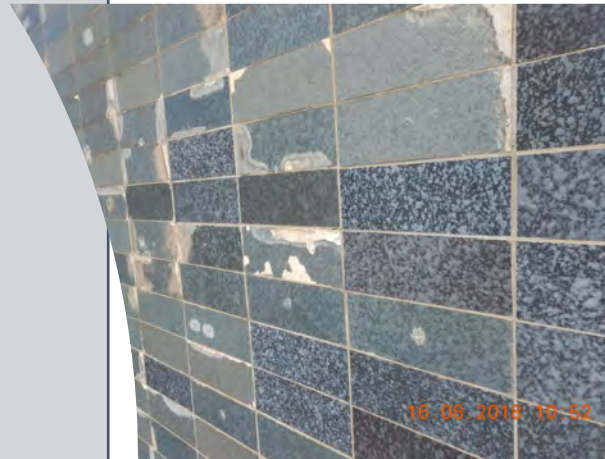
Displacement

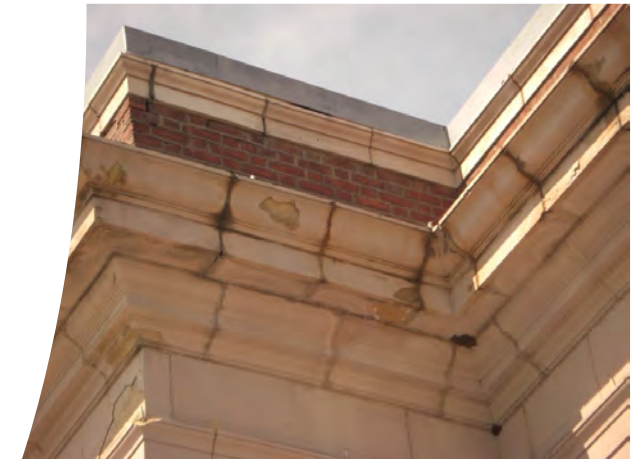
Glaze Spalling

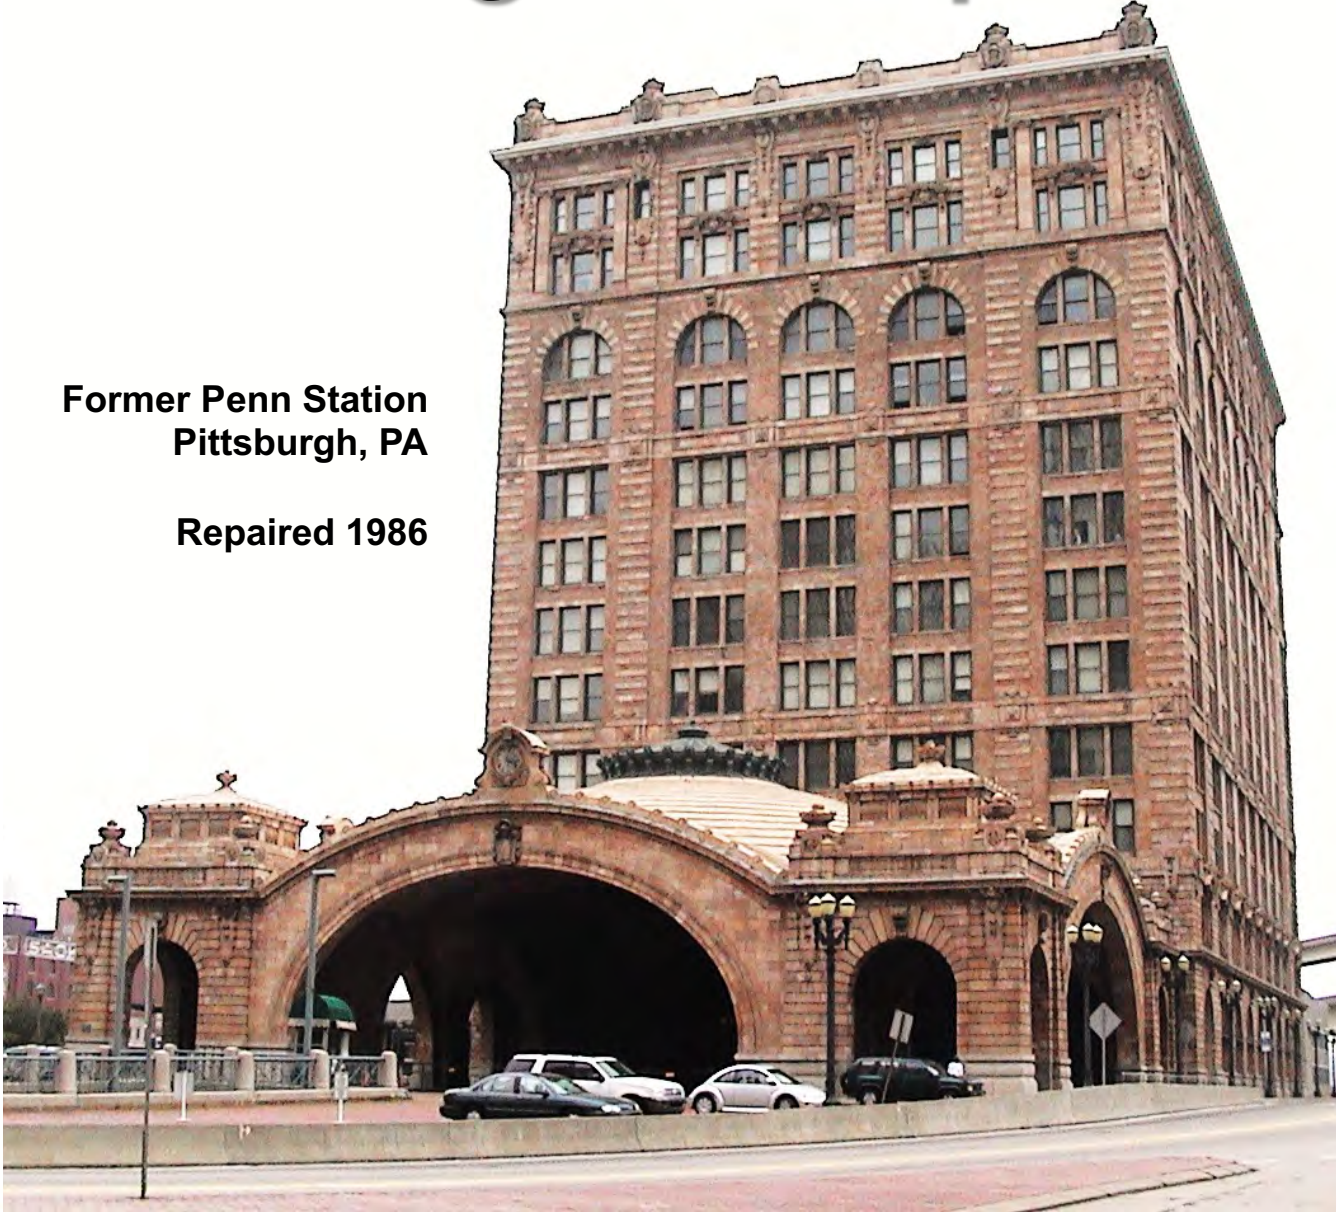
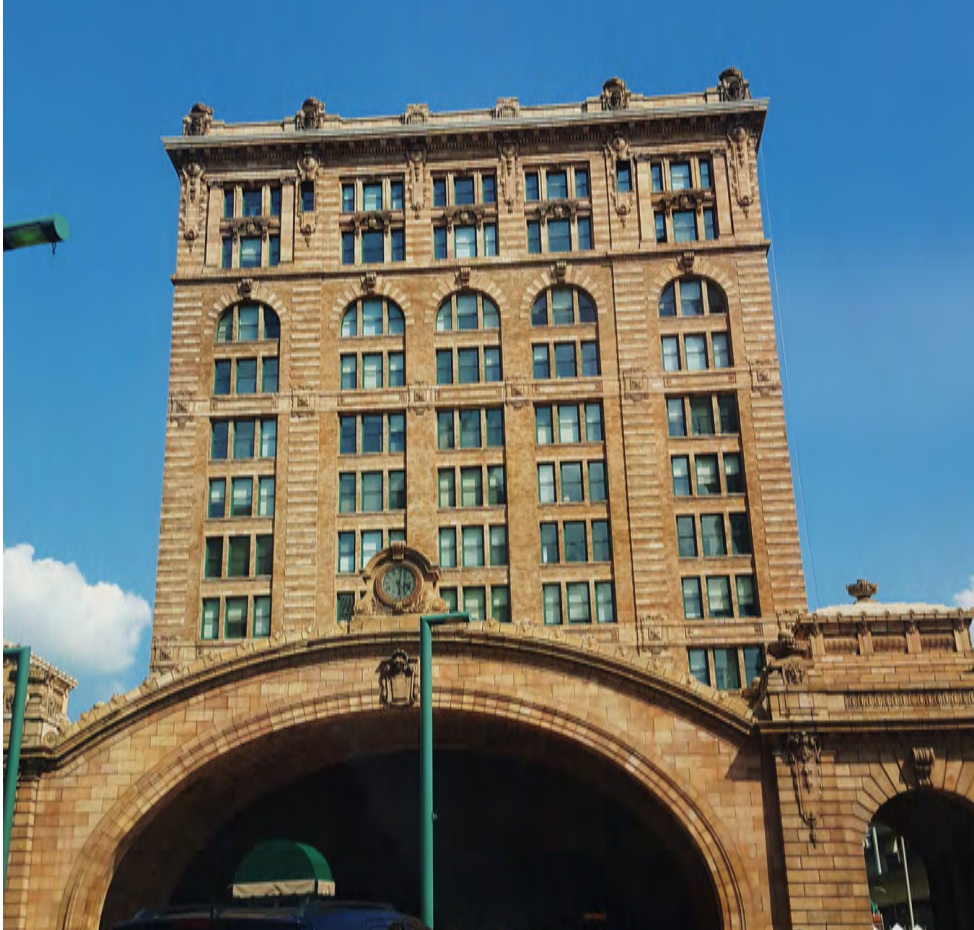
Former Penn Station
Pittsburgh, PA
Repaired 1986

30+ Years Later

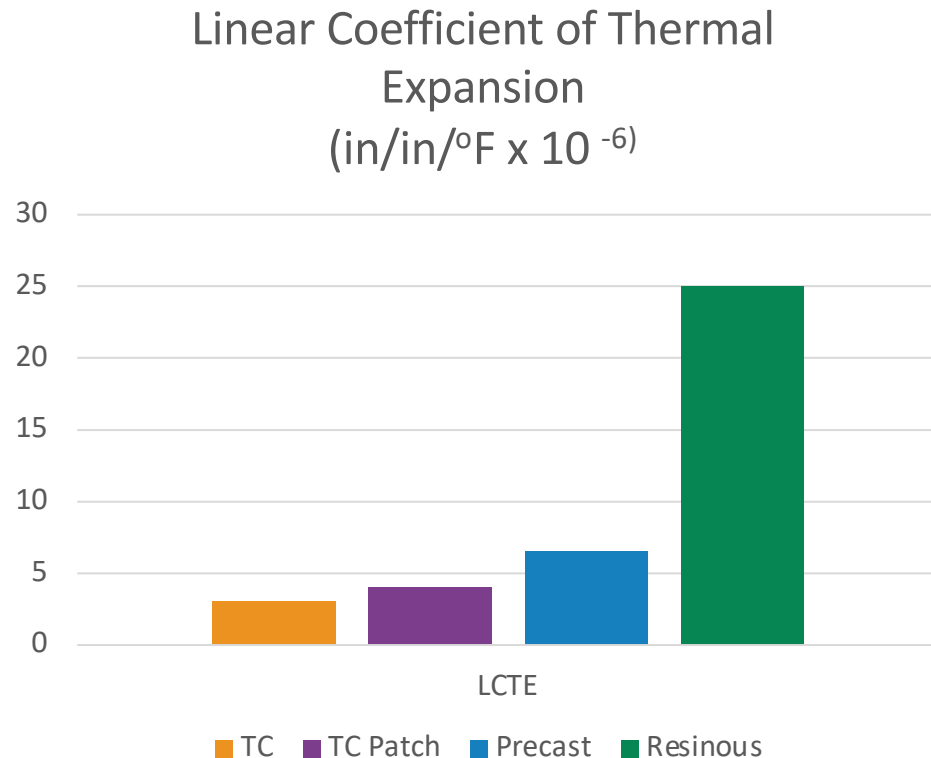
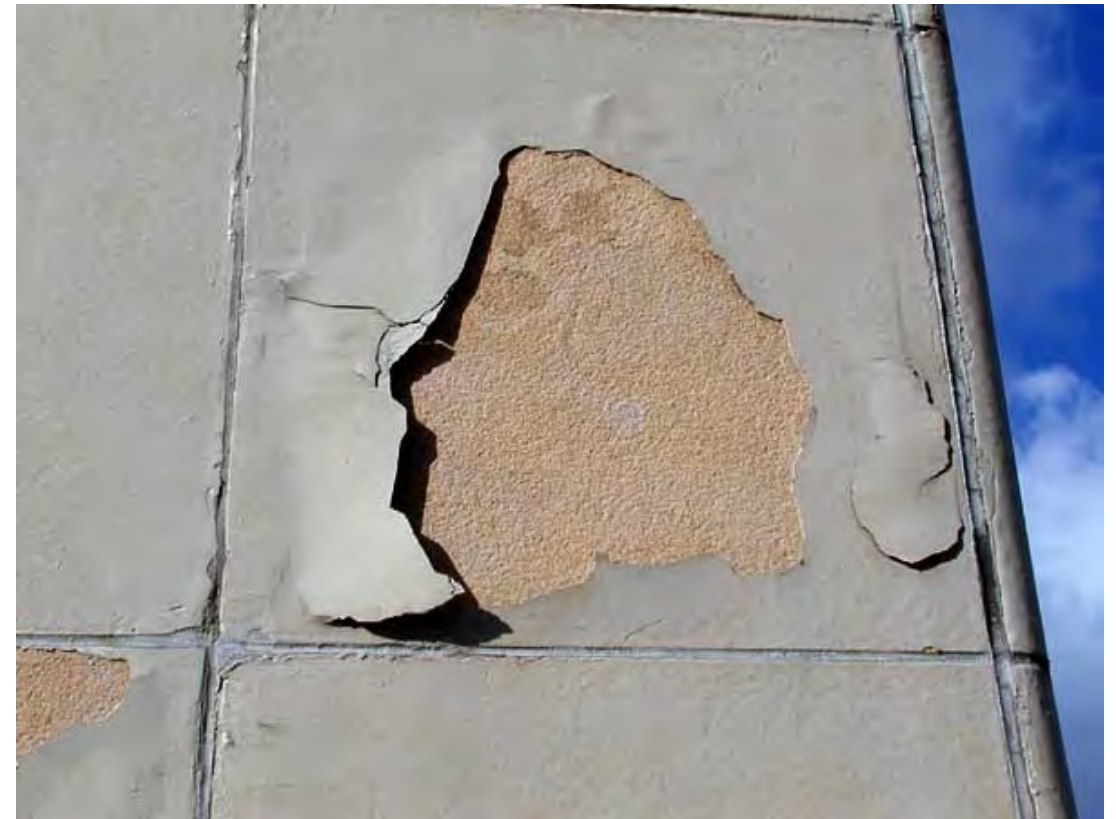
- Thermal Incompatibility of Most Repair Systems

Failed Epoxy-Based Resurfacing Mortar

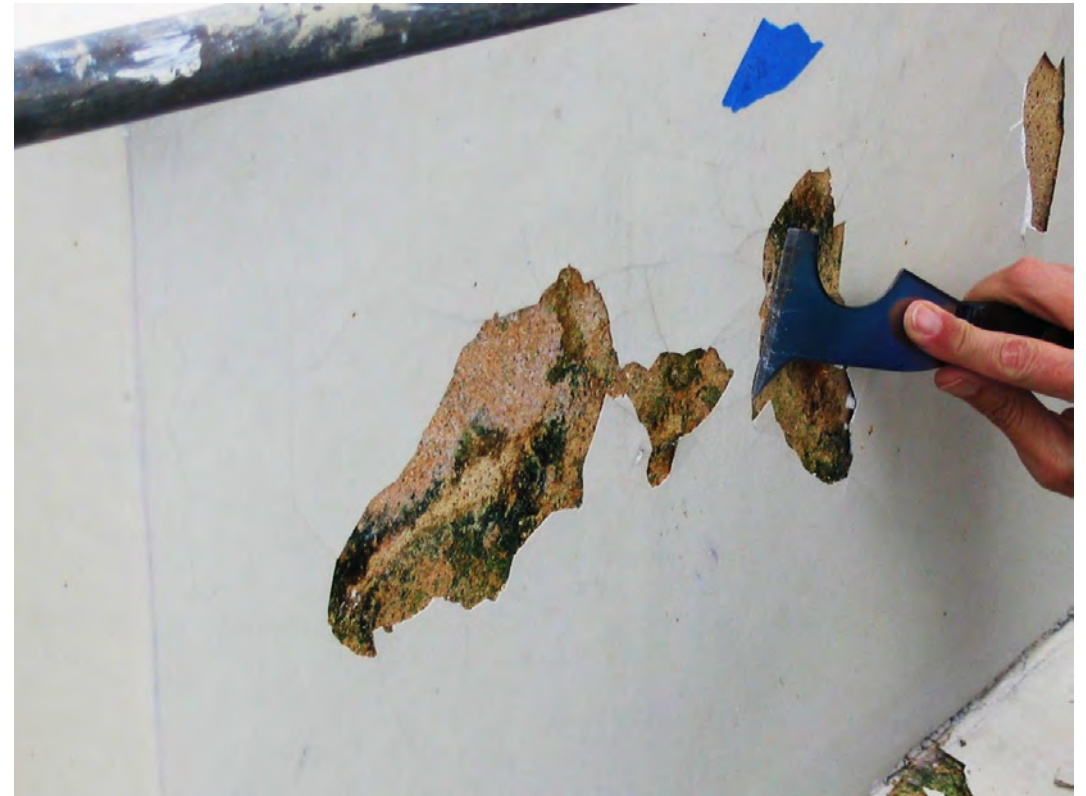
- Damaged TC Assemblies Tend to be Wet
- Most Repair Systems Perform Poorly in Applications to Wet Masonry
 - Dynamic Moisture Hinders Repair Applications
 - Recent Research Supports Use of Moisture-Insensitive Barrier Primer
- Few Projects Allow Time for Drying
 - Drying Can Take Many Years

Biological Growth in Wet Bisque Beneath Spalling Glaze

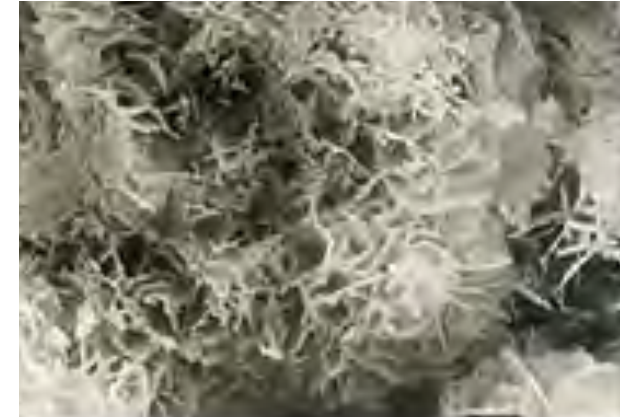
**MICROPHOTOGRAPH:
PORTLAND CEMENT IN EARLY
STAGE OF HYDRATION**

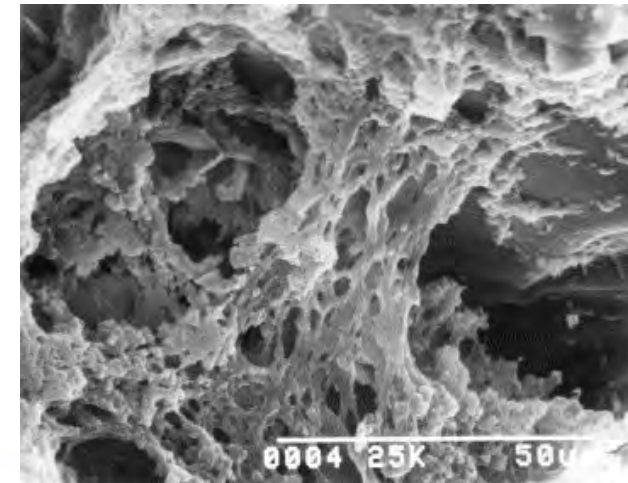
**MICROPHOTOGRAPH:
LATEX MODIFIED MORTAR AFTER ACID DIGESTION**

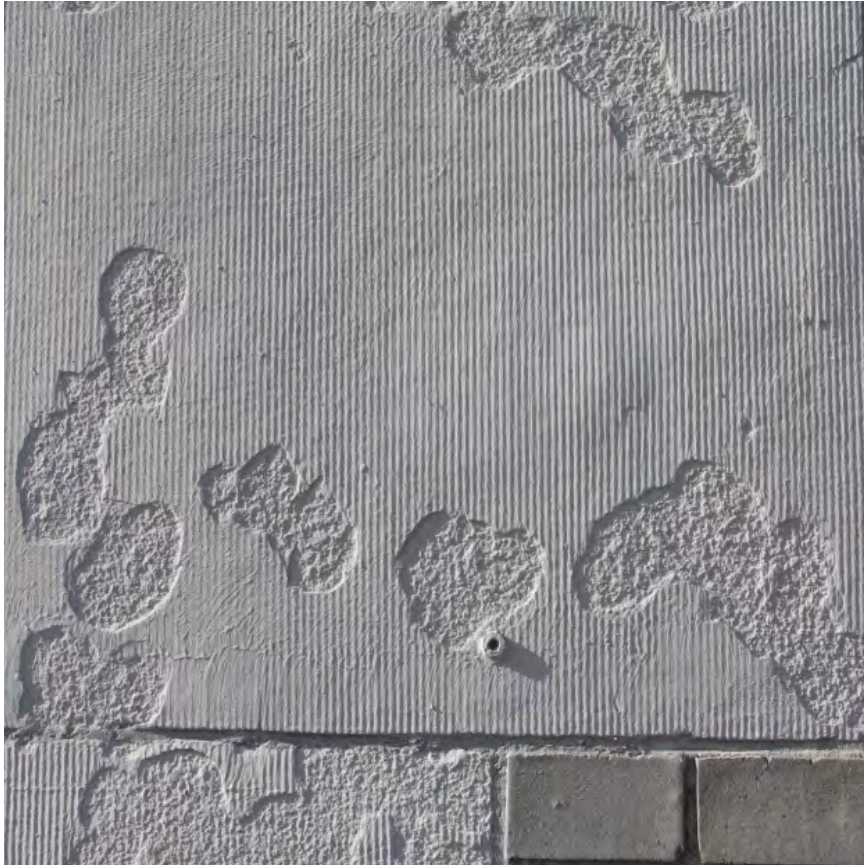
- You *Can* Just Coat the Bisque, But it Looks Like _____....

Coating Over Glaze Spalls Without Patching

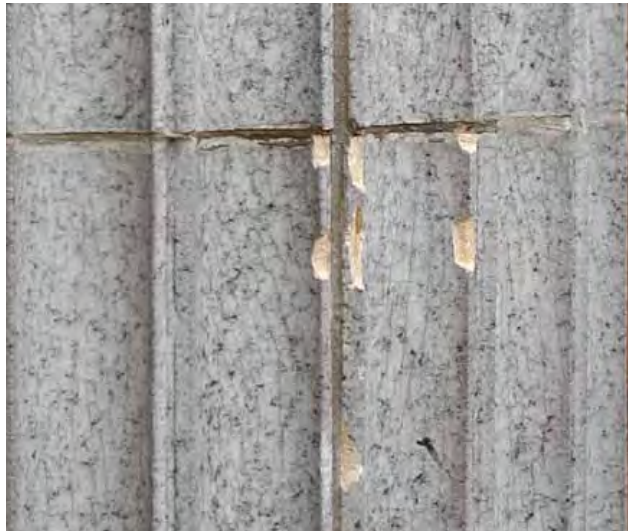
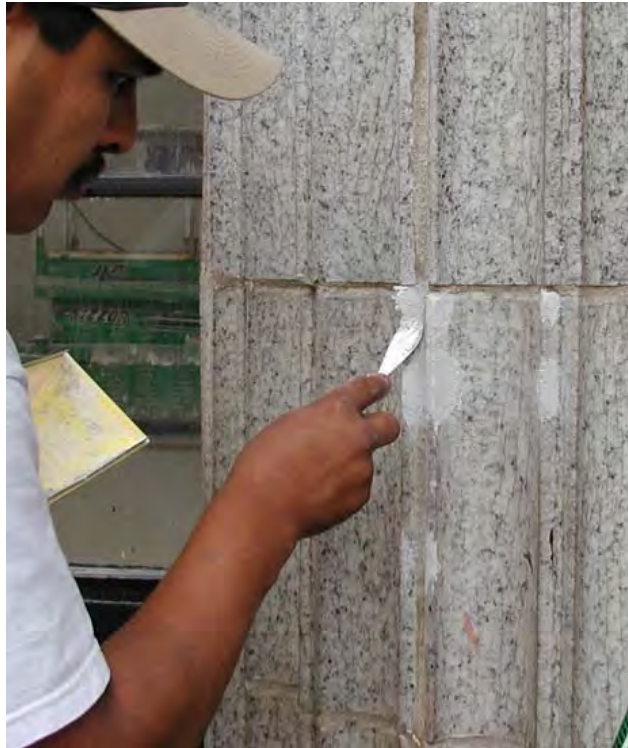
Thin Patch

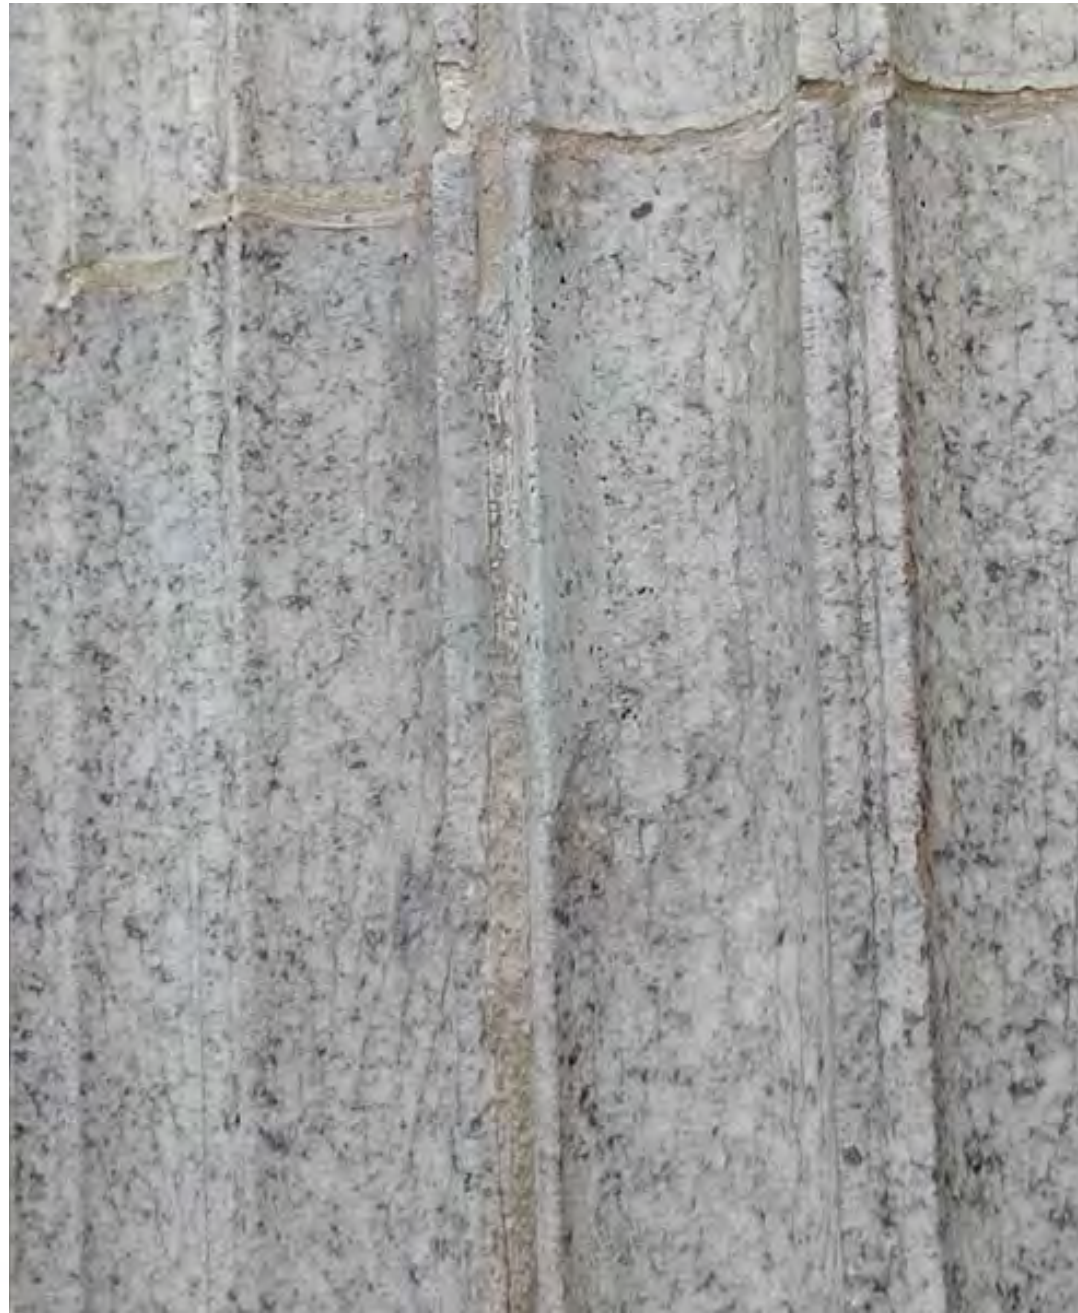
Custom Multi-Step Glaze-Matched Coating System

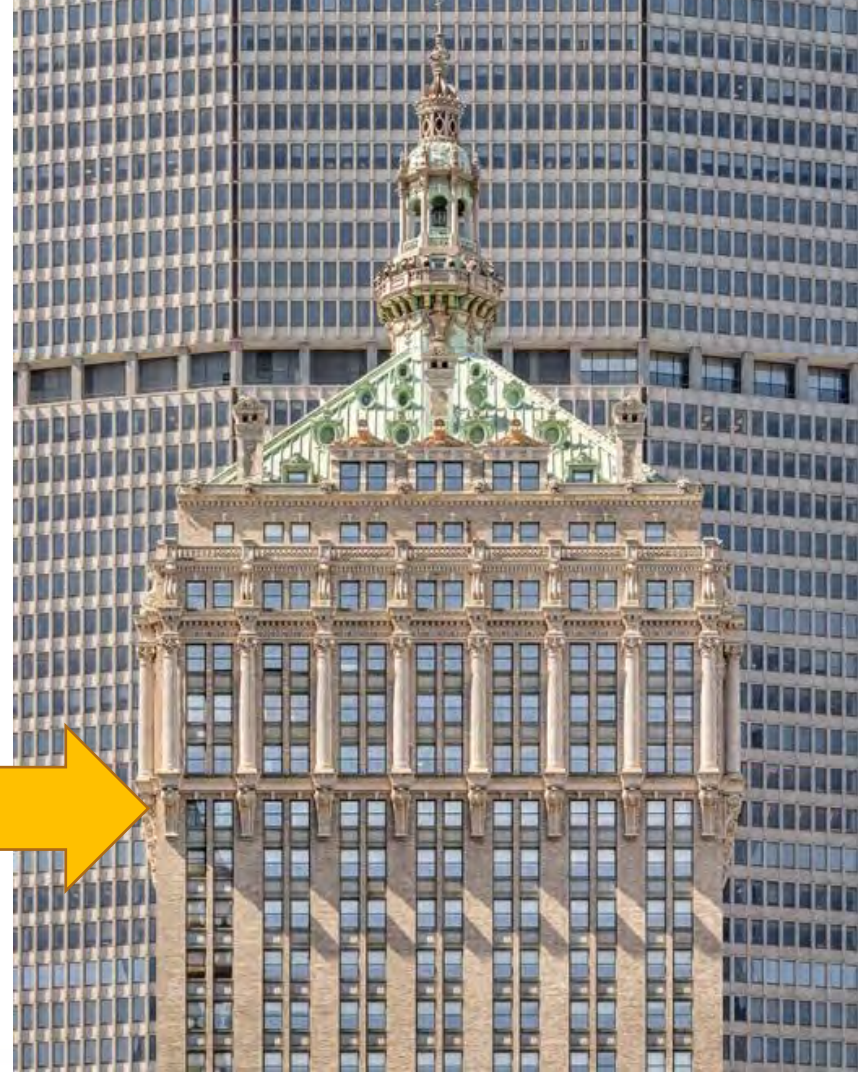
230 Park Avenue: 2010

30 OF THE 32 BRACKETS WERE FAILING, REQUIRING REPLACEMENT

- With Low-Shrinkage Repair Material, There Is No Limit to Patch Size
- Example: Terra Cotta Bracket Repairs at 230 Park Avenue, NYC
 - Cast In Place Patches Up to 1000 lbs./14” Thick

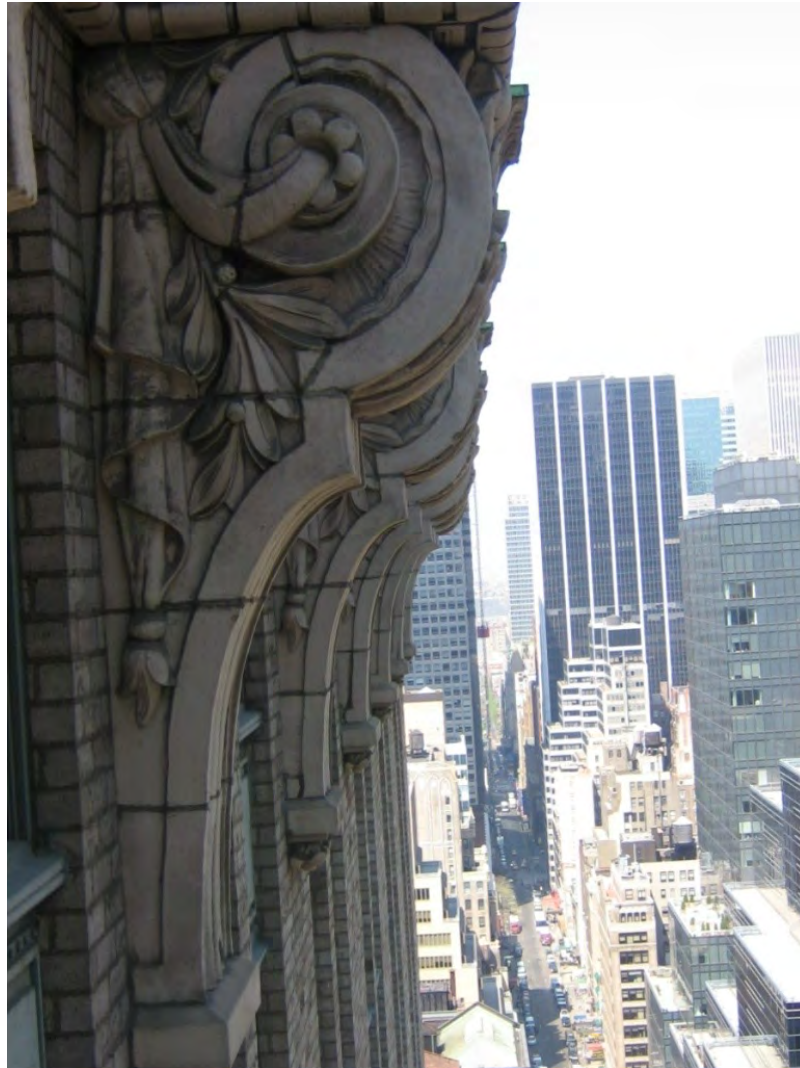
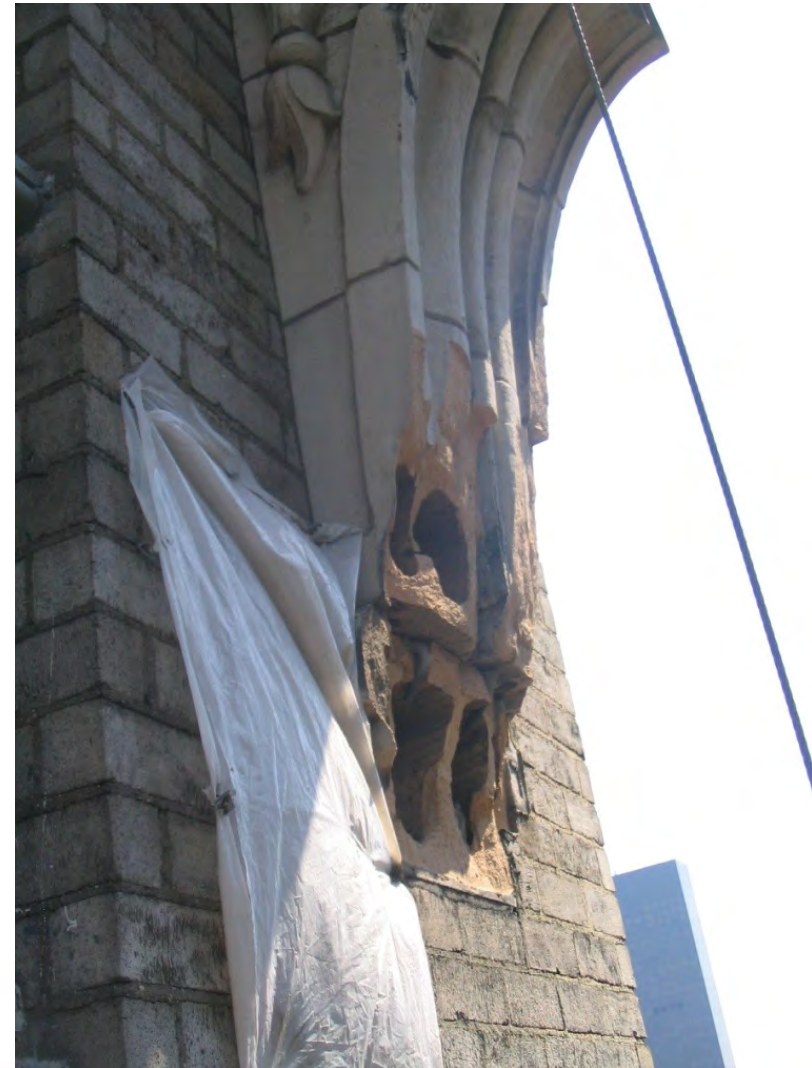
230 Park Avenue: Repair

- 14" Thick Castings Poured in Terra Cotta Patching Compound After Anchor Installation
- Individual Castings Weighed Up to 1000 lbs.
- Repair Cost <5% of Replacement Cost

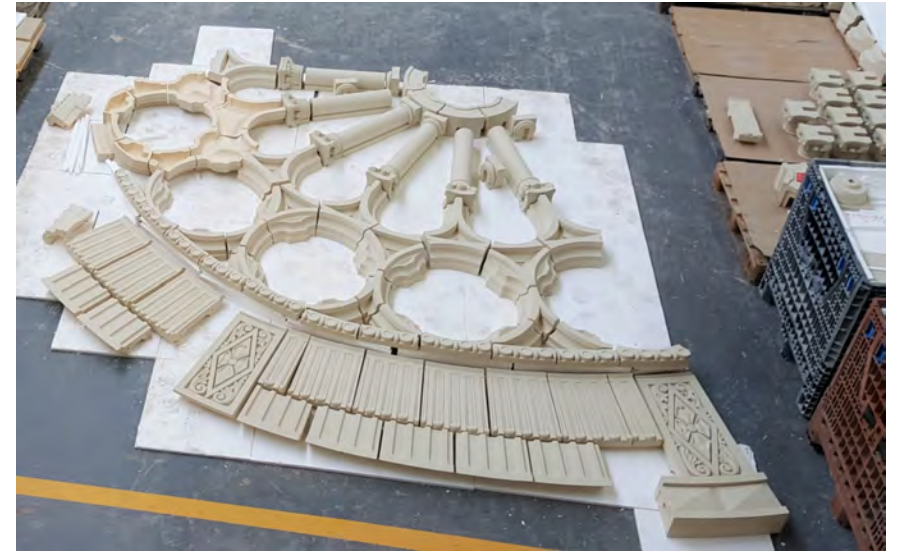
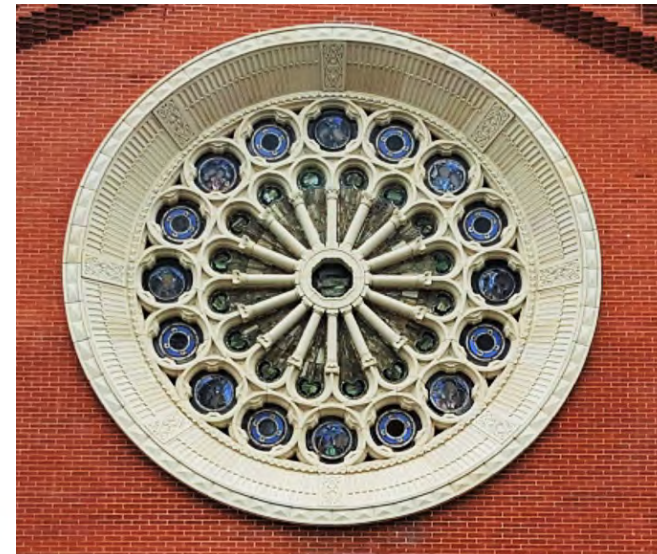
In-Kind Replacement

- PRO's
 - Maximum Compatibility
 - Historically Accurate
 - Highly Durable
 - Fireproof
 - No Joint or Anchoring Redesign
- CON's
 - Costly
 - Long Lead Times

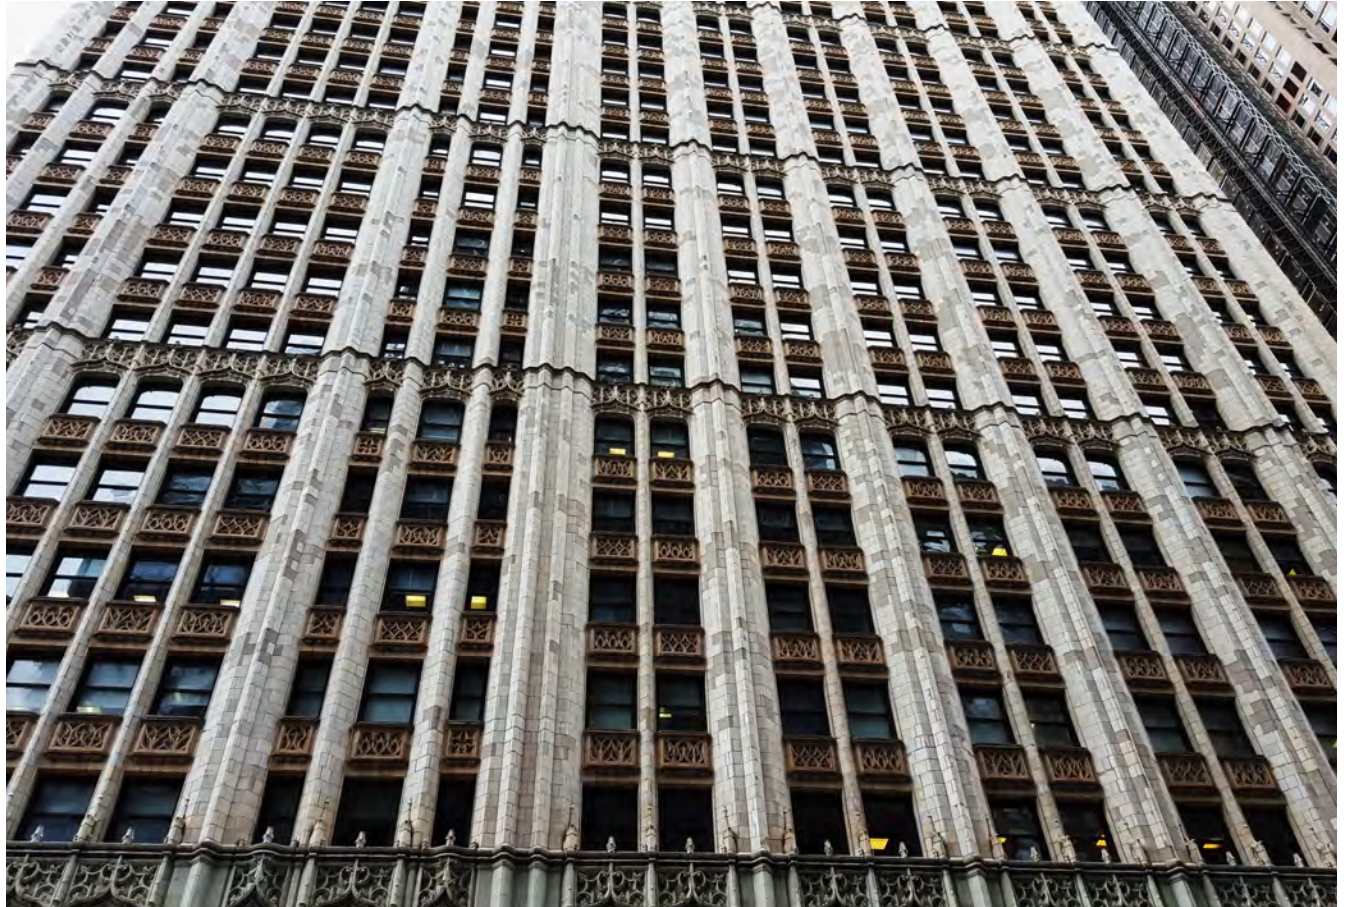
Precast Concrete

- PRO's
 - Low Cost
 - Rapid Production
- CON's:
 - Poor Weathering
 - Thermal Expansion Mismatch
 - High Density
 - Potential Steel Corrosion
 - Anchoring Redesign

Woolworth Building
New York

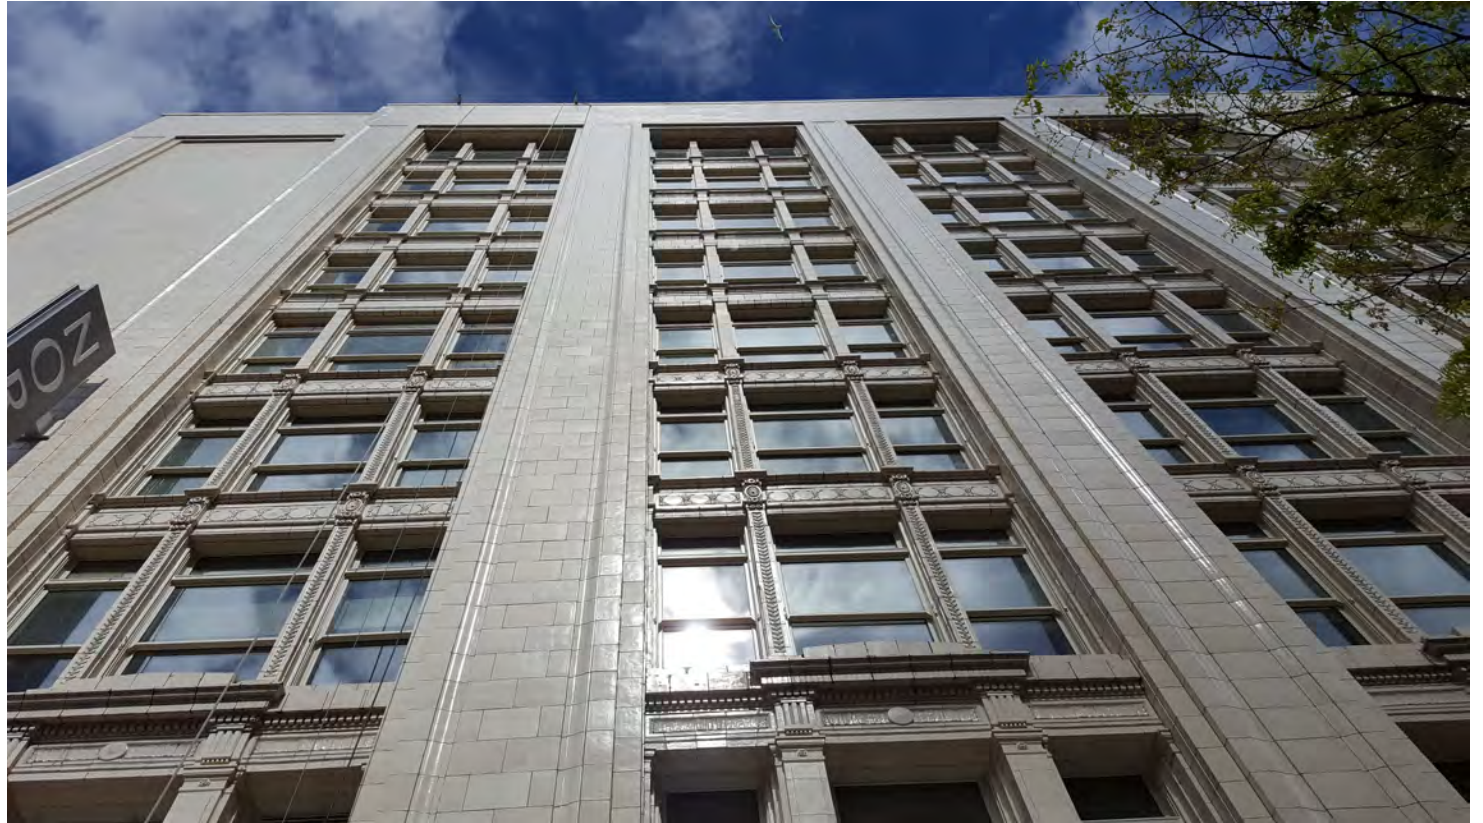
GFRC

- PRO's
 - Lightweight
 - Moderate Cost
 - Rapid Production
 - Good Initial Esthetics
- CON's
 - Thermal Expansion Mismatch
 - Requires Redesigned Anchoring & Joints
 - May Tend to Weather Poorly

Nordstrom Flagship Store
Seattle

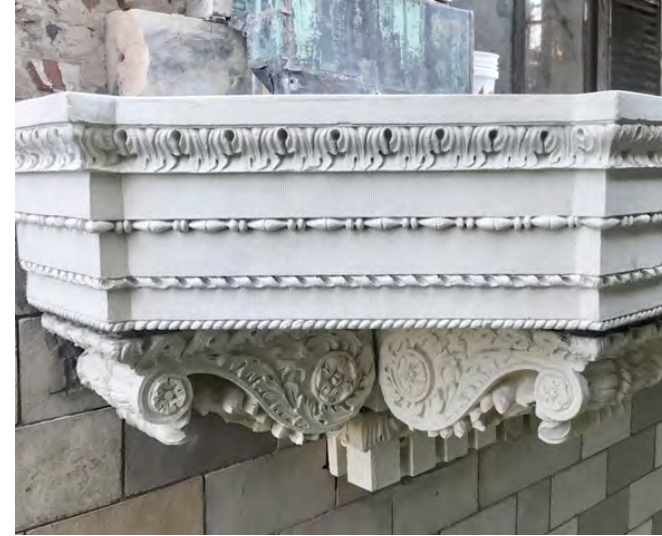
Resinous - Proprietary

- PRO's
 - Rapid Production
 - Good Initial Esthetics
- CON's
 - Large Thermal Mismatch
 - Requires Joint Redesign & Sealants
 - Mortar & Sealant Bonding Issues
 - Potential Fire Issues
 - Some Systems Demonstrate Poor Long-Term Esthetics

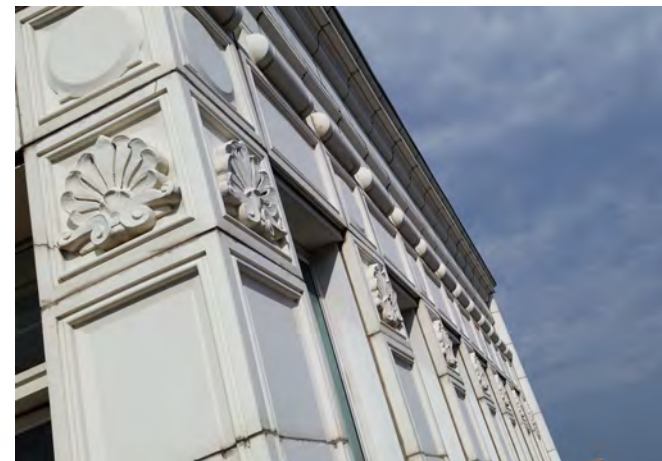
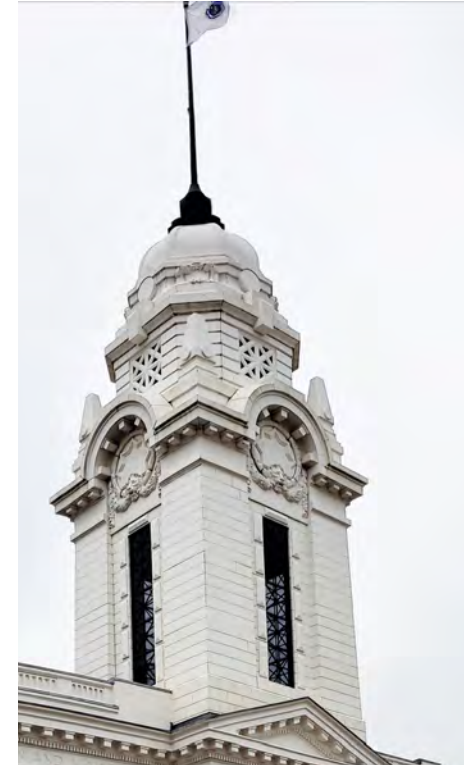
Resinous Castings

FRP Replacement

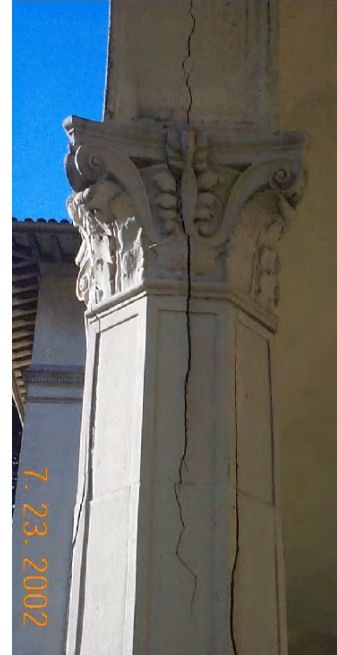
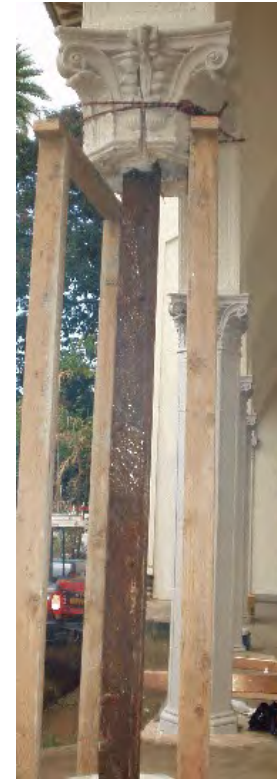
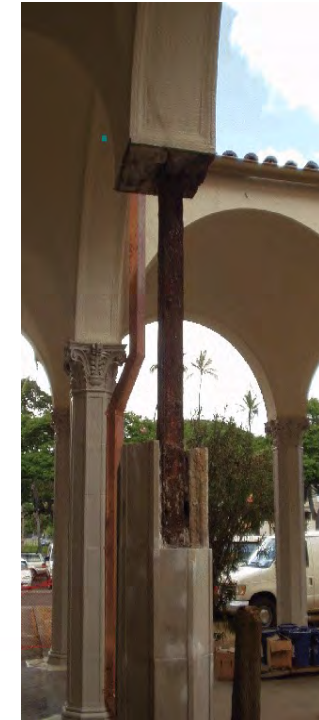
**US COURTHOUSE & POST OFFICE
HONOLULU, HI 2003**

- While Some Units Could Be Patched, Many Shattered
- Replacements Cast On Site Using Custom Terra Cotta Repair Mortar

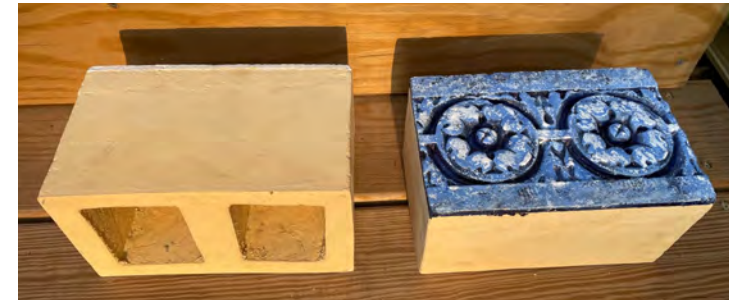
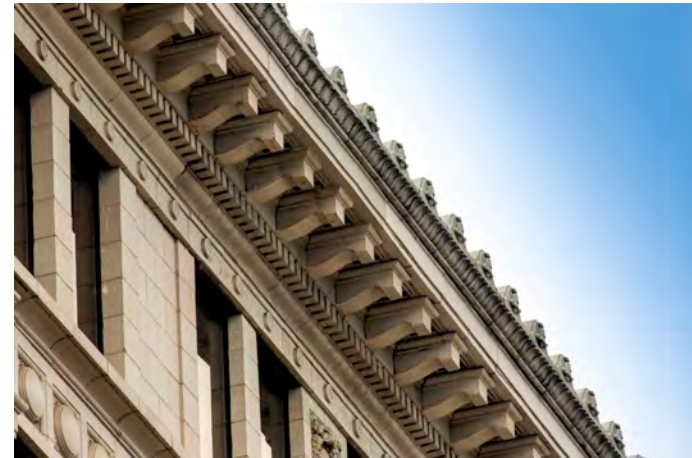
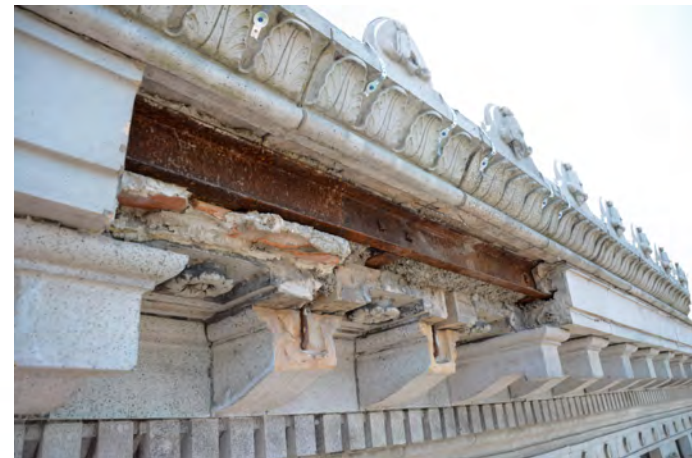
Cementitious - Proprietary

- PRO's
 - Hollow, Lightweight Units
 - Excellent Thermal Compatibility
 - Drop-In, One-for-One Replacement
 - No Anchoring Changes
 - No Joint Redesign or Sealants
 - Partial-Depth Replacement Possible
 - Rapid Production
 - No Mortar/Sealant Bonding Issues
 - Castings Are Non-Combustible
 - Easily Repairable if Needed
- CON's
 - It's Not Terra Cotta
 - Glazes Matched with Durable Coatings
 - Eventual Maintenance

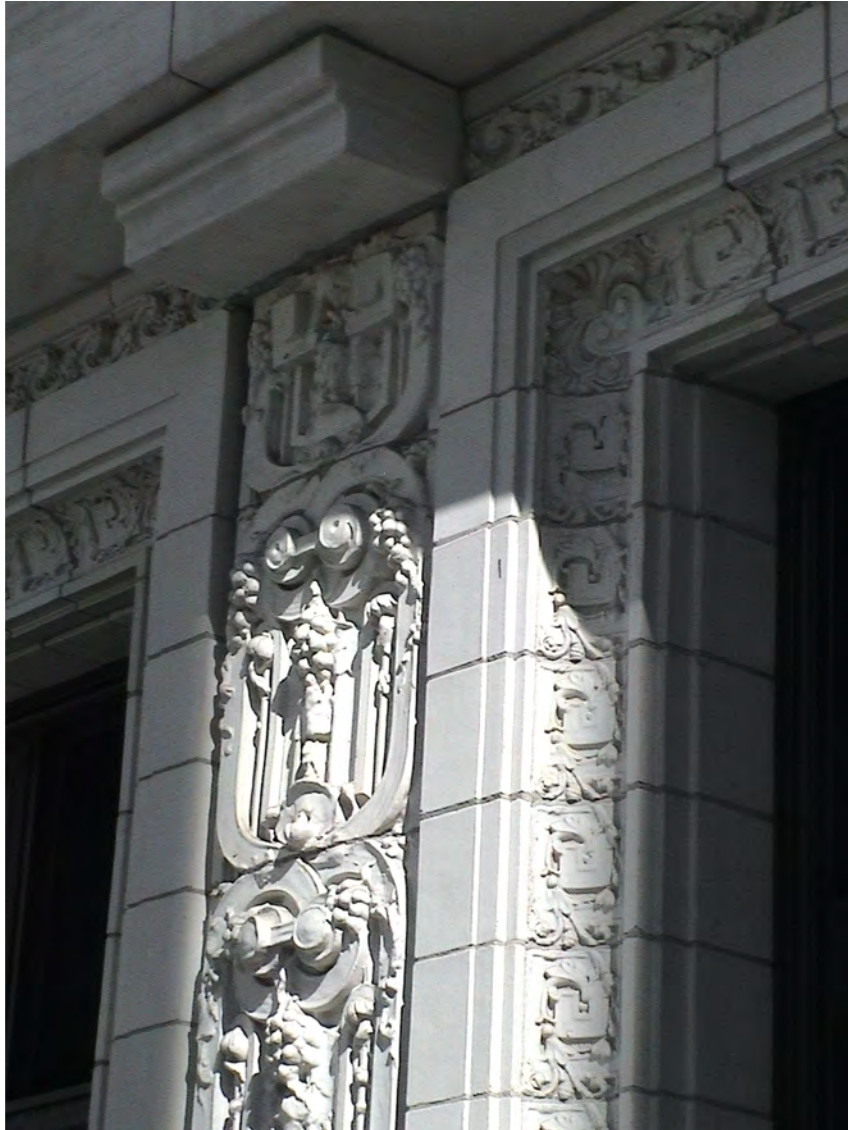
GLAZE MATCHING 1: Polyurethane

- Waterborne Aliphatic Polyurethane
- Thin Film
- Can Be Clear, Translucent or Opaque
- Can Be Gloss, Satin or Flat
- Depth: Clear Coats Over Color Coats
- Detail: Can Layer & Sponge-Apply Multiple Colors

New York State Education Building
Albany, NY

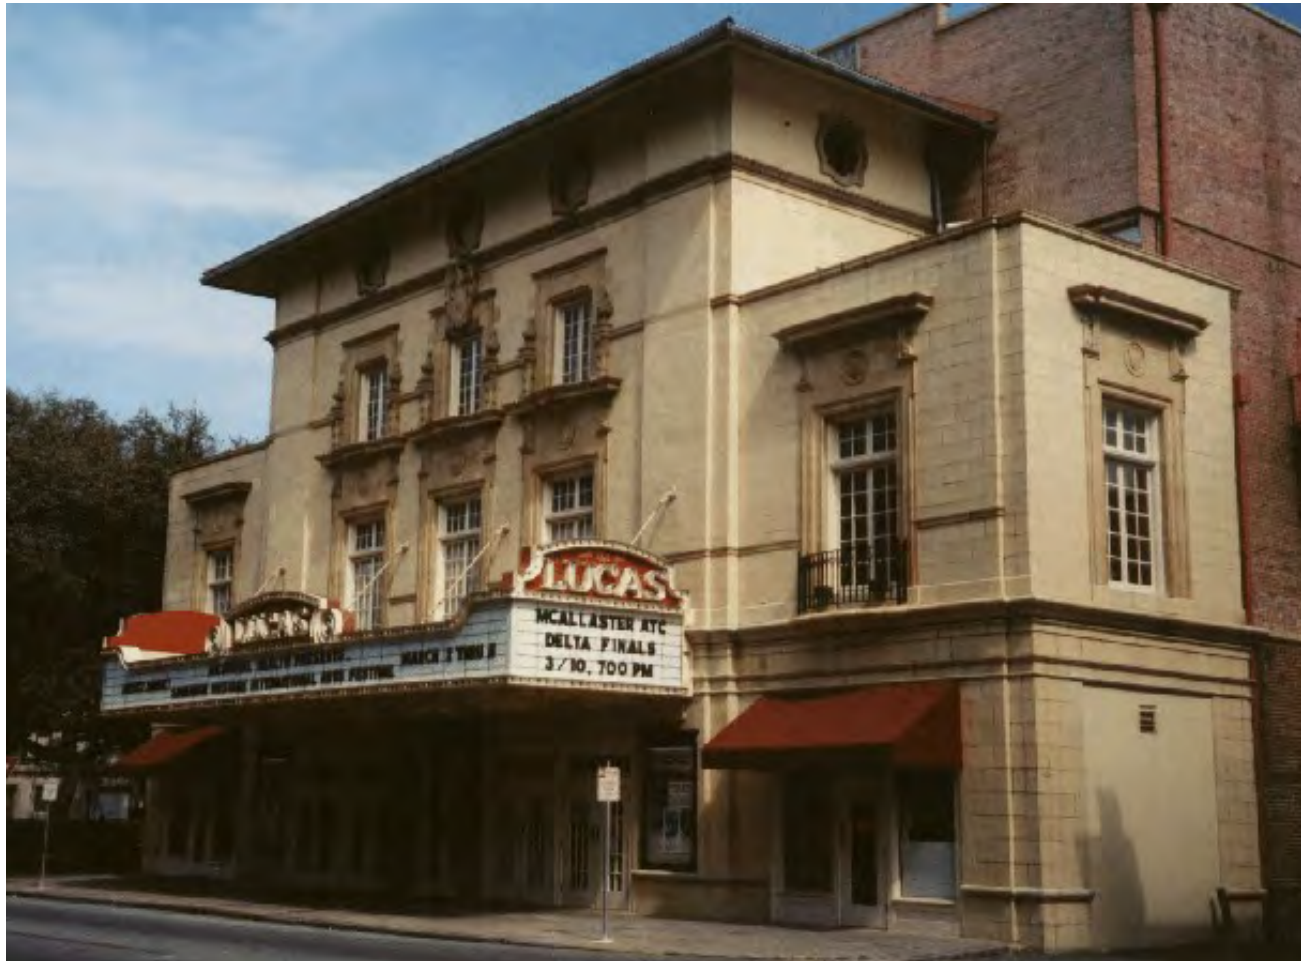
GLAZE MATCHING 2: Acrylic

Lucas Theater, Savannah, GA

- Matte Finish
- High Permeability
- Crack Bridging & Weather-Proofing
- Opaque
- Surface Tolerant
- Can Also Use As Base Coat for Polyurethane Top Coat

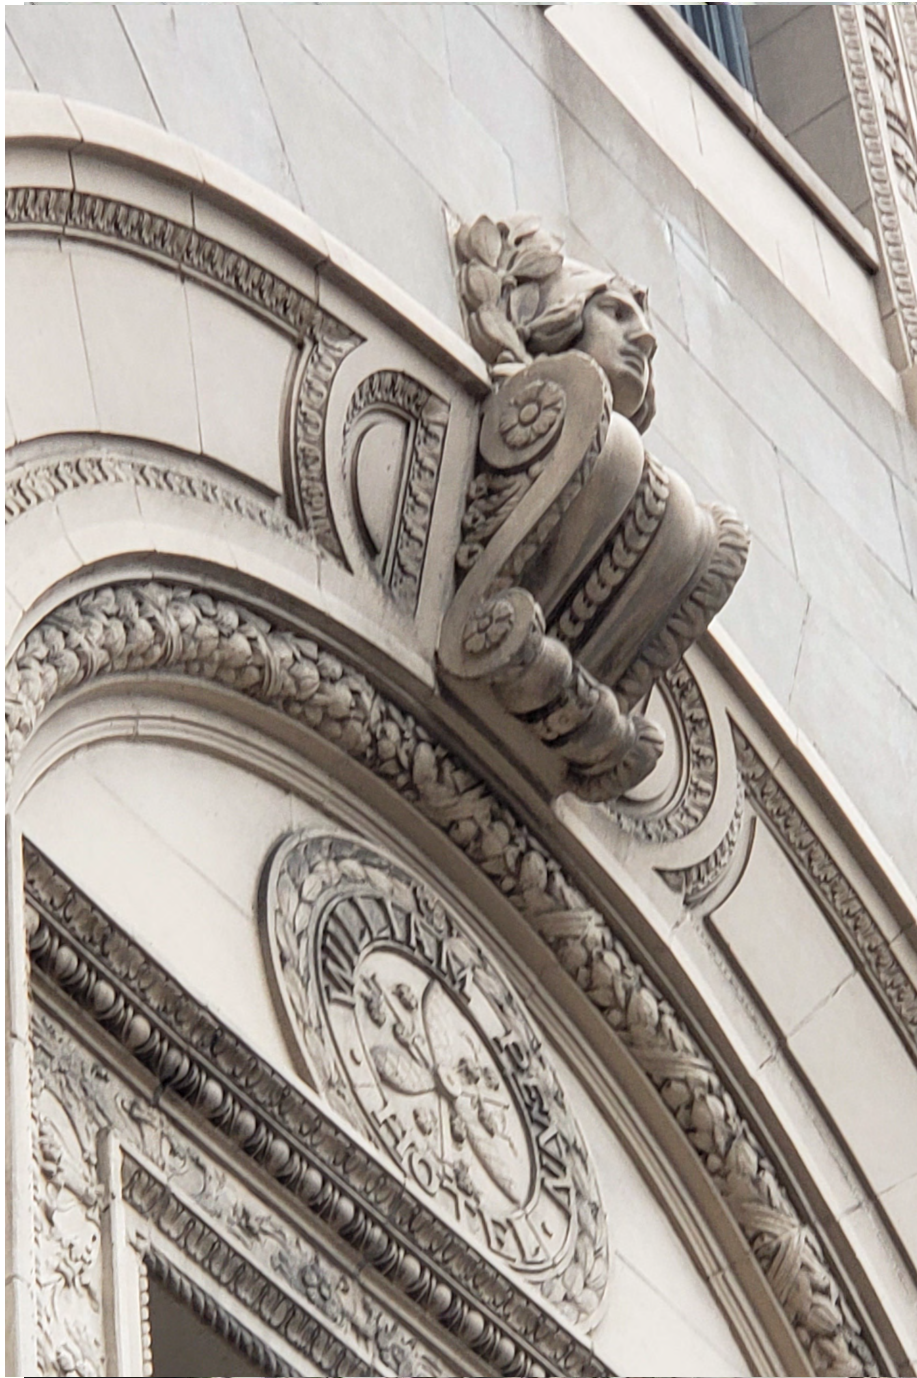
ACRYLIC GLAZE COATING

- Matte Finish Glaze Coating
- Requires No Primer
- Good Detail Retention
- Durable

Omni William Penn Hotel
Pittsburgh, PA
