April 5, 2022
ICRI 2022 Spring Convention

Repair of Architectural Terra Cotta

Michael P. Edison
President
Edison Coatings, Inc.

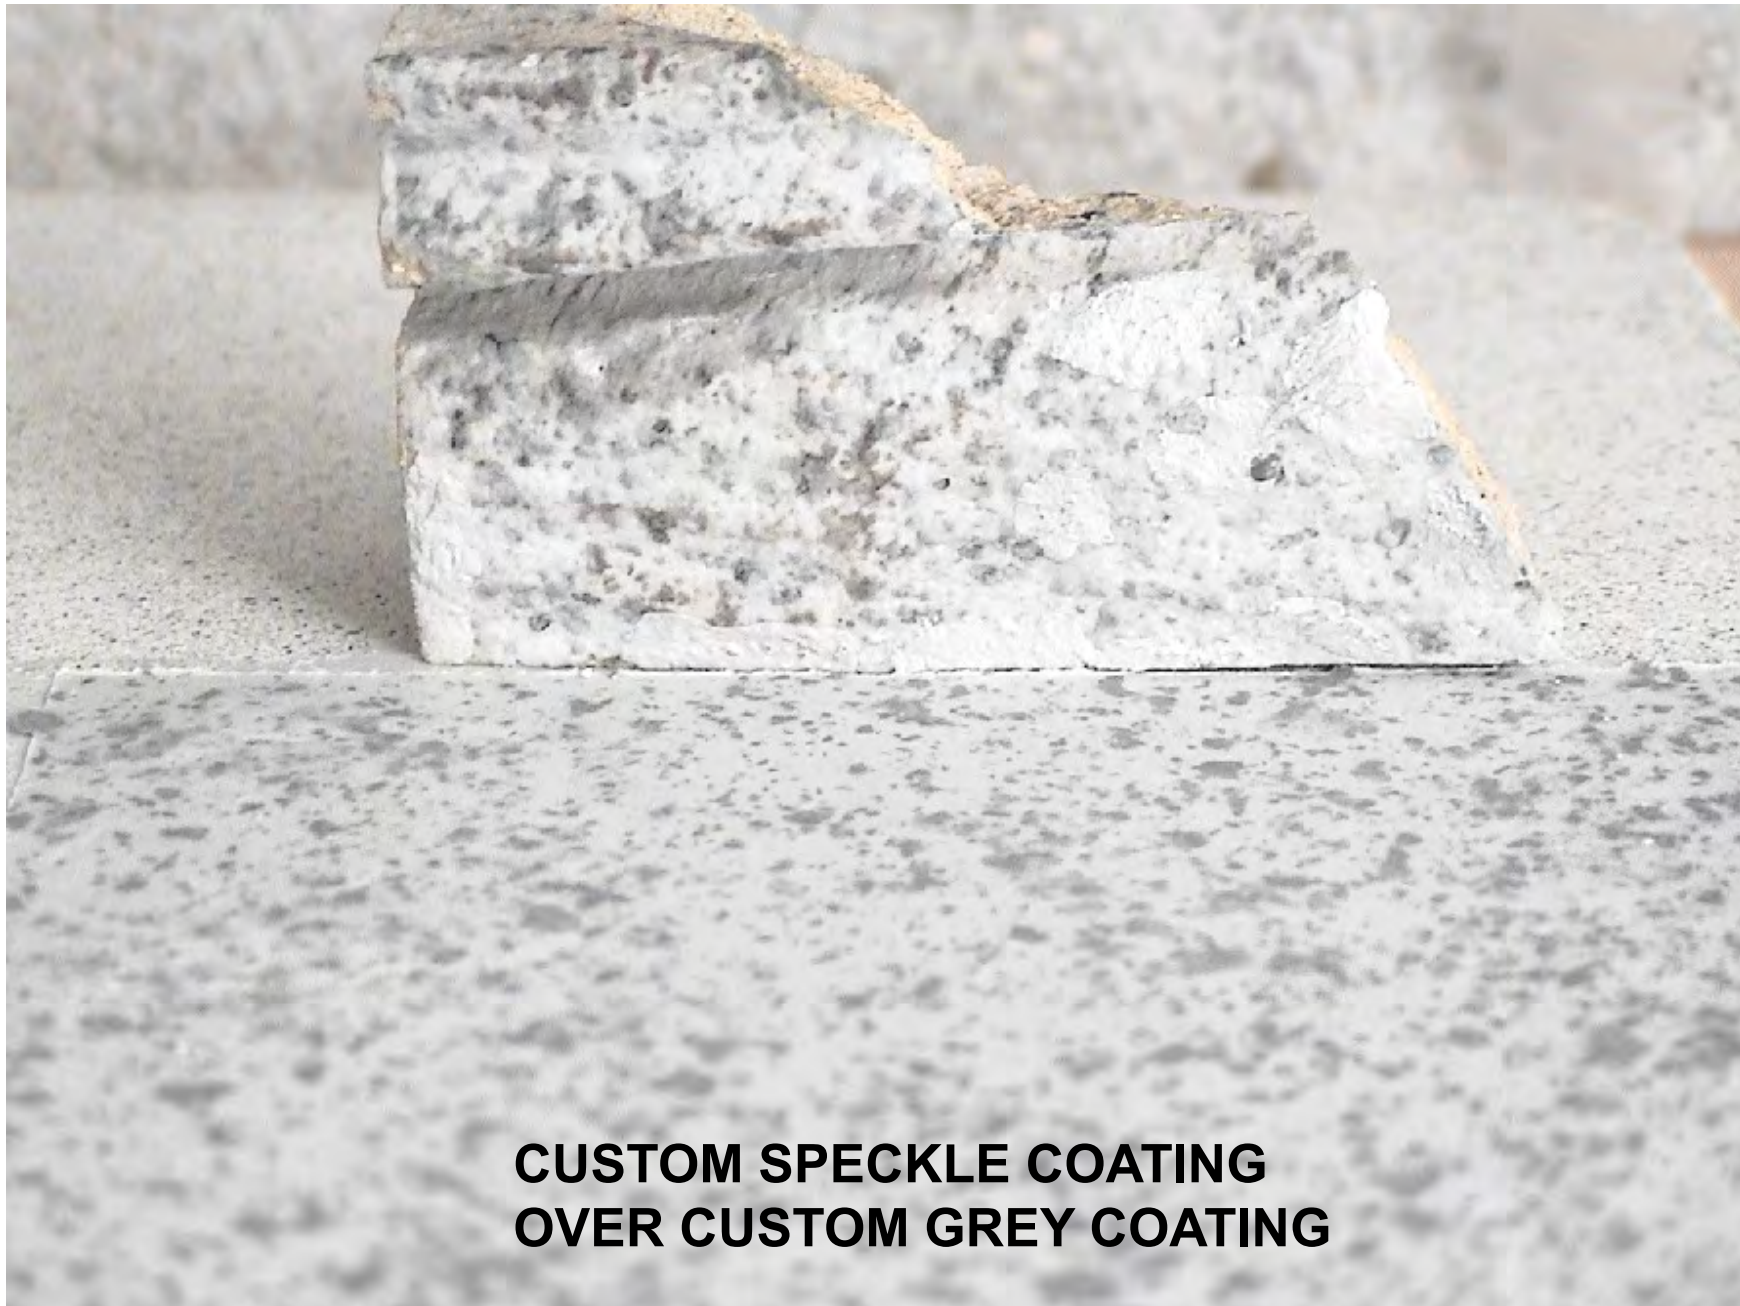
SPECKLE REPRODUCTION

**CUSTOM SPECKLE COATING
OVER CUSTOM GREY COATING**

- Color Flakes
Suspended in Clear
Binder
- May Be Controlled for
Size, Concentration &
Color

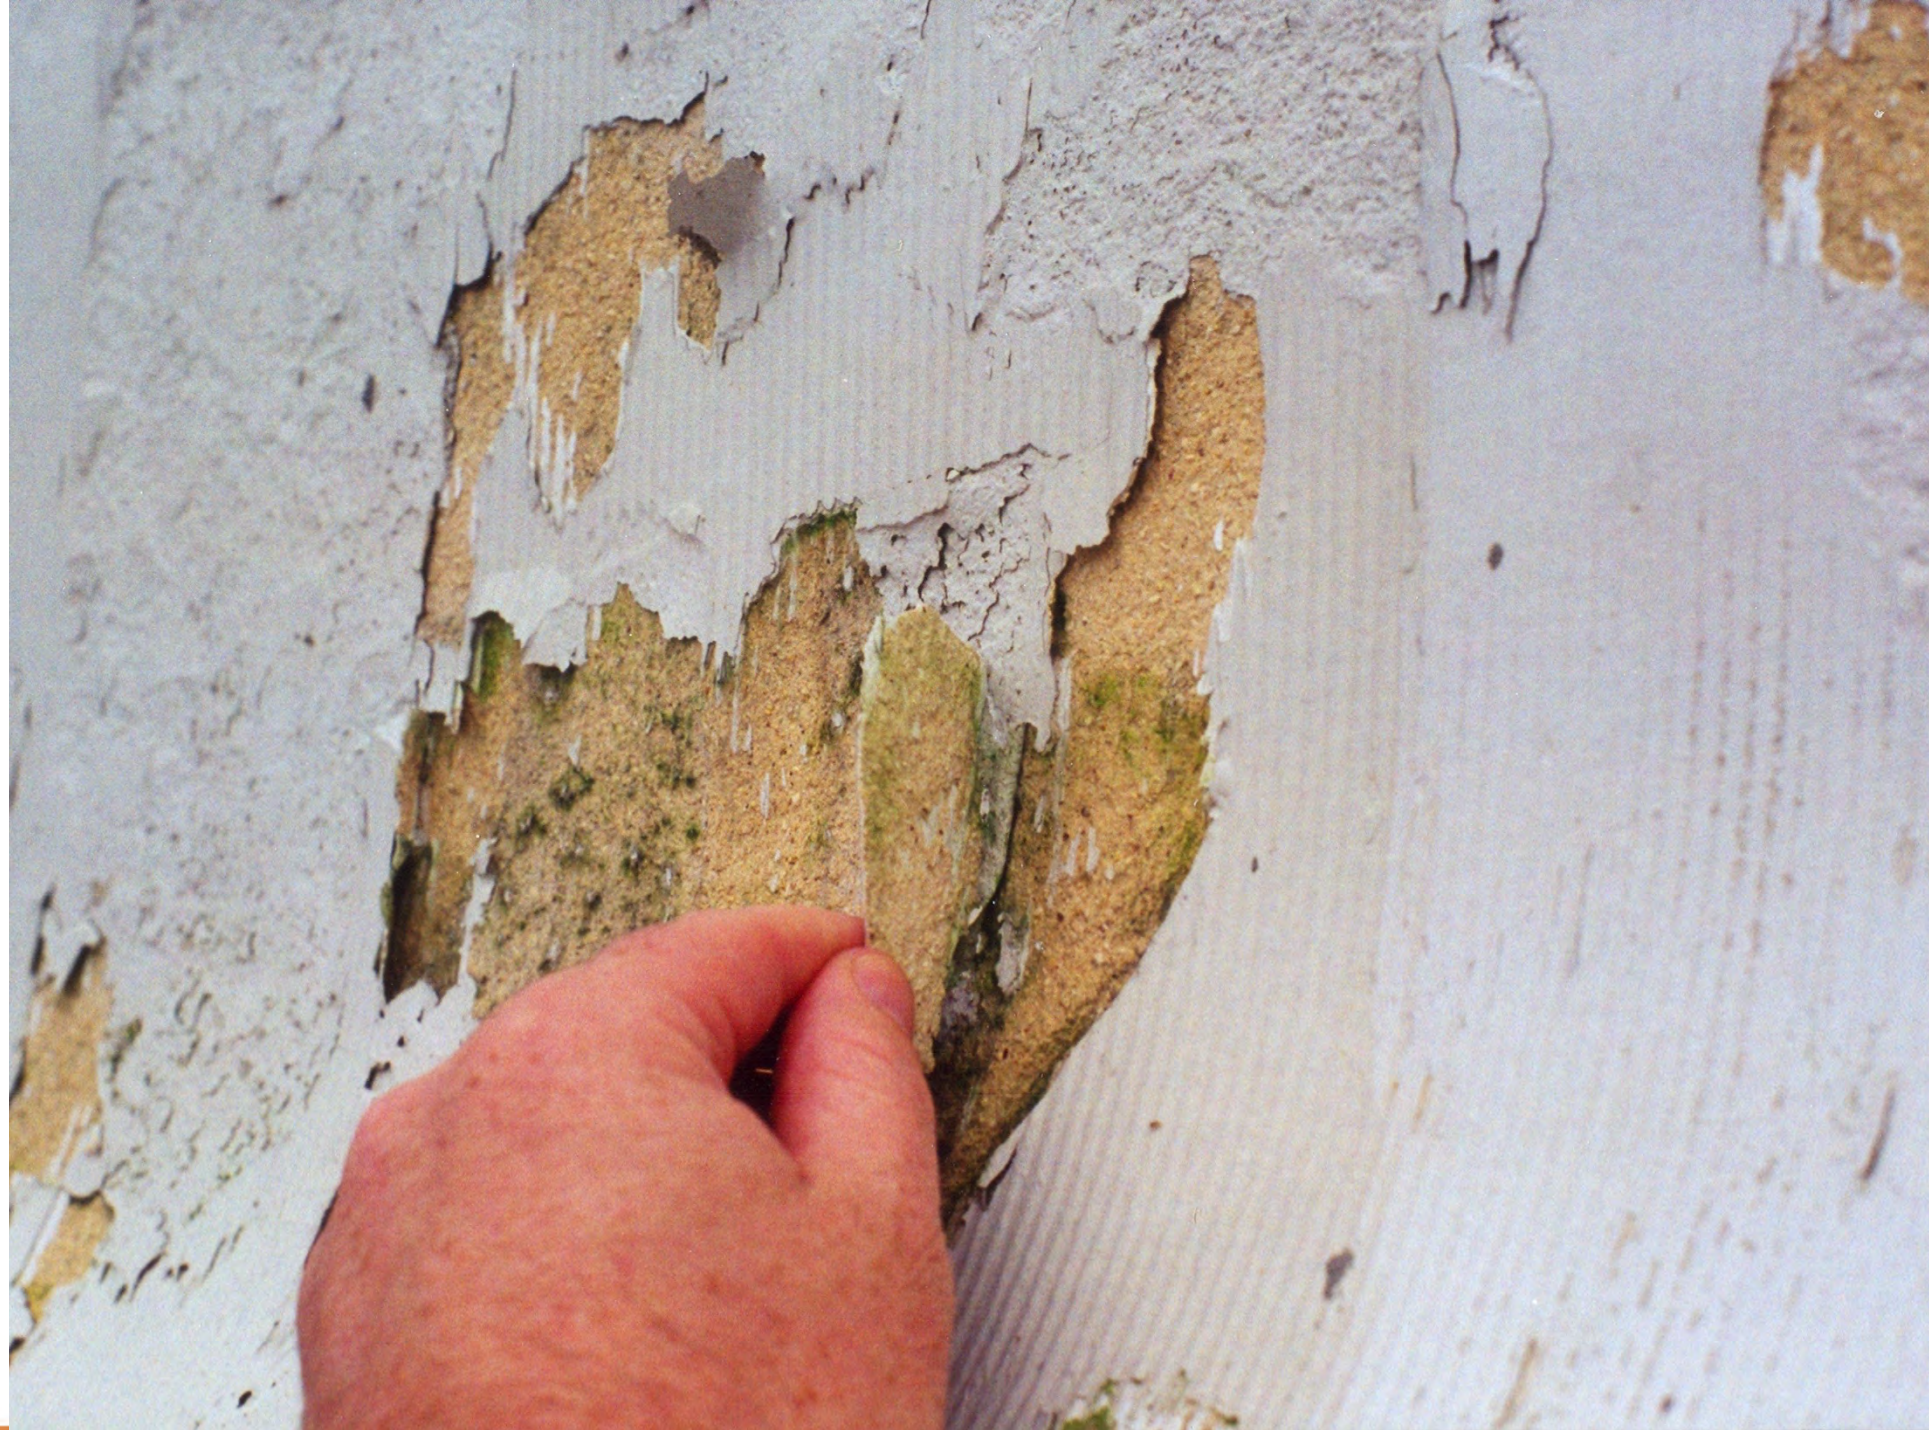
DRYING PLAN 1998

1. STABILIZE

- a. New Roof
- b. Parapet Flashings & Joints
- c. Seal Openings
- d. New Heating System

2. Install Test Areas

3. STOP!

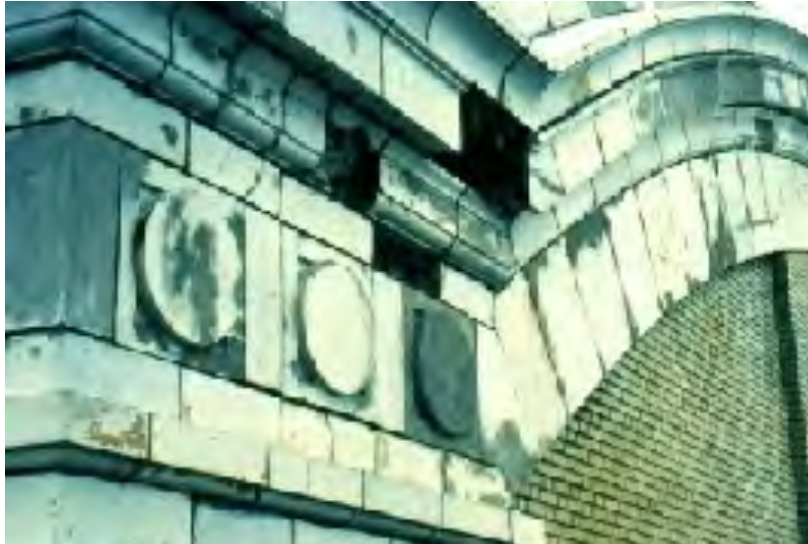
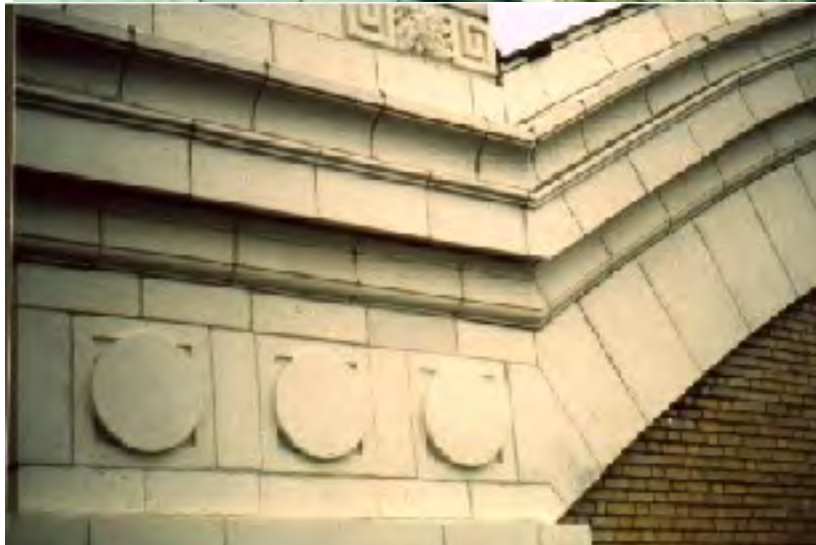
DRYING PLAN 1999

1. BREATHE!

- a. Open All Joints
- b. Scale Loose Glaze
- c. Drill 10,000 Holes
- d. Apply Permeable Primer

2. STOP & TEST

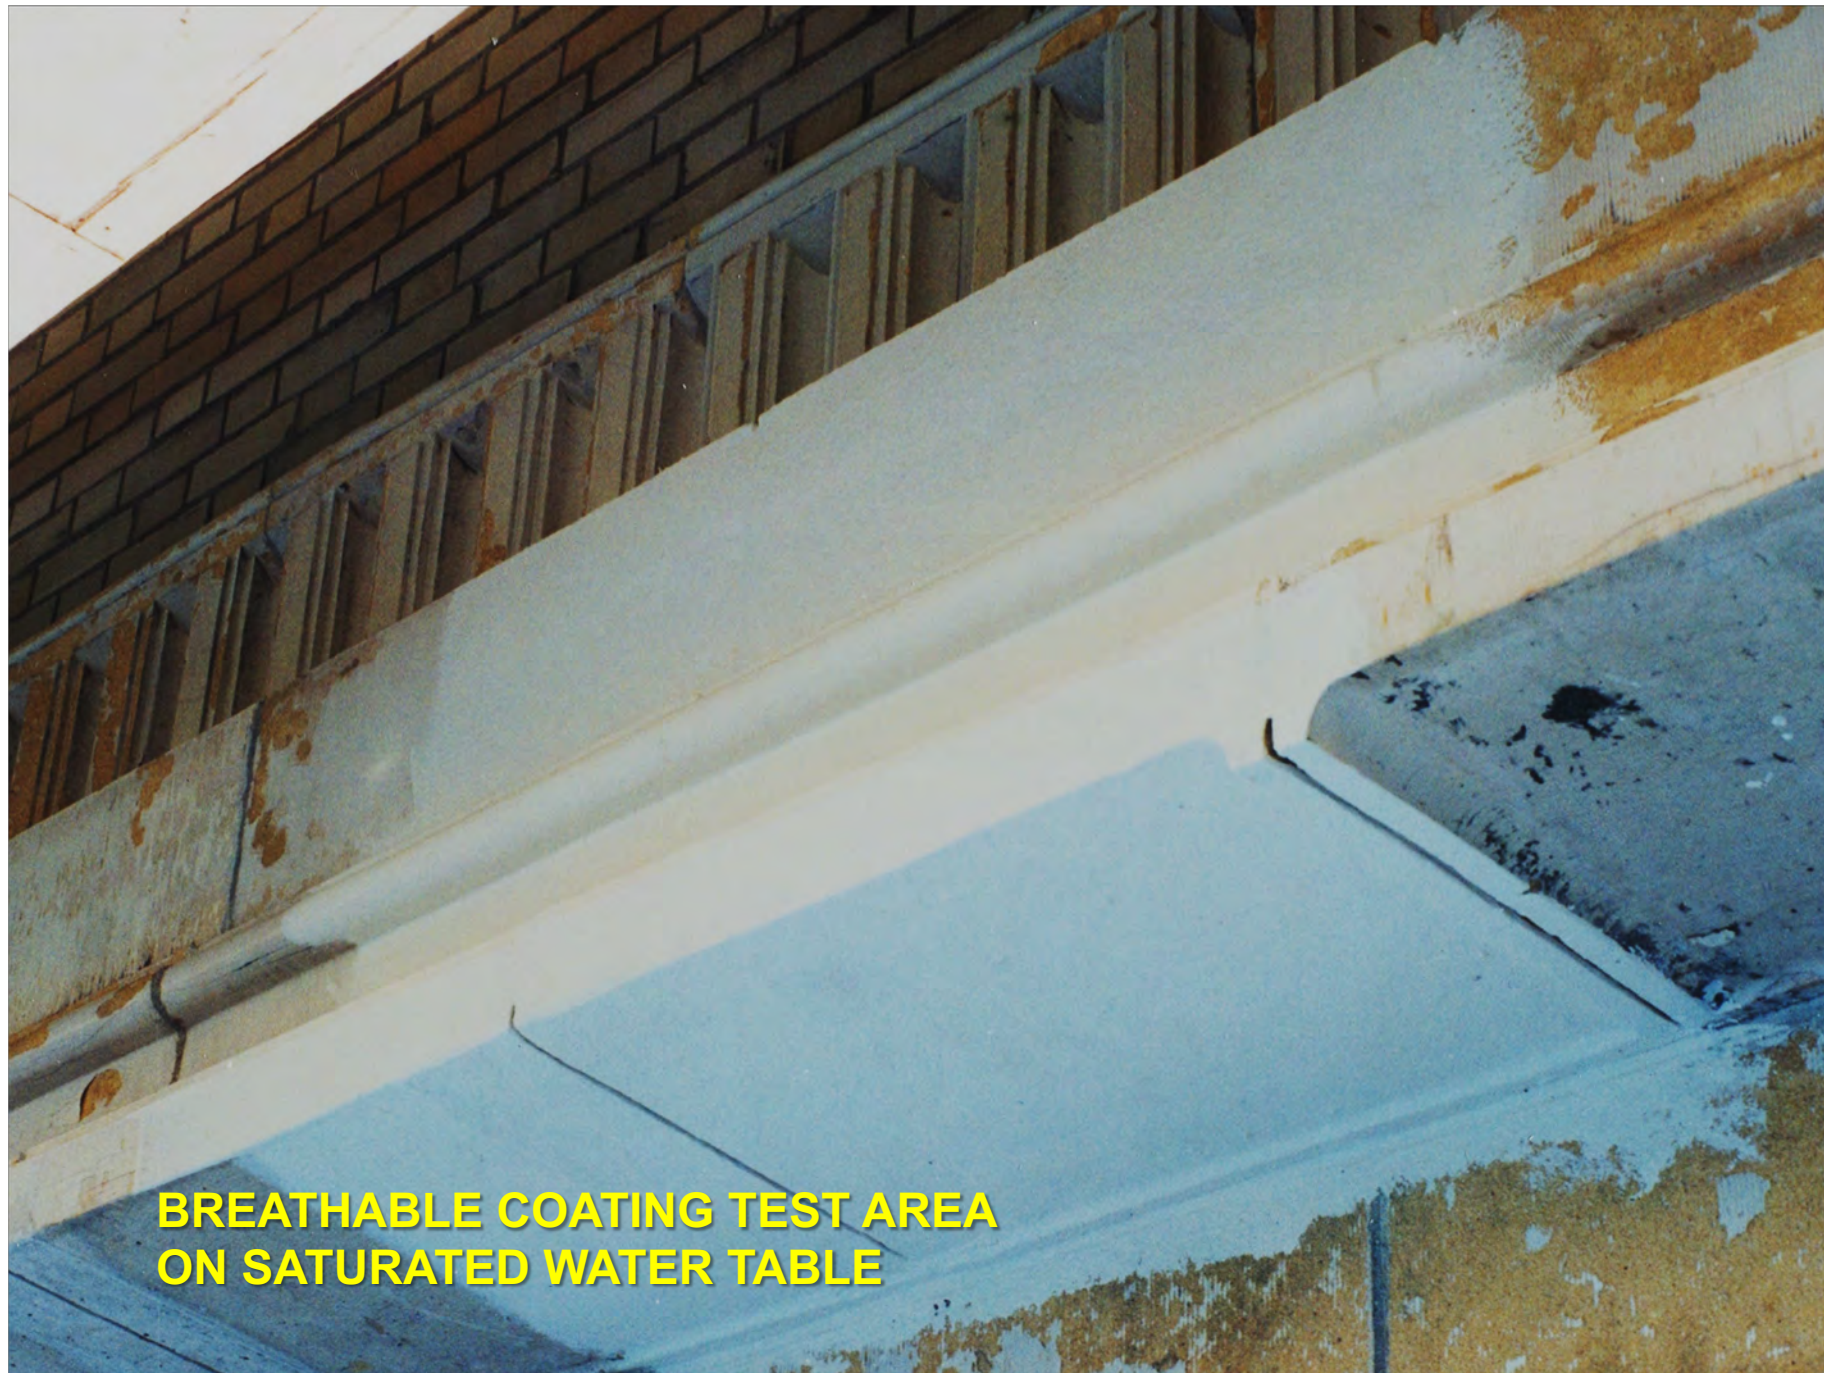
**BREATHABLE COATING TEST AREA
ON SATURATED WATER TABLE**

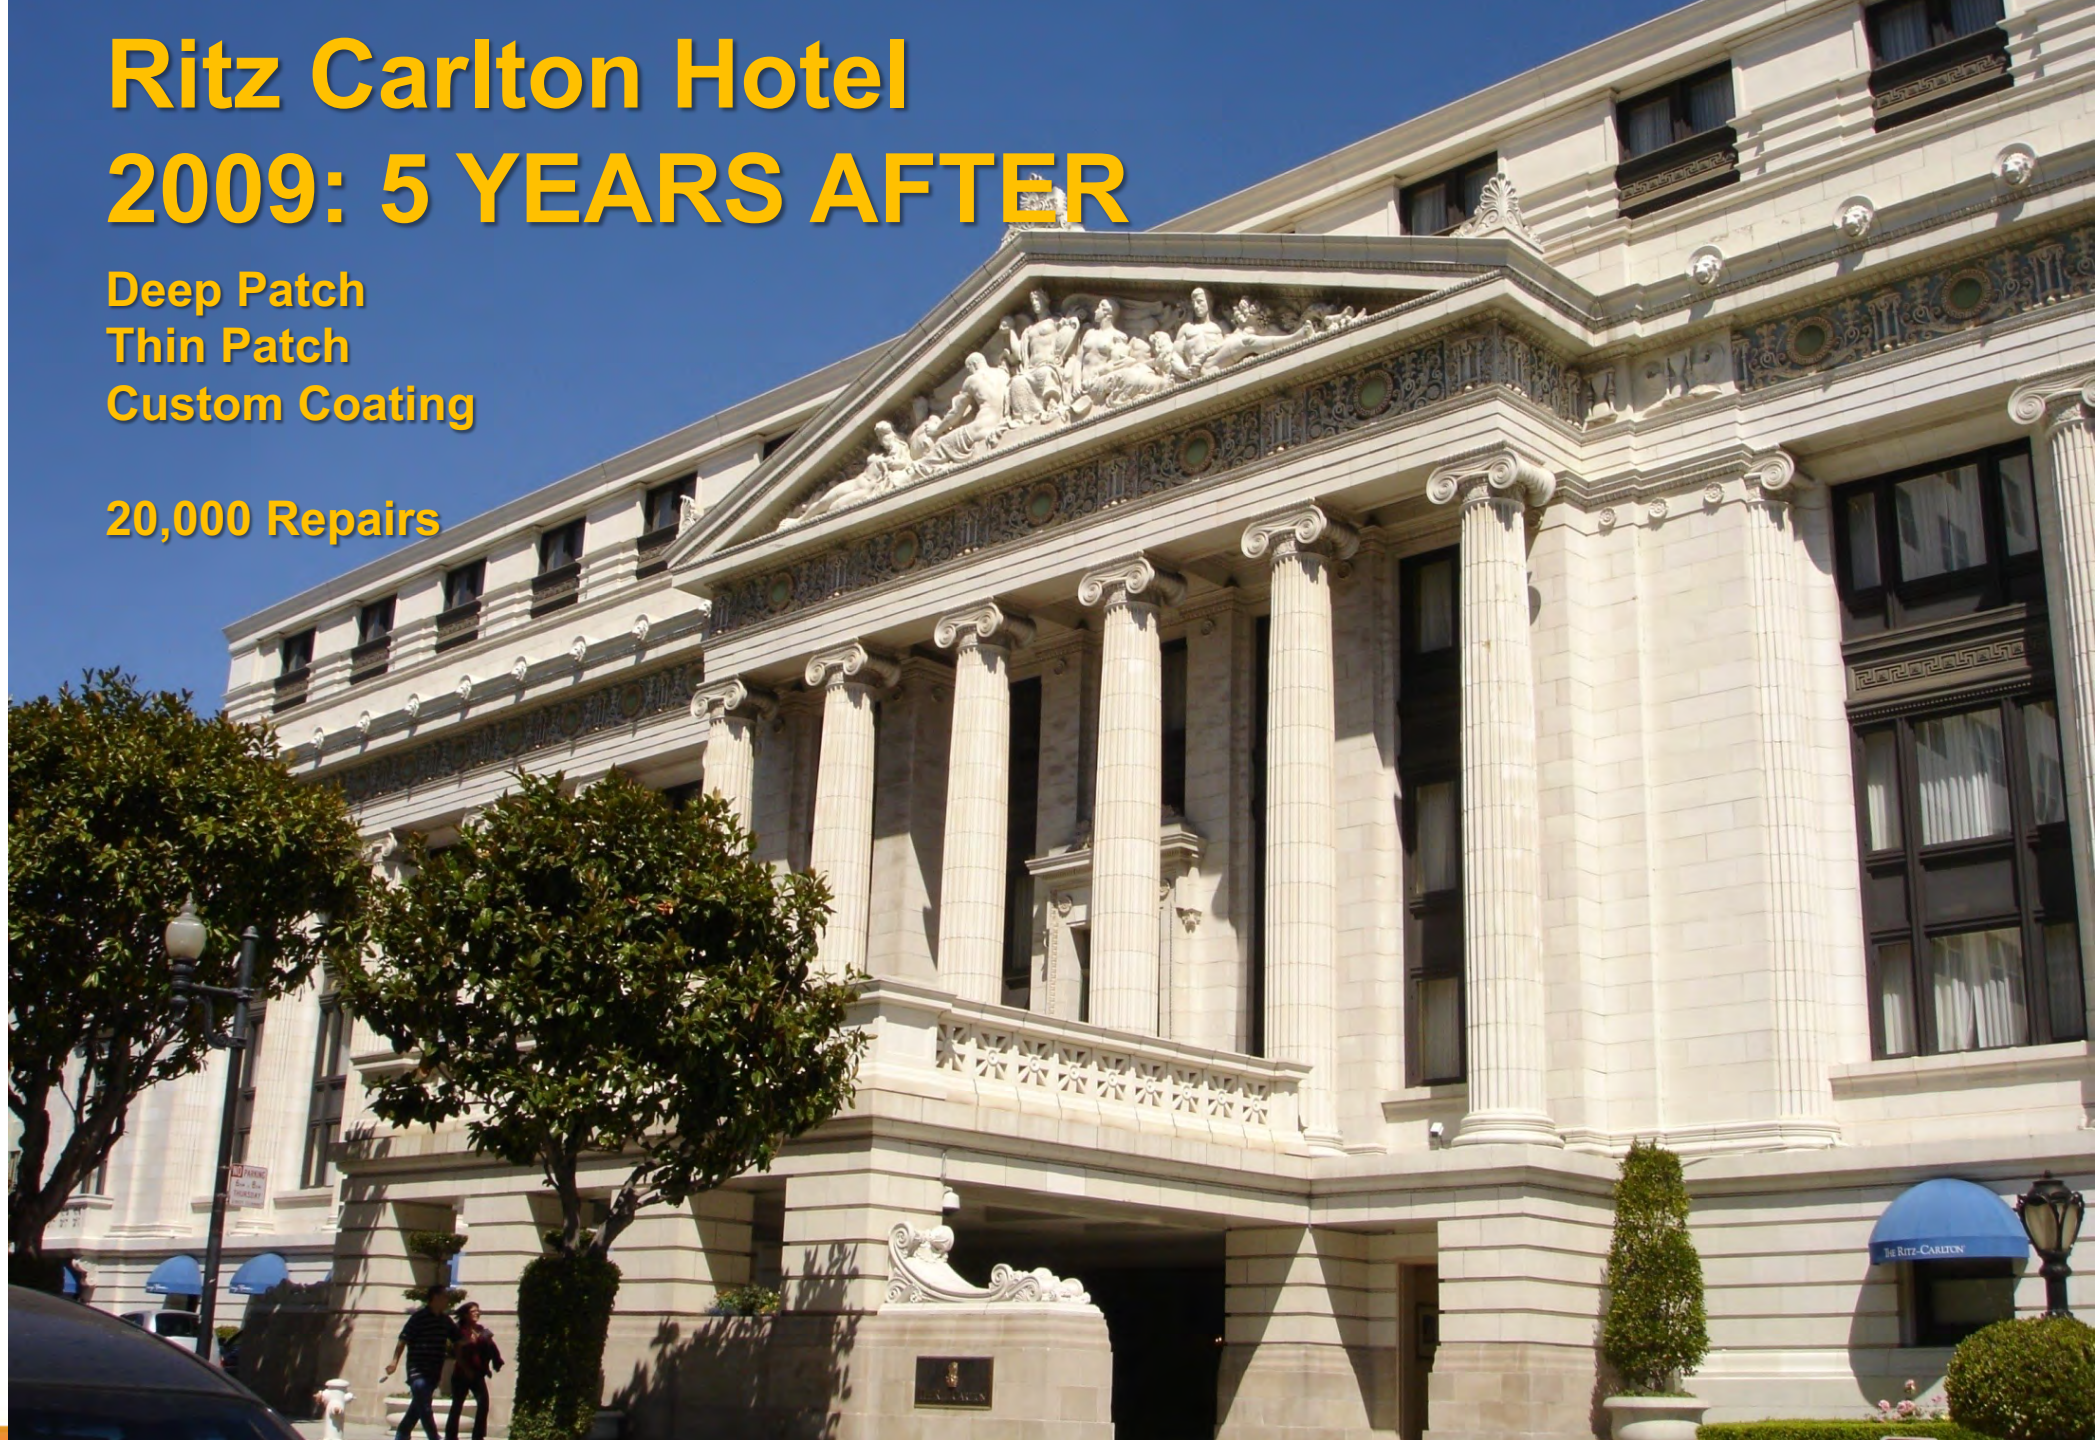
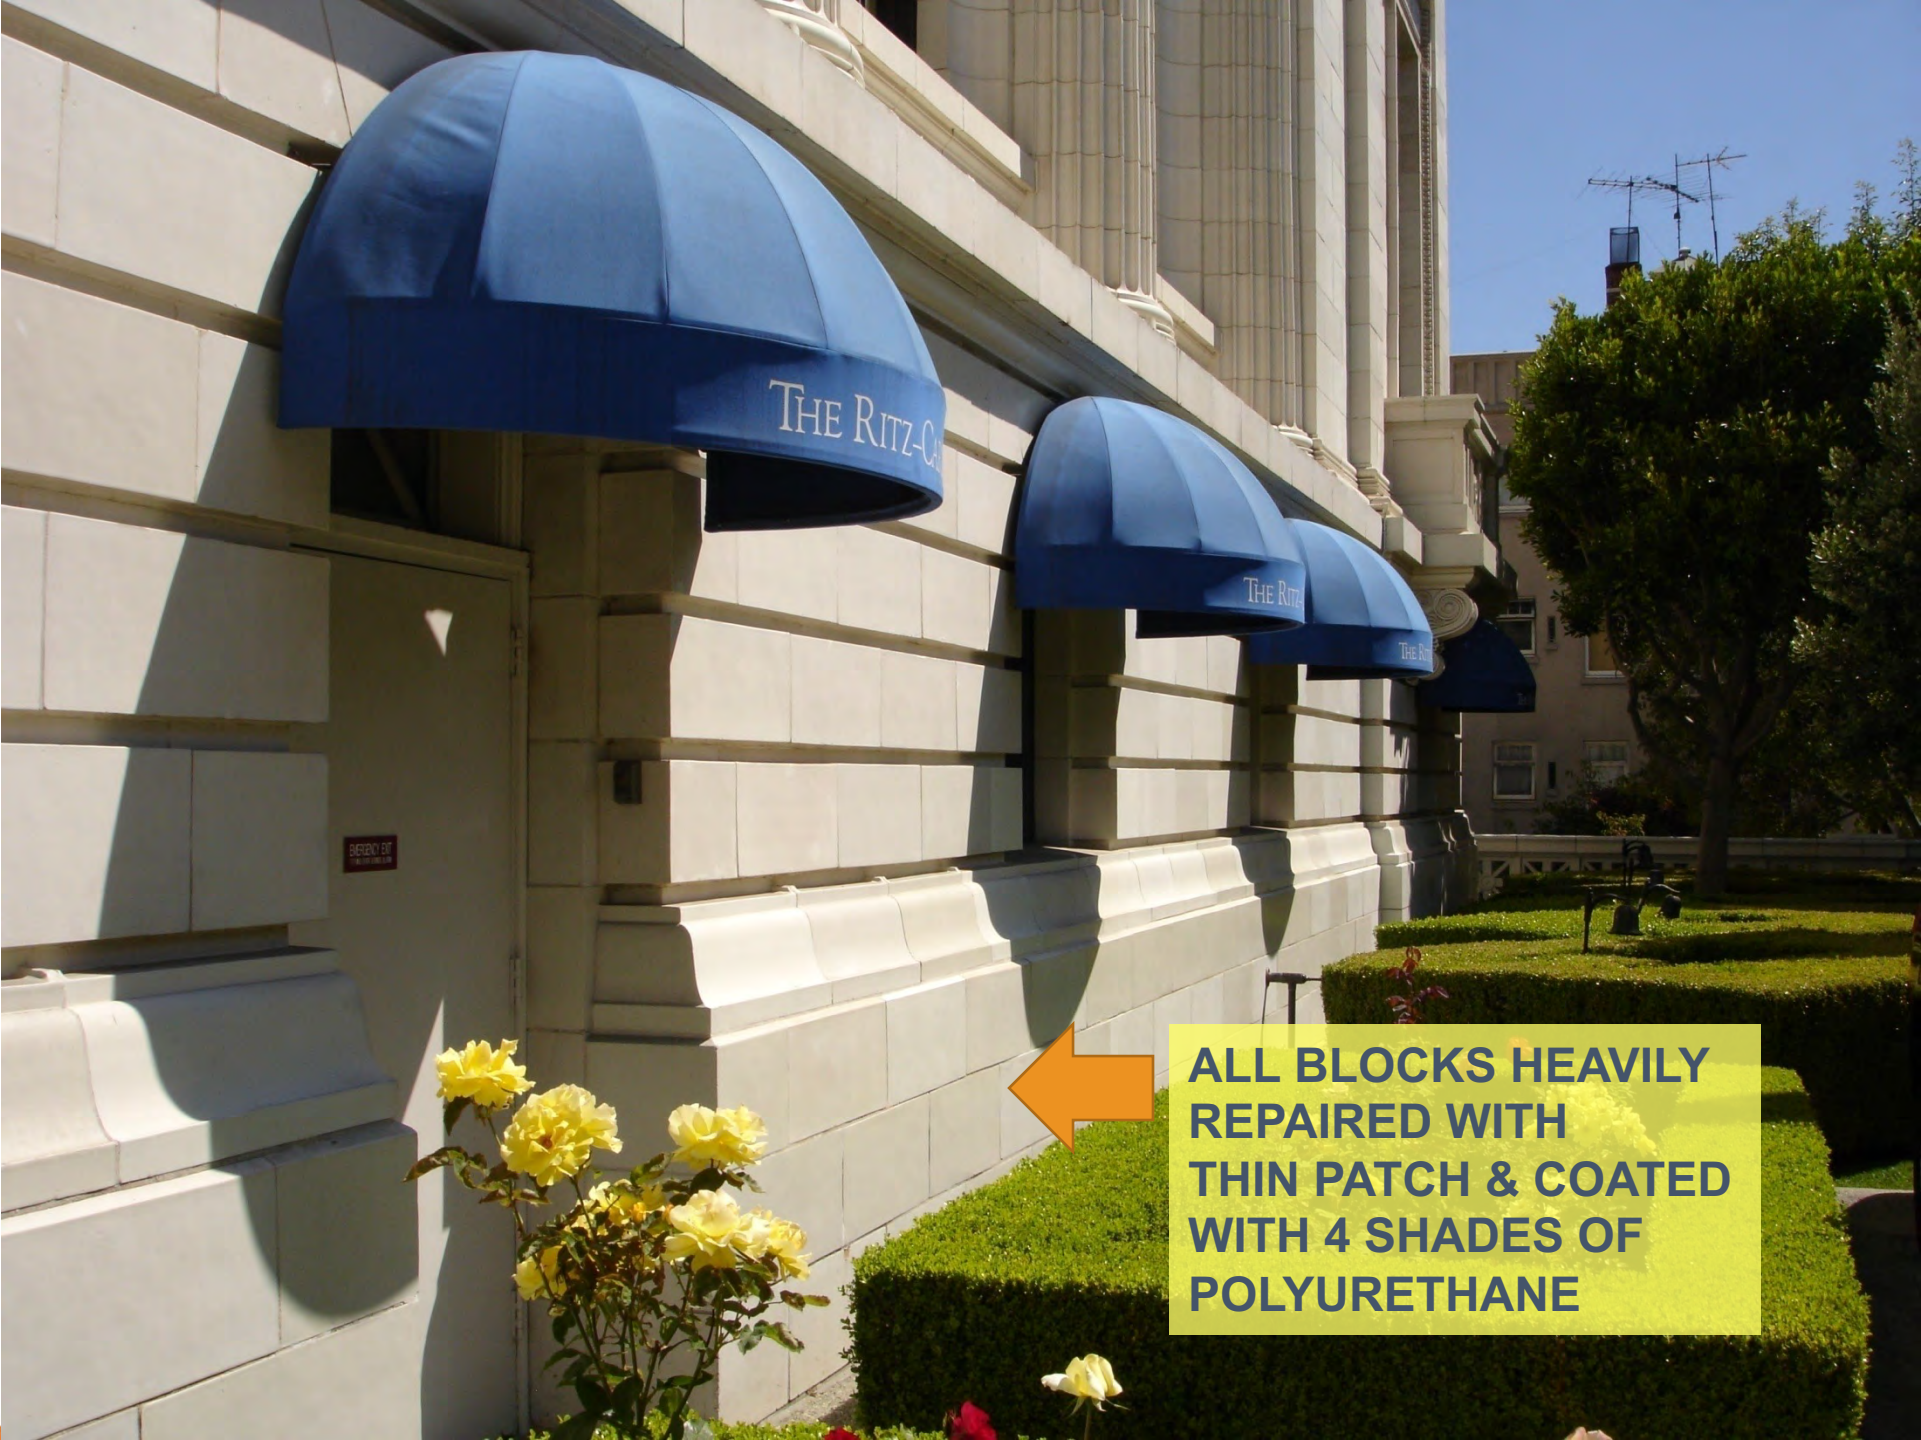
ALL BLOCKS HEAVILY REPAIRED WITH THIN PATCH & COATED WITH 4 SHADES OF POLYURETHANE

Deep Patch
Thin Patch
Custom Coating

20,000 Repairs

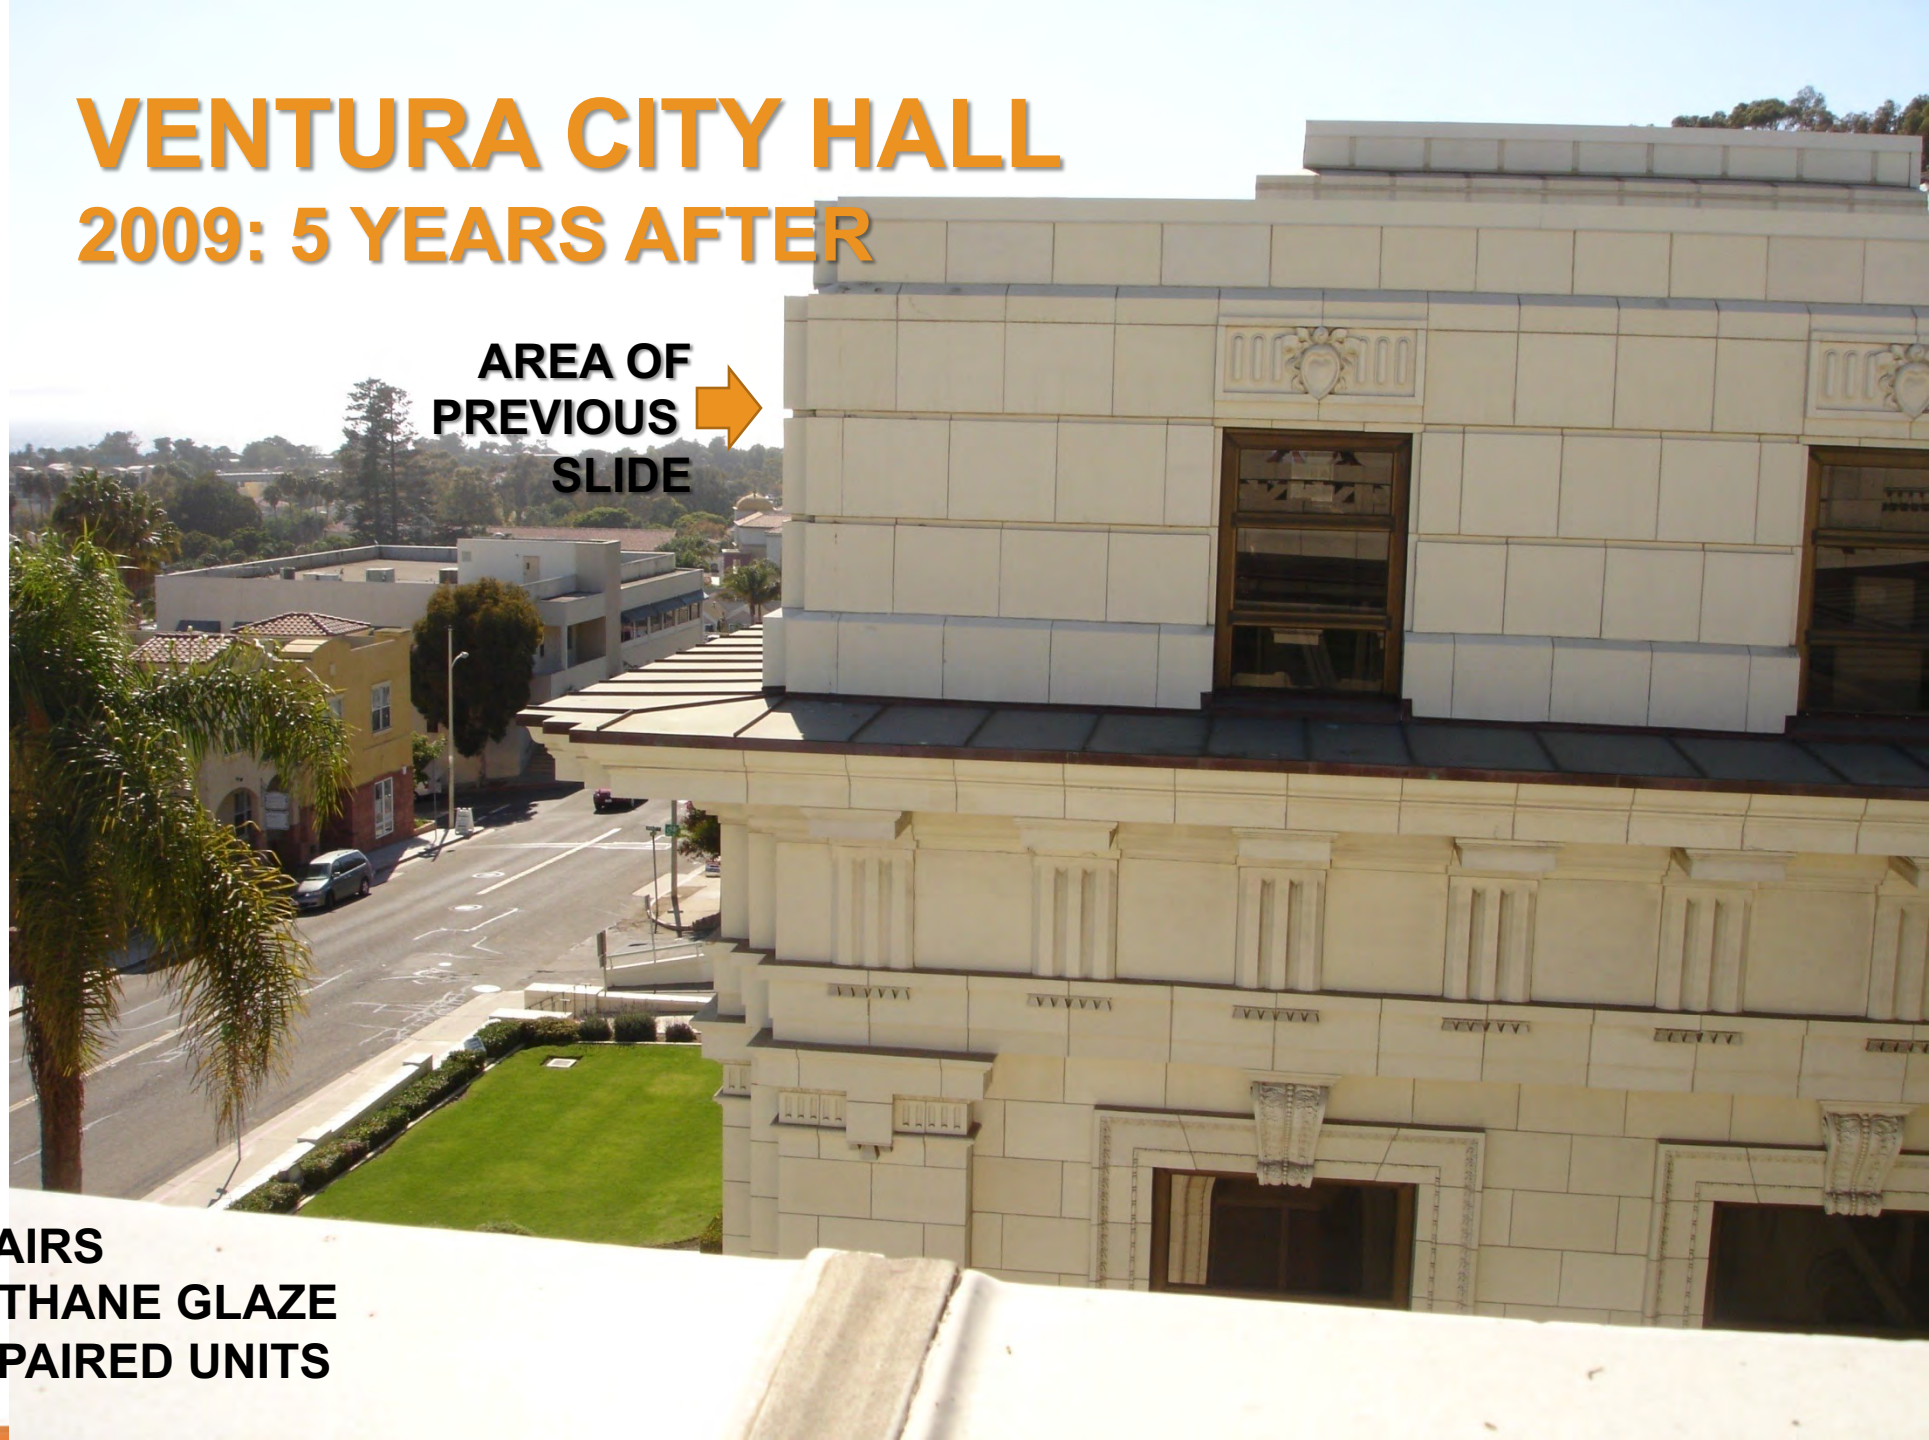
THIN REPAIRS
POLYURETHANE GLAZE
10,000 REPAIRED UNITS
