MASTER BUILDERS SOLUTIONS

Solutions for the Repair and Protection of Underwater Structures

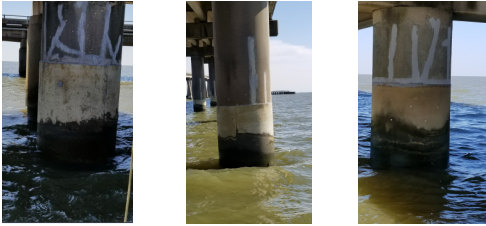
**Lake Pontchartrain Causeway,
New Orleans, Louisiana**

»Encapsulations in 2017

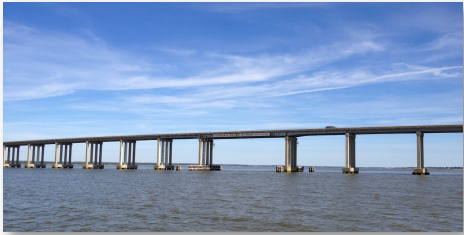
**Rappahannock River Bridge,
Tappahannock, Virginia**

- »1993
- »RC Piers Showing Corrosion and Spalling
- »Encapsulations all Above Water

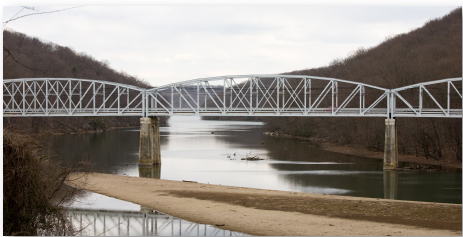
**Warren Road Bridge,
Baltimore, Maryland**

- Deteriorated piers
■ Large concrete pier
