Rapid Bridge Replacement projects in Ottawa

Case Study Island Park Drive Overpass, Ottawa

Extending service life of concrete structures

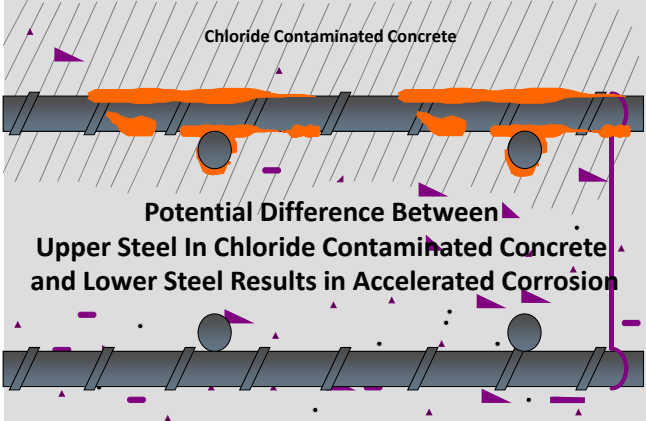
**Potential Difference Between
Upper Steel In Chloride Contaminated Concrete
and Lower Steel Results in Accelerated Corrosion**

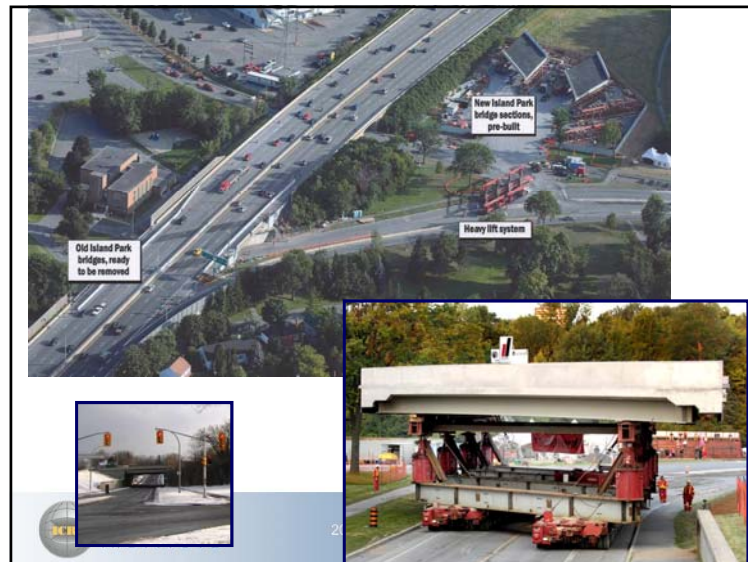
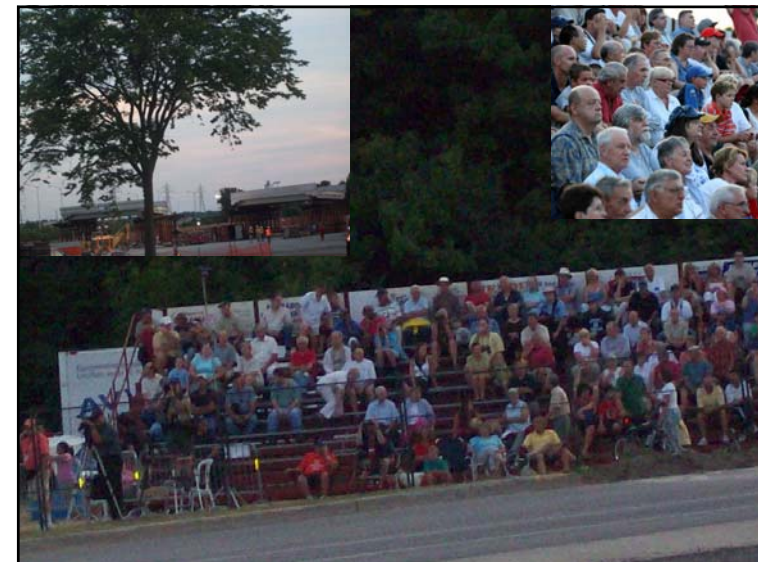
Highway 417 Island Park Overpass, Ottawa, Canada

- Rapid Deck Structure replacement overnight
- Substructure rehabilitation with Galvanic anodes, designed to last as long as the new deck.
