CONTROLLING CORROSION ON THE LA UNIDAD BRIDGE IN CAMPECHE, MEXICO

BY JORGE COSTA, MIKE RESTLY, AND CARLOS LEÓN

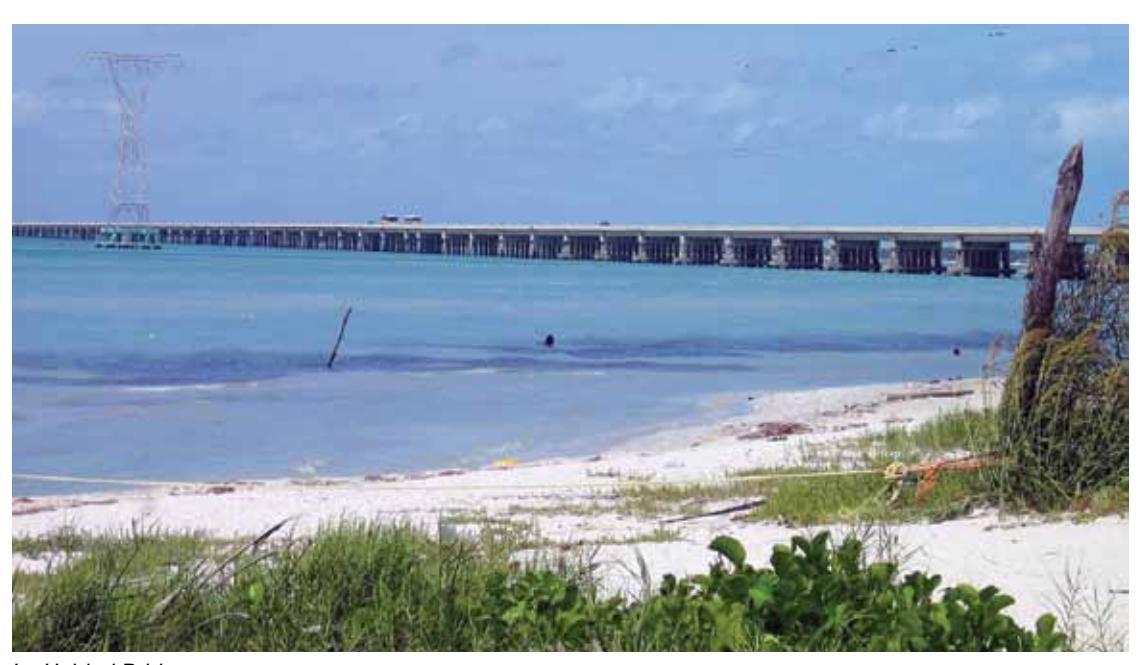
La Unidad Bridge

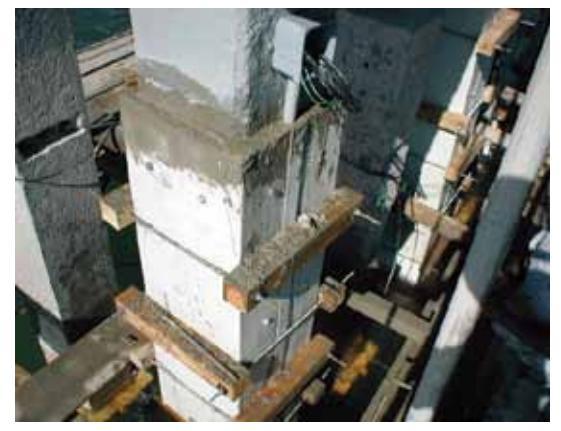
Lifejacket filled with concrete

electrical continuity in the steel reinforcement. When they did not find electrical continuity, they had to establish it by welding. An electric arc thermal spray unit was used to melt the zinc alloy and apply it to the surface. Zinc was applied to the piles in the amount of 1 lb/ft² (0.042 kg/m²).

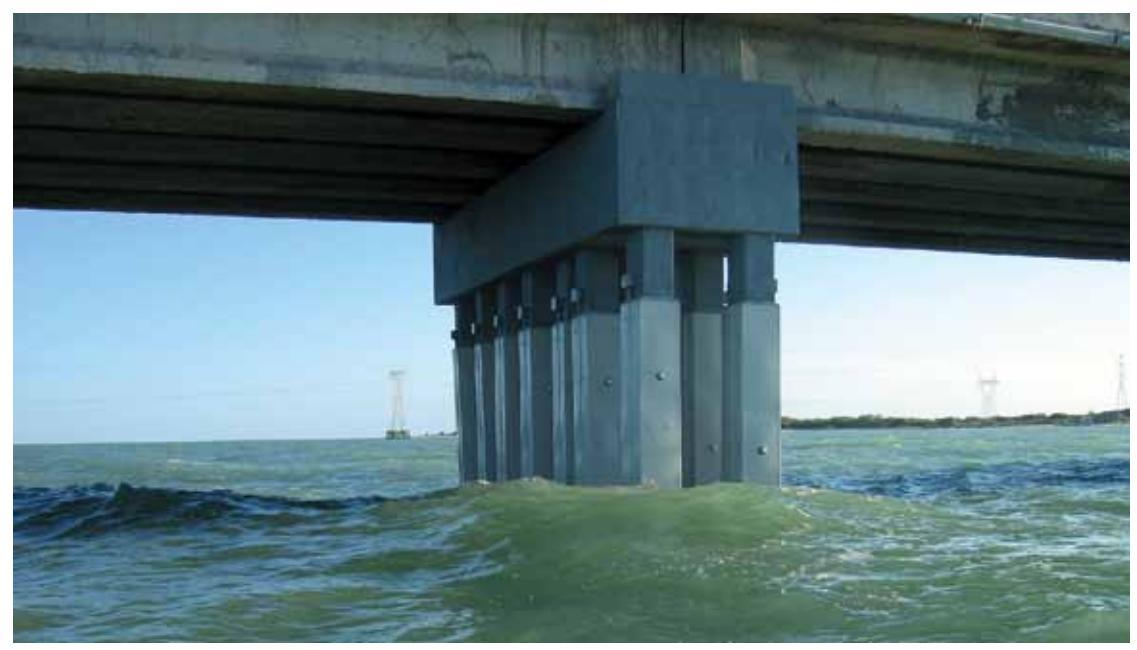
Completed installation of Lifejacket® and metalized zinc cathodic protection systems
