WATER STRUCTURES CATEGORY

# Innovative Repairs Restore Northern Spillway Pier

MANITOBA, CANADA

SUBMITTED BY VECTOR CONSTRUCTION LTD.—WINNIPEG, MANITOBA, CANADA

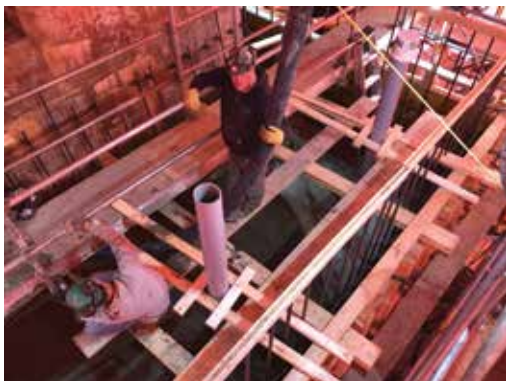
After 87 years of service in an aggressive northern environment, the structure needed some maintenance. Yearly safety inspections between 2008 and 2017 showed an escalation in deterioration and spalling at the base of the pier, suggesting freeze-thaw damage and corrosion of

the reinforcing steel. Of primary concern was the increasing risk of structural failure, which could result in an uncontrolled flow of water.

To fully assess the integrity of the existing concrete, a combination of destructive (concrete cores) and non-destructive testing (hammer sounding and sonic/ultrasonic testing) was conducted. The results of the evaluation indicated that one of the piers (Pier 1) had concrete defects beyond the original scope of the project, requiring far more work than concrete “chip-and-patch” repairs. The results prompted an immediate project shut-down to develop a new scope of work to address safety concerns. A concrete containment wall—or “jacket”—was devised as a temporary stabilization solution which would allow the spillway to operate normally, along with containing the pier in the event of a failure.

After safe access to the work area was established and water control measures had been completed, heating and hoarding on Pier 1 was necessary to allow it to warm above freezing to ensure the existing concrete sluiceway was safe to construct the concrete containment wall.
