Trinity Stadium Rehabilitation

HAVERHILL, MASSACHUSETTS

SUBMITTED BY SIMPSON GUMPERTZ & HEGER, INC.—WALTHAM, MASSACHUSETTS

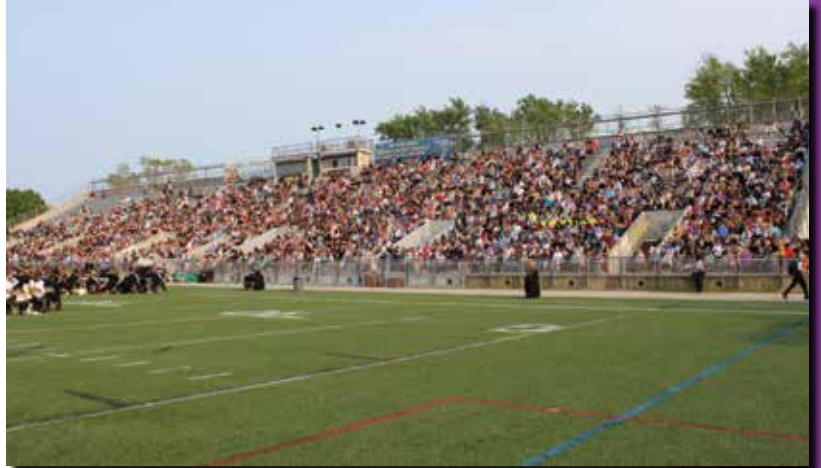
The grandstand experienced severe and widespread concrete deterioration due to nearly seventy years of exposure to weather, resulting in half of the stadium being removed from service approximately twenty years ago. In 2007, the City of Haverhill, Massachusetts, started planning the rehabilitation of the grandstand to restore full use of the stadium and extend its useful service-life.

Deterioration was predominantly due to cyclic freezing and thawing action. While some damage was severe and required repair or replacement, there was little to no damage in other locations. By repairing the deteriorated concrete and protecting the remaining concrete, the useful service-life of the grandstand was restored, while allowing the majority of the existing concrete to remain in place.

while also upgrading the structure with additional desired functions. The project not only included small-scale localized concrete repair, large-scale complete reconstruction, application of a new waterproofing membrane, and repair of the joints, but also incorporated the addition of an accessible seating area at the front of the grandstand.
