Apeejay House, Repair and Restoration

MUMBAI, MAHARASHTRA, INDIA

SUBMITTED BY LEAKSEAL

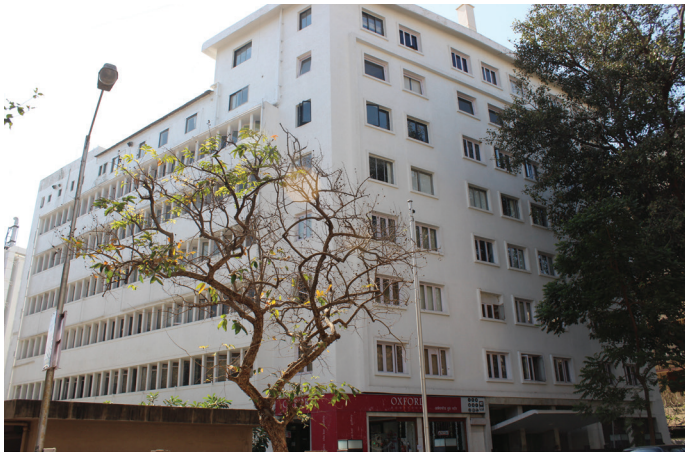
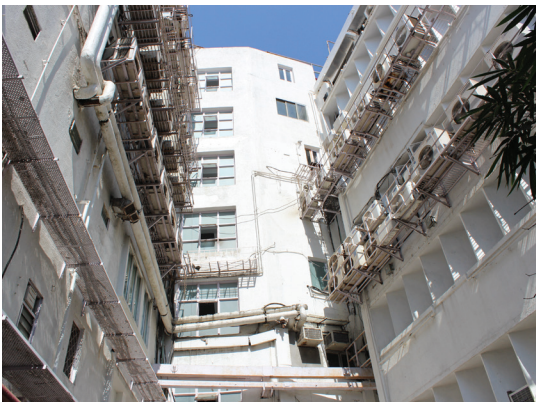
Because the building faces the sea, the hostile marine environment, corrosion control conditions, and poor maintenance led to severe deterioration of the building's external concrete façade. In some locations, concrete

chunks started falling from beam and balcony areas. The sanitary installations were also leaking heavily—creating algal and fungal residues that were damaging the building, coupled with a potential health risk. Visible cracks on the external side of the building also contributed to leakage of water within the building.

application of new sealants and coatings. The project consisted of repairs and replacement of major areas of the external façade, and repair to exposed portions of concrete elements, such as slab edges and columns. In addition, repairs included rehabilitation of the external façade treatment, replacement of façade render, repair/replacement of concrete members/slabs, jacketing of columns, corrosion control, and casting of concrete cornices and delicate architectural elements, including application of an external synthetic plaster with a unique and innovative paint pattern to match the existing building appearance.

It was determined that extensive restoration work was needed, including concrete repair, strengthening of structural members, corrosion protection, and the
