# Guarding Against Common Parking Garage Problems

By Rick Edelson

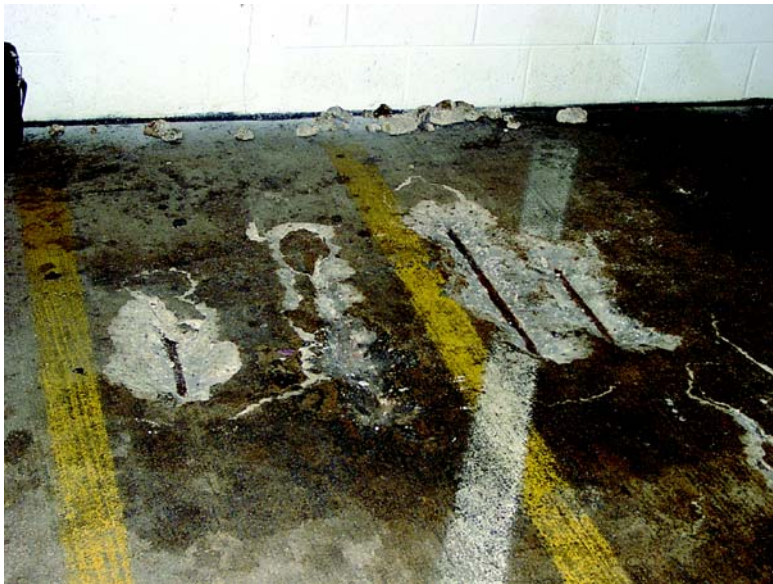
*My garage is spalling and breaking up! Is this dangerous?*

Spalling concrete can lead to dangerous structural instability due to the loss of concrete and corrosion of the reinforcing steel. Repairing spalling concrete is simple, yet expensive. Basically, the deteriorated concrete is removed, the rust is cleaned off the reinforcing bars (bars are replaced if severely corroded), the bars are then coated with a corrosion inhibitive coating, and new, specially modified concrete is placed and bonded to the old concrete.

Prevention is easy and inexpensive: clean the garage floors. The floors should be routinely broom cleaned and washed down to remove salt before it is absorbed into the concrete. Also, reseal the floors every three to five years. Most buildings have a water repellent sealer applied to the concrete floors at the time of construction. Sealers are excellent because they help prevent water from being absorbed into the concrete, but they must be reapplied every 3 to 5 years to remain effective. Reapplication is a major deterrent to absorption of salt water. The cost of reapplying a sealer is relatively low compared

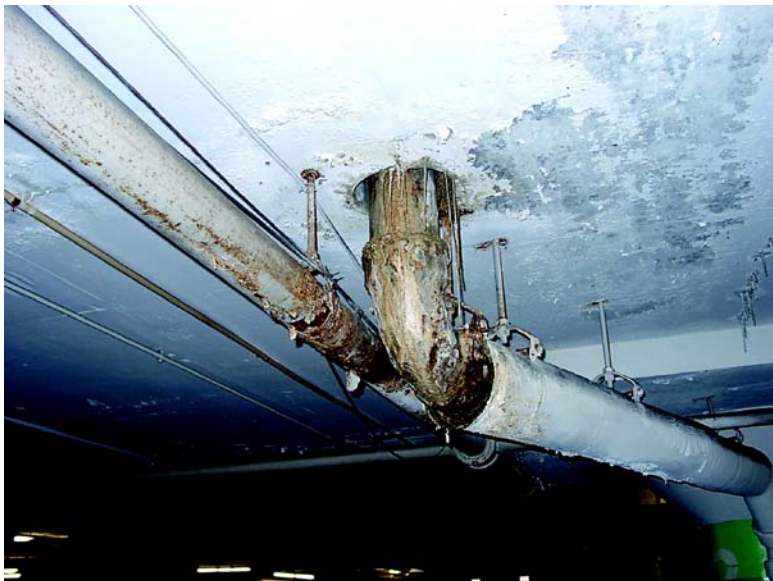
*That white stuff is dripping from the concrete and ruining the paint on the cars. What do I do?*

That white deposit dripping onto cars is water-soluble lime, which is dissolved and leached out of concrete by water passing through the cracks in the concrete. Once lime falls on a car, it is guaranteed to remove the car's finish, and nothing except immediate removal can prevent the damage. Overhead gutters are often installed to divert water coming through cracks away from cars, but this does not solve the problem—it only treats the symptom. The only true solution is to seal the cracks in the floor that are allowing the water to pass through the concrete.

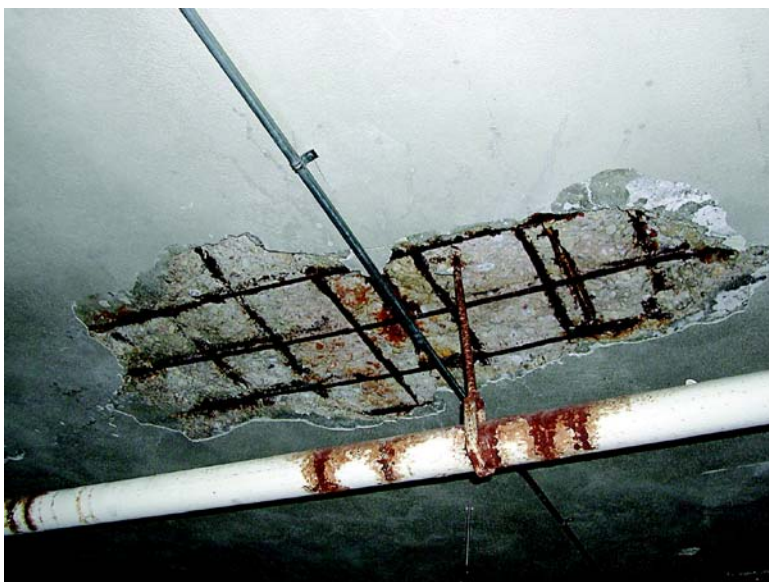
*Chunks of concrete are falling from the ceiling. How do I stop this before someone gets hurt?*

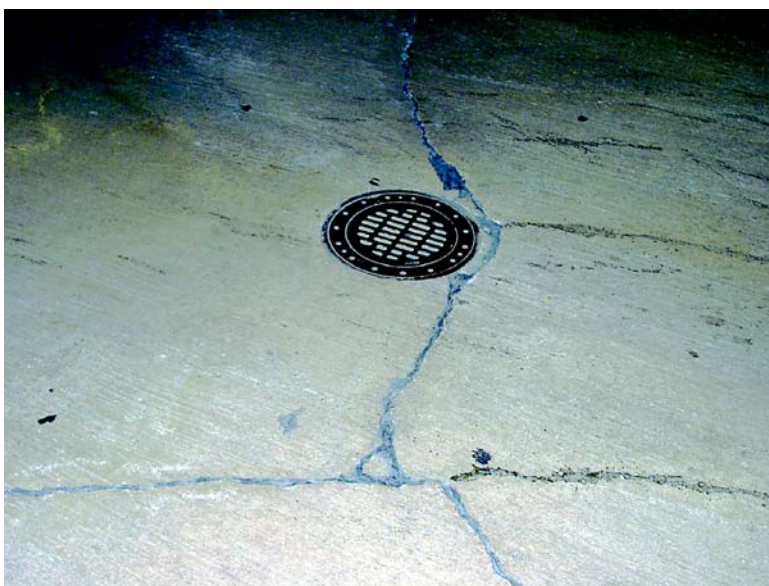
*My floor is cracking. Will it fall down?*

Cracks, by themselves, did not cause deterioration of concrete. Water enters the cracks, comes in contact with the reinforcing bars, then causes the corrosion and the related spalling; or water enters the cracks and expands as it freezes, causing the concrete to spall and crack even more. Cracks in the floor can be caused by many things, such as normal shrinkage or thermal expansion and contraction. They can also be induced by structural over-stresses in the floor-framing members, however. If the cracking is severe, that is, more than random isolated cracks, it is always prudent to have a professional engineer investigate the underlying causes. Other than cracks caused by structural over-stresses, repairs usually involve cutting or routing the crack into the shape of the groove and then filling the groove with high-quality sealant to prevent the penetration of water. Repair costs can be as high as \$2.50 to \$5.00 per linear feet of crack. Building owners and managers can't prevent the cracking. It occurs as a result of normal shrinkage of concrete or can also be caused by improper structural design and/or poor construction practices.
