MULTI-STORY CAR PARK REPAIR AND MAINTENANCE: A HOLISTIC APPROACH FOR CORROSION CONTROL

BY DAVID SIMPSON

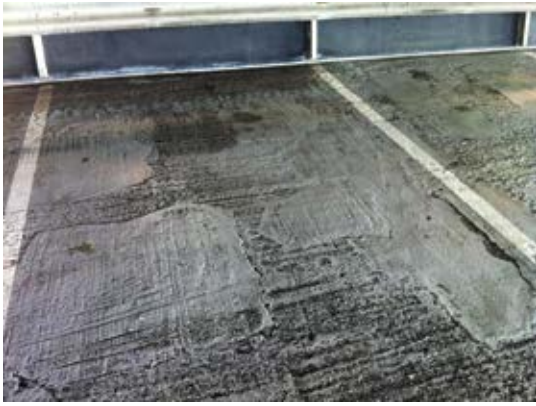
Fig. 1: Cosmetic surface patching

Many of these structures were originally designed and built to standards that failed to recognize the harsh environmental conditions they would be exposed to during their life. The majority of these structures were made from reinforced concrete which, at the time, was considered to be a stable medium. This lack of understanding combined with flawed design features and poor construction practices resulted in extensive and repetitive maintenance requirements over their life.¹ Various types of deterioration on multi-story car parks in the UK today can be seen in Fig. 1 to 3.

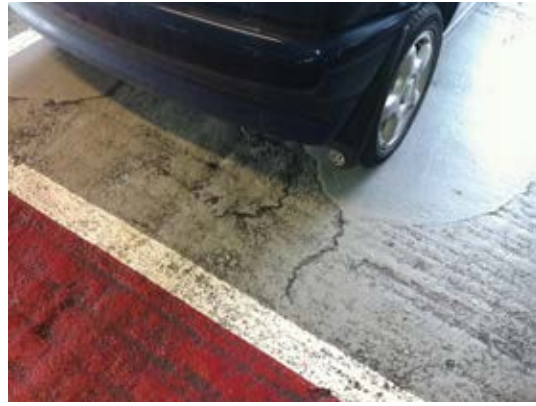
Fig. 2: Cracking and delamination

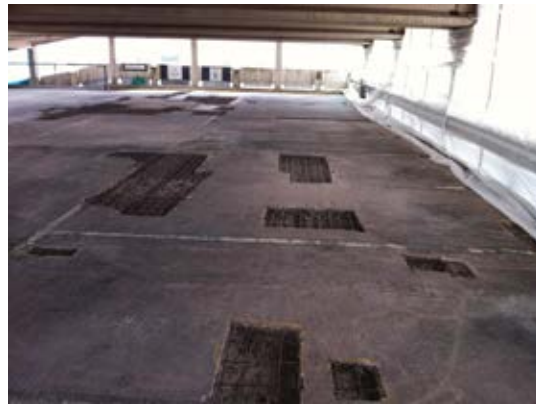
Fig. 3: Corroded areas prepared for patching

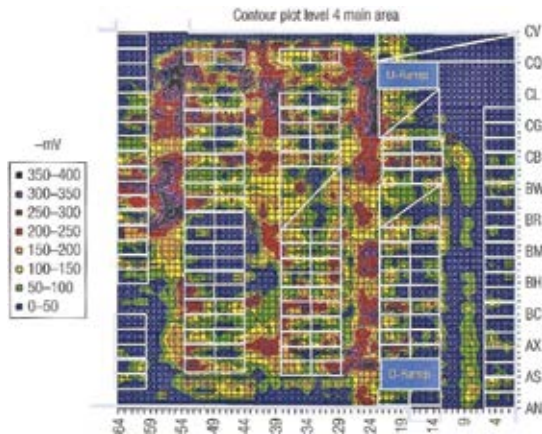
Fig. 4: Half-cell potential map illustrating variable corrosion potential⁴

While no single test method is proficient in determining the actual risk and rate of corrosion, full half-cell potential mapping combined with other sample tests may be more effective. The potential map shown in Fig. 4 is taken from The Institute of Structural Engineers guide to the “Design Recommendations for Multi-story and Underground Car Parks” (fourth edition)⁴ and illustrates the information that can be gathered and subsequently used to identify invisible but at-risk areas of future corrosion.

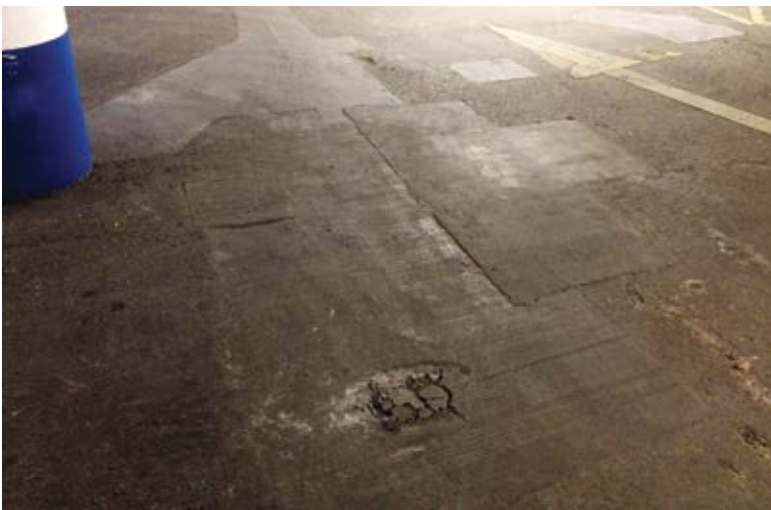
Fig. 5: Premature failure on car parks due to incipient anode formation

technique for more than a decade. The occurrence of incipient anode formation on car parks is a common sight in the UK (Fig. 5), with failure initiating in as little as 5 years depending on the severity of the environment. With the incorporation of galvanic anodes (Fig. 6), a repair may be stabi-

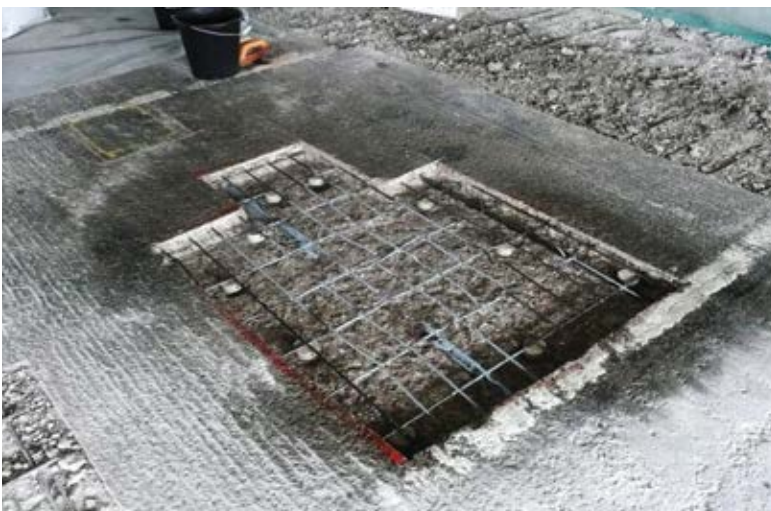
Fig. 6: Incorporation of galvanic anodes at periphery of patch

lized for up to 15 to 20 years, thereby improving durability and reducing maintenance. While this type of corrosion protection is a simple and commonly used technique, it only protects areas just outside of the repair area from incipient anode formation. Other high-risk undetected corrosion sites are not affected by this installation.

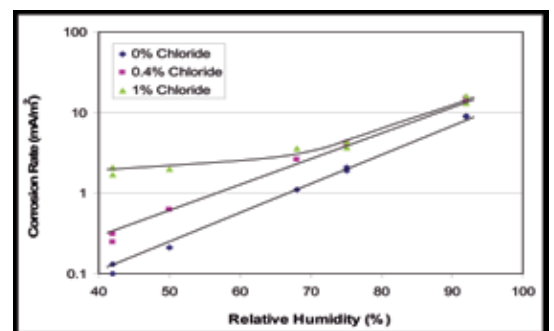
Fig. 7: Relationship between RH and corrosion rate of steel-reinforced concrete on carbonated mortars dosed with chloride. ($1 \text{ mA/m}^2 \sim 1 \mu\text{m/year}$)⁵

For carbonated concrete, corrosion risk may be minimized by controlling moisture content.⁵ Moisture content in the concrete can be measured by determining the relative humidity (RH) in the slab. *BRE Digest 491*⁶ discusses the impact of moisture in the concrete (Fig. 7). This publication reveals that the rate of corrosion may be controlled by reducing the internal RH of the concrete. However, this approach might not be completely effective if significant chloride concentrations are already present.⁷ Corrosion of reinforcing steel affected by carbonation could also be the result of minimal concrete cover over the reinforcement. For areas with minimal cover, even low levels of chloride (0.4% by weight of cement) can increase the corrosion rate at relatively low RH values.⁵

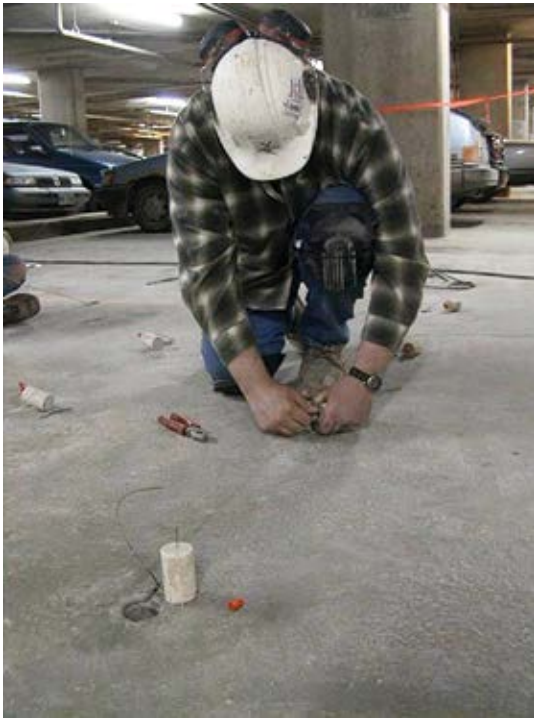
Fig. 8: Installation of zonal embedded galvanic anodes

anodes is one method that might address this risk. Half-cell mapping can identify those high-risk areas that may be related to minimal concrete cover and/or very high chloride concentrations. Once these at-risk areas are detected, galvanic anodes (Fig. 8) could be installed in the identified areas. A completed galvanic anode installation can be seen in Fig. 9.

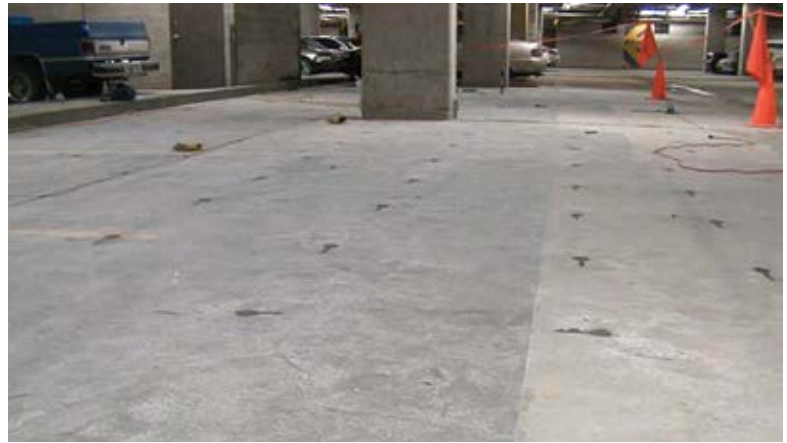
Fig. 9: Completed galvanic anode installation
