GARMIN INTERNATIONAL EXPANSION REQUIRES SPECIAL FLOORING

Garmin International Manufacturing Facility

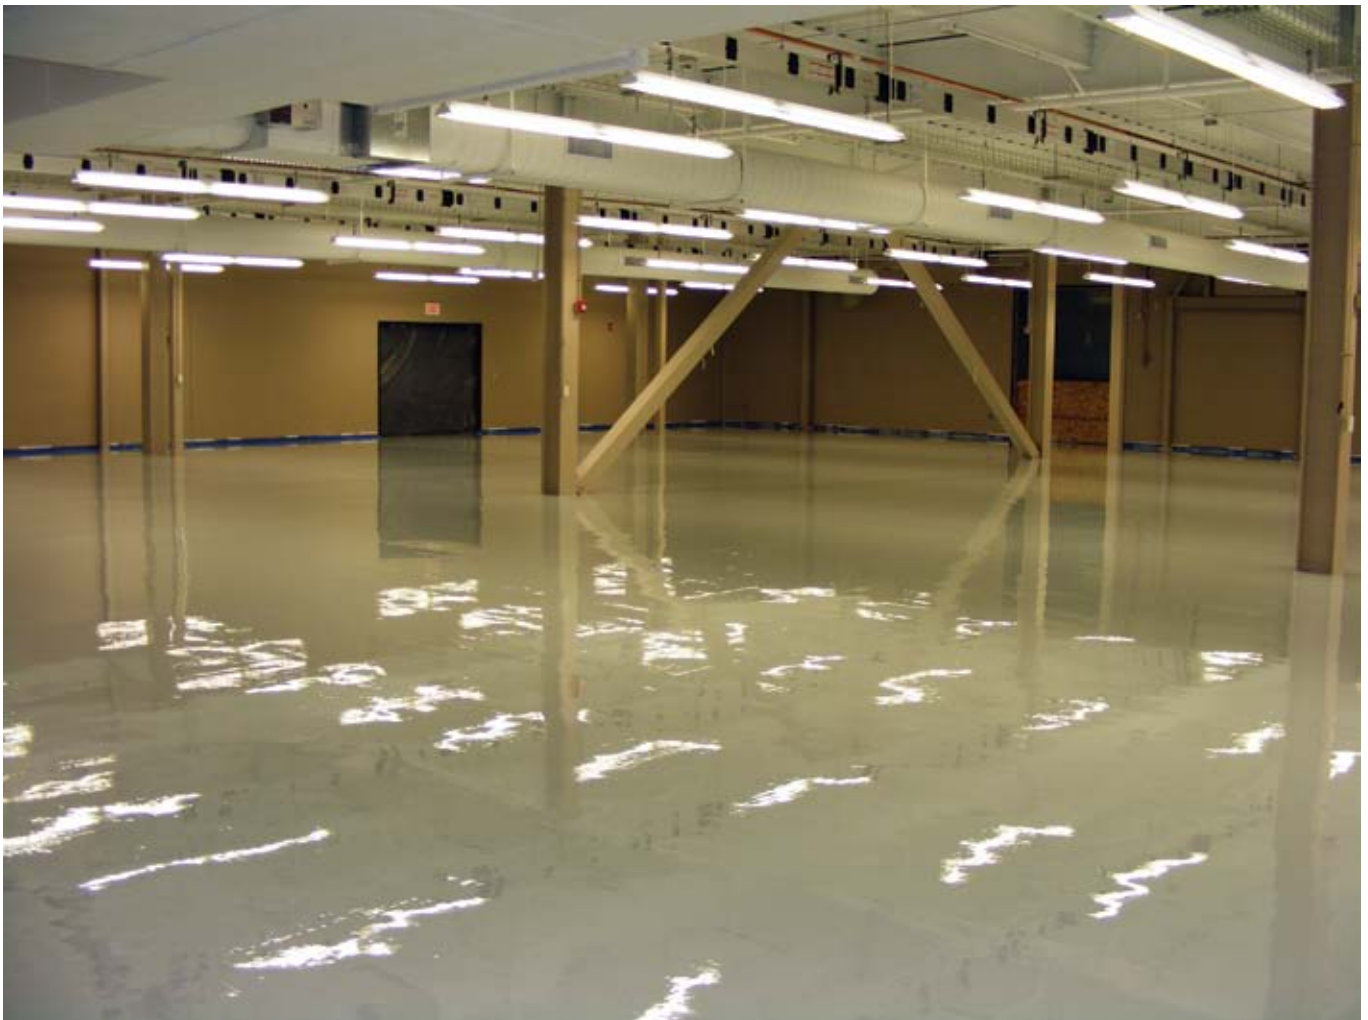
Garmin's ESD floor after completion of installation

The final ESD topcoat is a 100% solids epoxy and was applied at 16 to 18 mils (0.4 to 0.5 mm) using a notched rubber squeegee and back-rolled with a nap roller. The final finish was a smooth, highly reflective, and easily cleanable surface. An unexpected benefit was the greatly increased room brightness level due to the reflectivity of the surface.

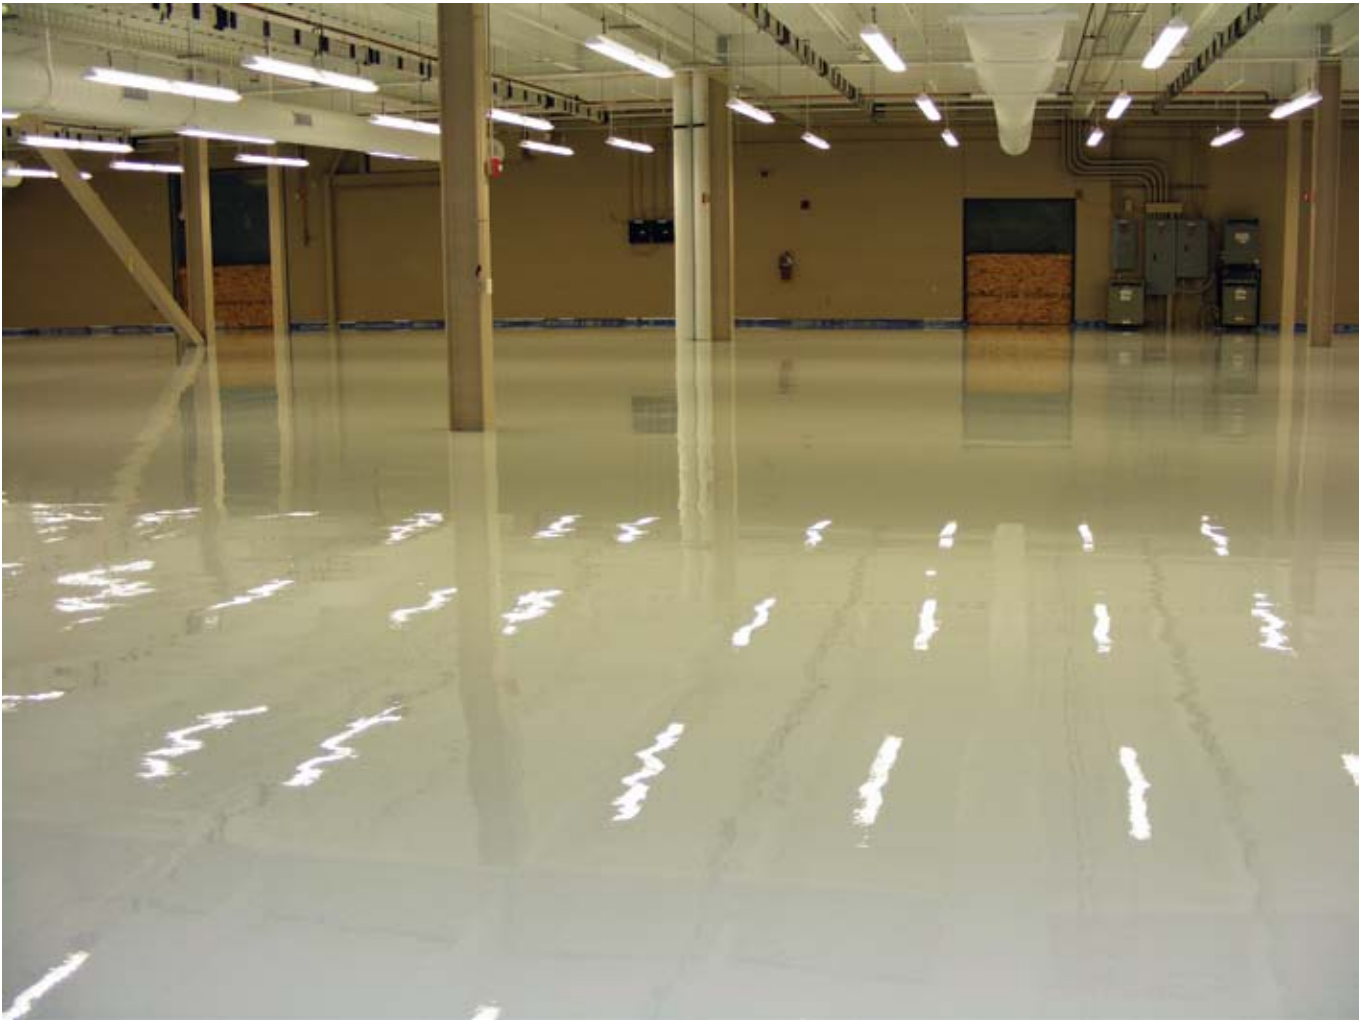
Garmin's ESD floor after completion of installation
