REPAIR OR REPLACE: THE PRICE OF AGING WATER/ WASTEWATER INFRASTRUCTURE

BY JASON SPINNATO

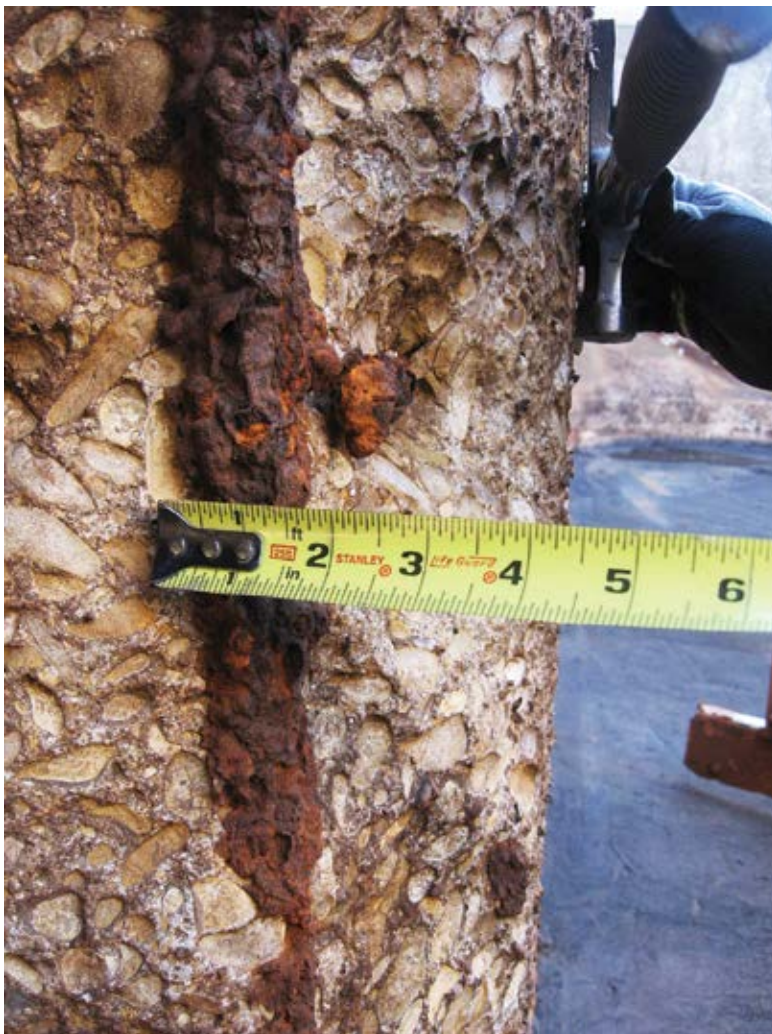
Fig. 1: Severe concrete matrix loss and corrosion of underlying reinforcement due to carbonation

In water/wastewater facilities, one of the major causes of deterioration is carbonation due to high relative humidity and reactions to acidic process fluids. The alkalines in the concrete matrix react with carbon dioxide in the air to lower the pH of the concrete and allow deterioration to occur. It is common for the deterioration to manifest itself in spalling or widespread breakdown of the concrete matrix. If the carbonation is severe, it may lead to corrosion of the reinforcing steel (Fig. 1). Because

carbonation cannot be visually observed, it is important to perform testing of the concrete by taking core samples at various locations to determine the full extent of carbonation. Typically, carbonation occurs in the slower-moving open-air structures such as primary clarifiers and aeration basins found in wastewater plants or the flocculation/sedimentation basins found in water treatment plants.

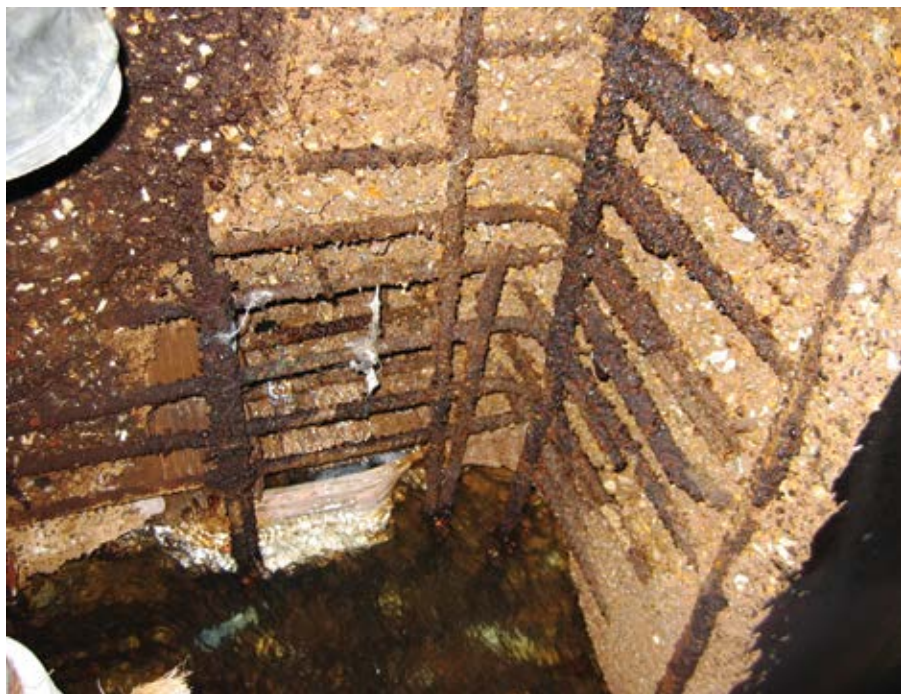
Fig. 2: Severe concrete and reinforcing steel deterioration due to hydrochloric acid exposure

Deterioration due to hydrochloric acid in water/wastewater plants typically occurs in the chlorine contact basins. These basins are located at the end of the treatment process where gaseous chlorine is added to the treated water prior to discharge. Once the applied chlorine dissolves in the water, it forms hydrochloric acid and begins to reduce the alkalinity of the concrete. This leads to deterioration of the concrete matrix, the loss of concrete cover, and corrosion of the reinforcing steel (Fig. 2).

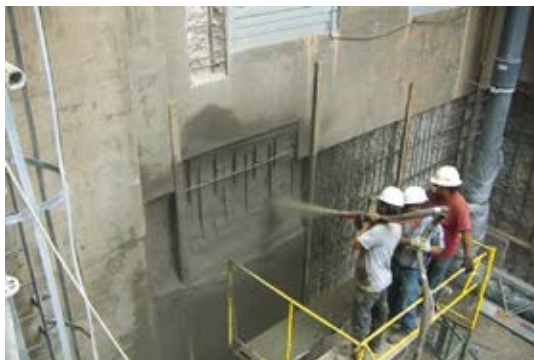
Fig. 3: Installation of spray-applied repair mortar at vertical repair areas

If it is determined that a structure can be rehabilitated, the extent and type of repairs will be dictated by the results of the original evaluation. Many repairs for areas experiencing spalling, matrix loss, or chemical attack can be accomplished using repair mortars. A hand-applied mortar is best suited for small areas, while a spray-applied mortar may be appropriate for large areas (Fig. 3). Form-and-place or pump techniques using relatively fluid repair mortars should be considered for deep repairs or those with heavy concentrations of reinforcing steel.

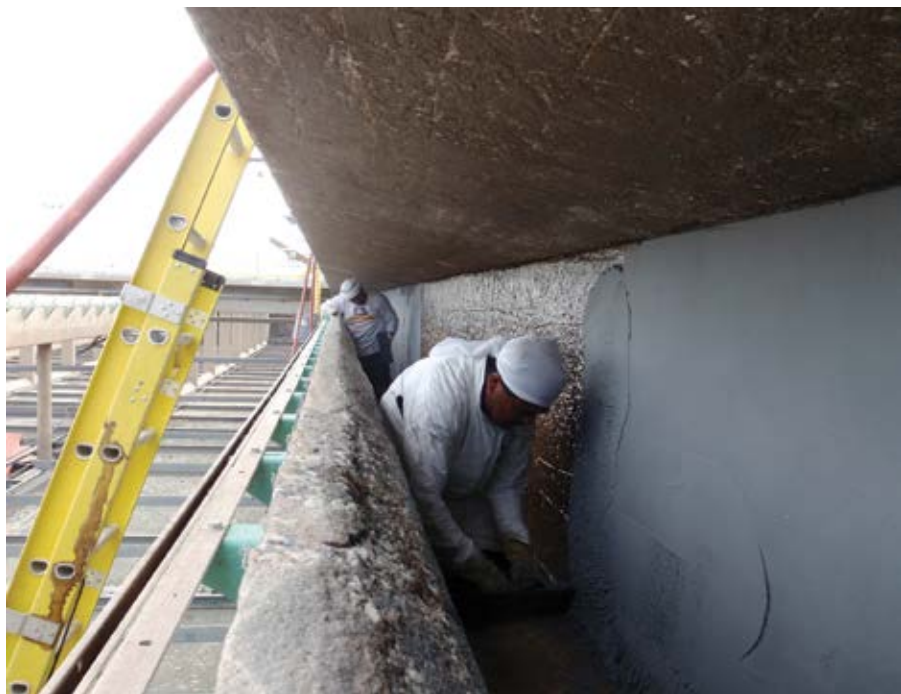
Fig. 4: Application of epoxy-based, quartz-reinforced composite overlay on the effluent trough of a clarifier basin

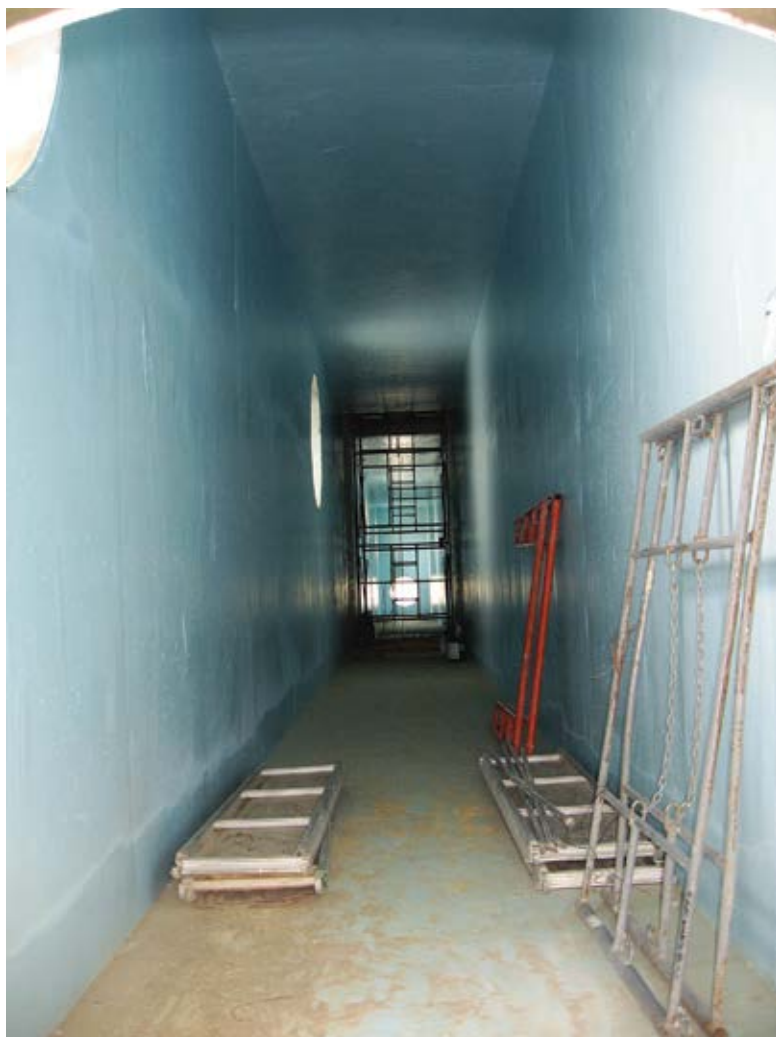
Fig. 5: Epoxy-based liner applied to surface of a wastewater effluent channel
