# Restoration of the Corning Centerway Bridge

**Joseph Logan, PE, Principal**  
**Fisher Associates, PE, LS, LA, DPC**

# Centerway Arch Bridge

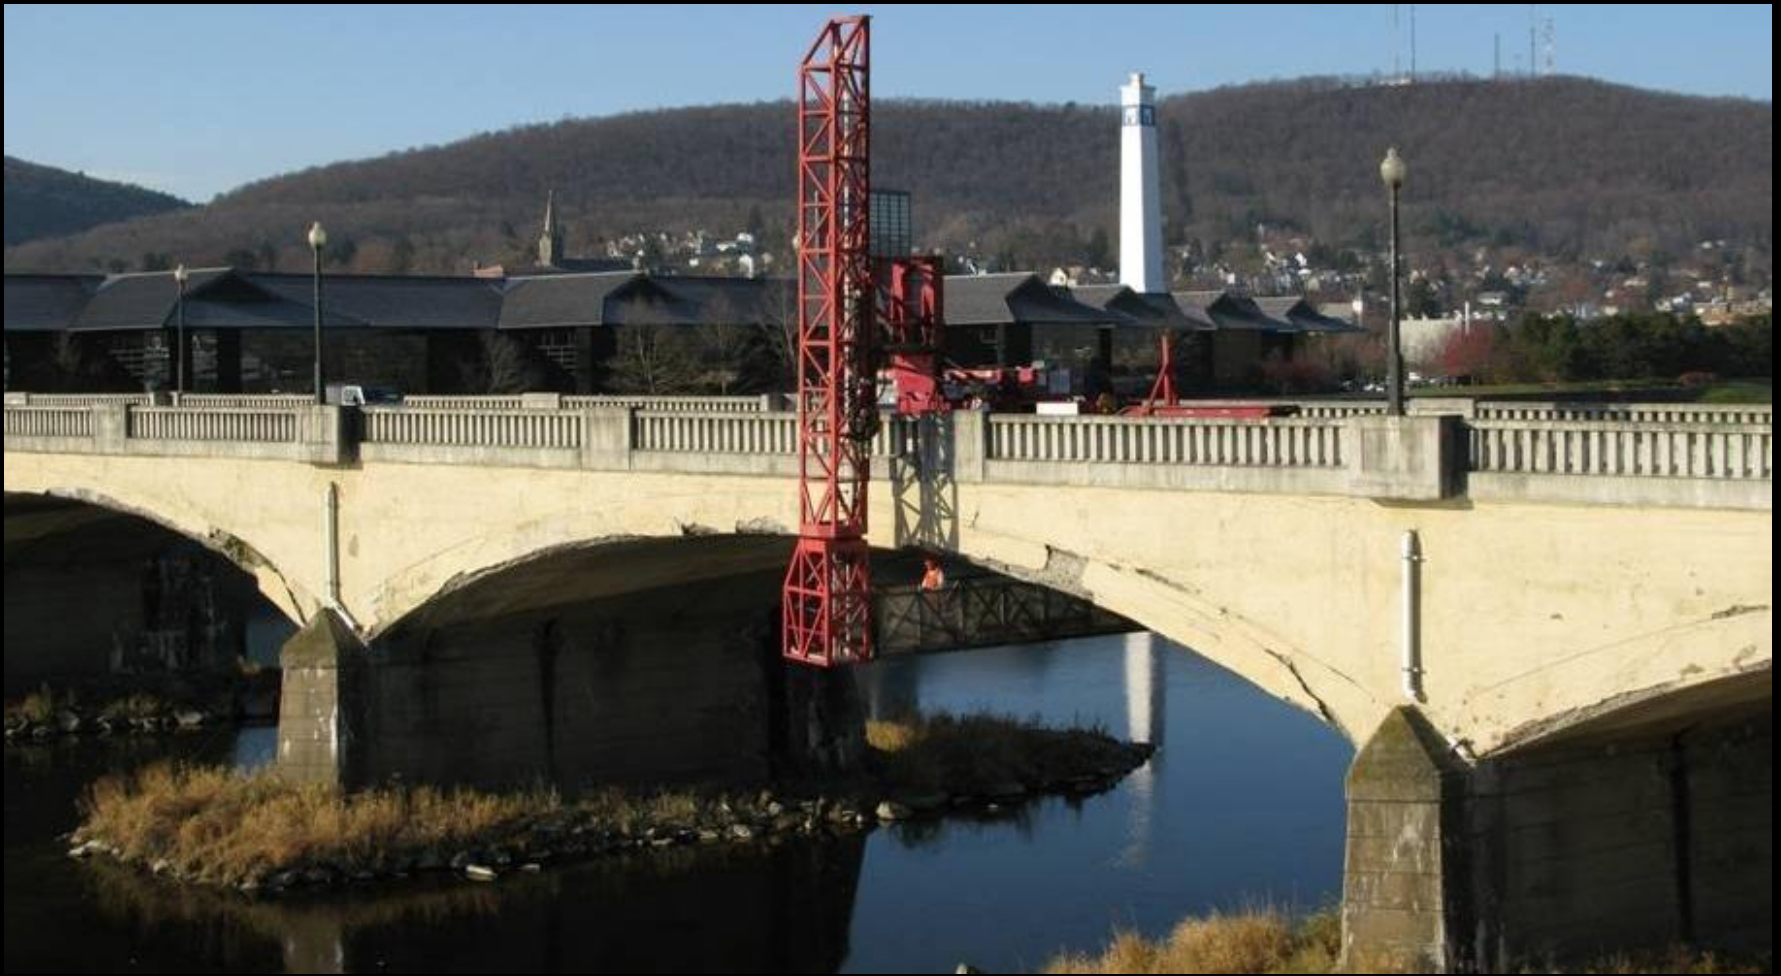
# In-depth Bridge Inspection

Full detailed inspection and testing program

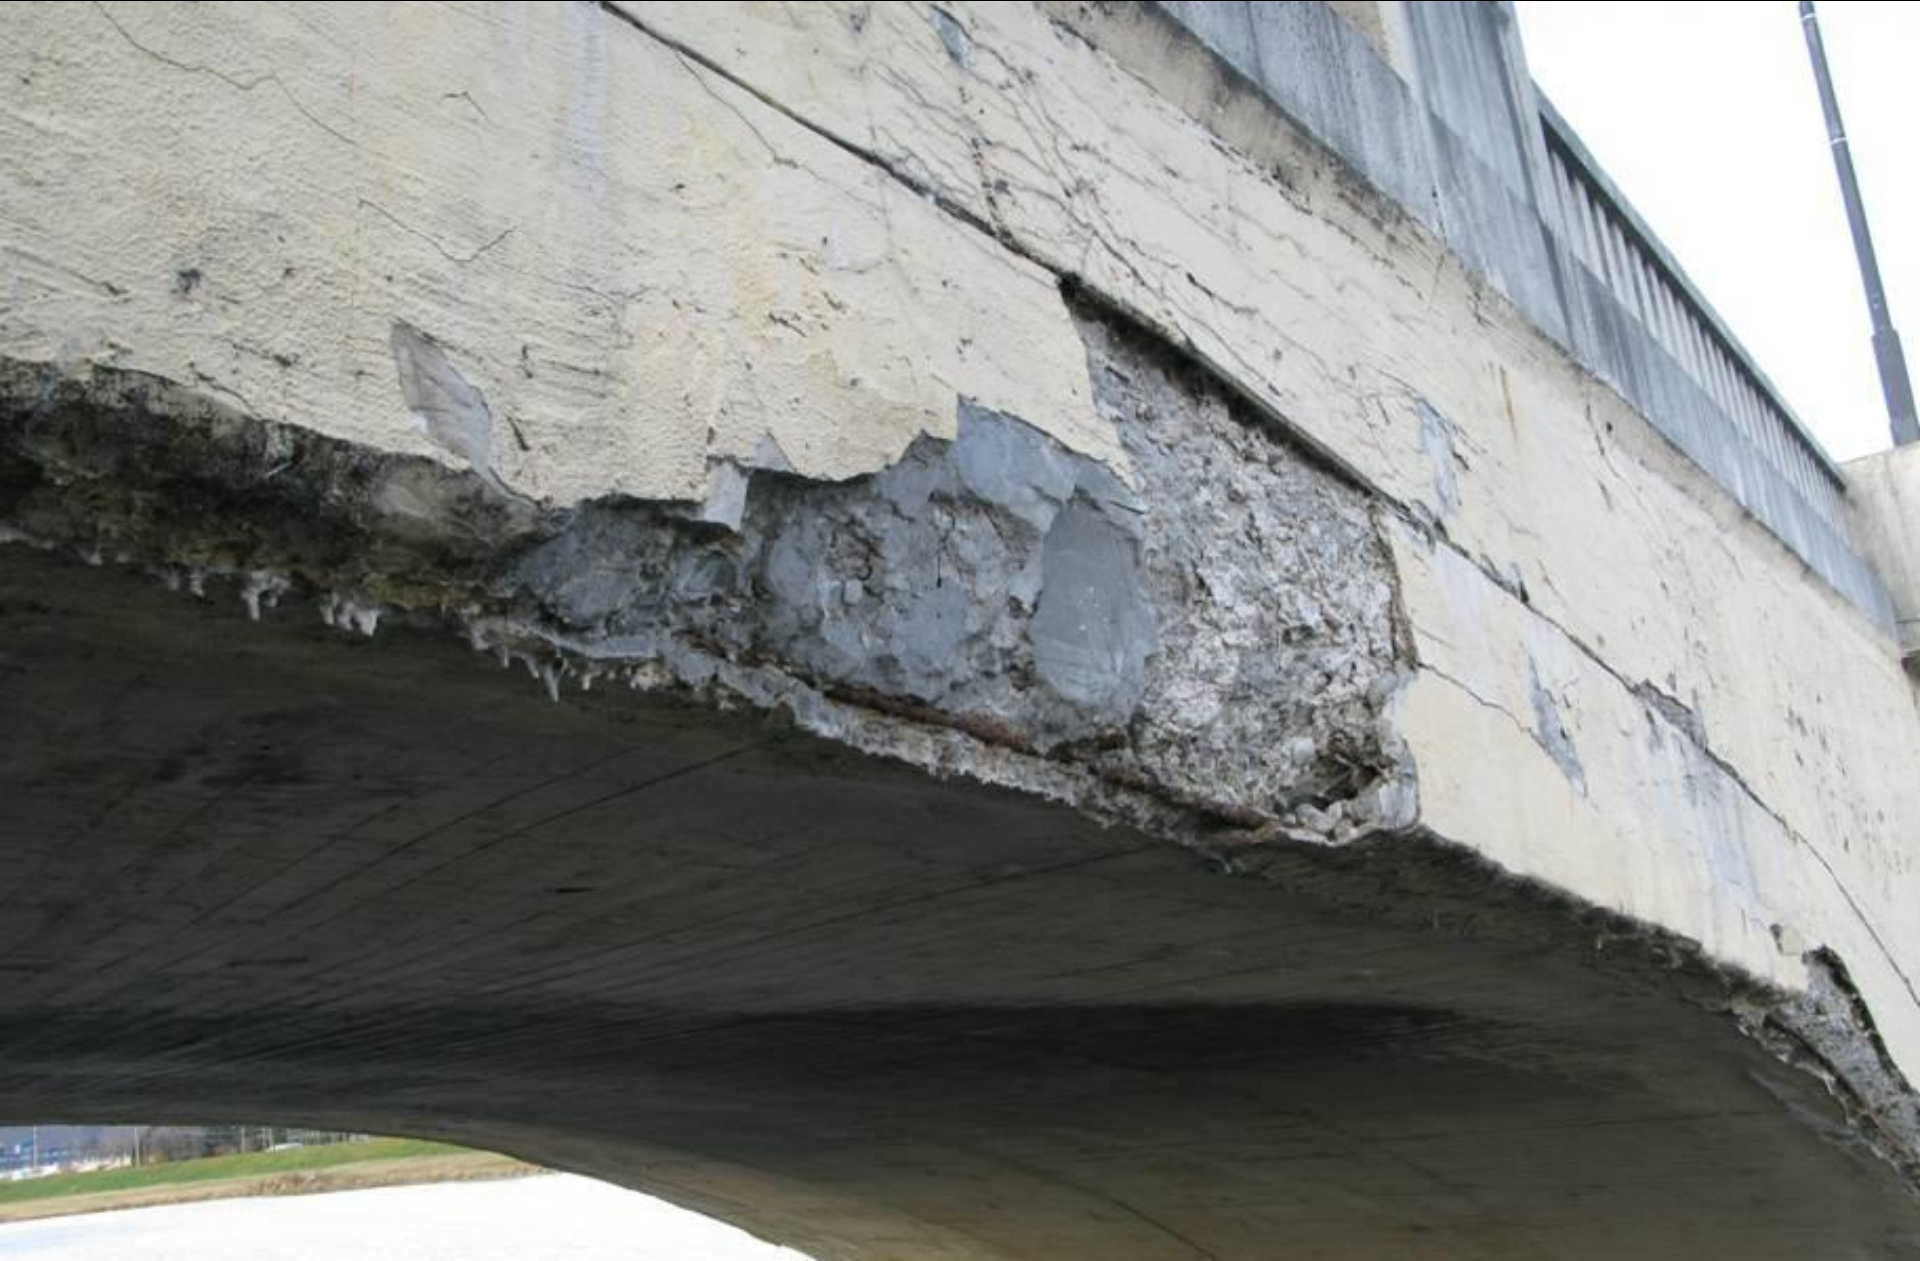
# Spandrel Walls

- Concrete in Abutments, Wingwalls, and Spandrel Walls show spalling, advanced concrete degradation due to moisture retention from coating applied in 1989 due to Alkali-Silica Reaction (ASR).
- Concrete Arches were not coated, but exhibited advanced ASR, cracking, and some delamination.
- Complete loss of integrity from ASR.  
Restoration/overlay is not feasible due to condition.

- Resurface with Precast Panels and reinforce to obtain desired design life: minimum 25 years.
- Provide surface texturing in panels to evoke historic façade.
- Precast concrete parapets removed, stored and reset. Bump-outs removed and replaced in-line for new lighting.
