# “From Textbook to Practice: Case History of Failure and Repair of an Underground Wastewater Vault”

Structural Diagnostics Services  
Walter P Moore

October 13, 2011

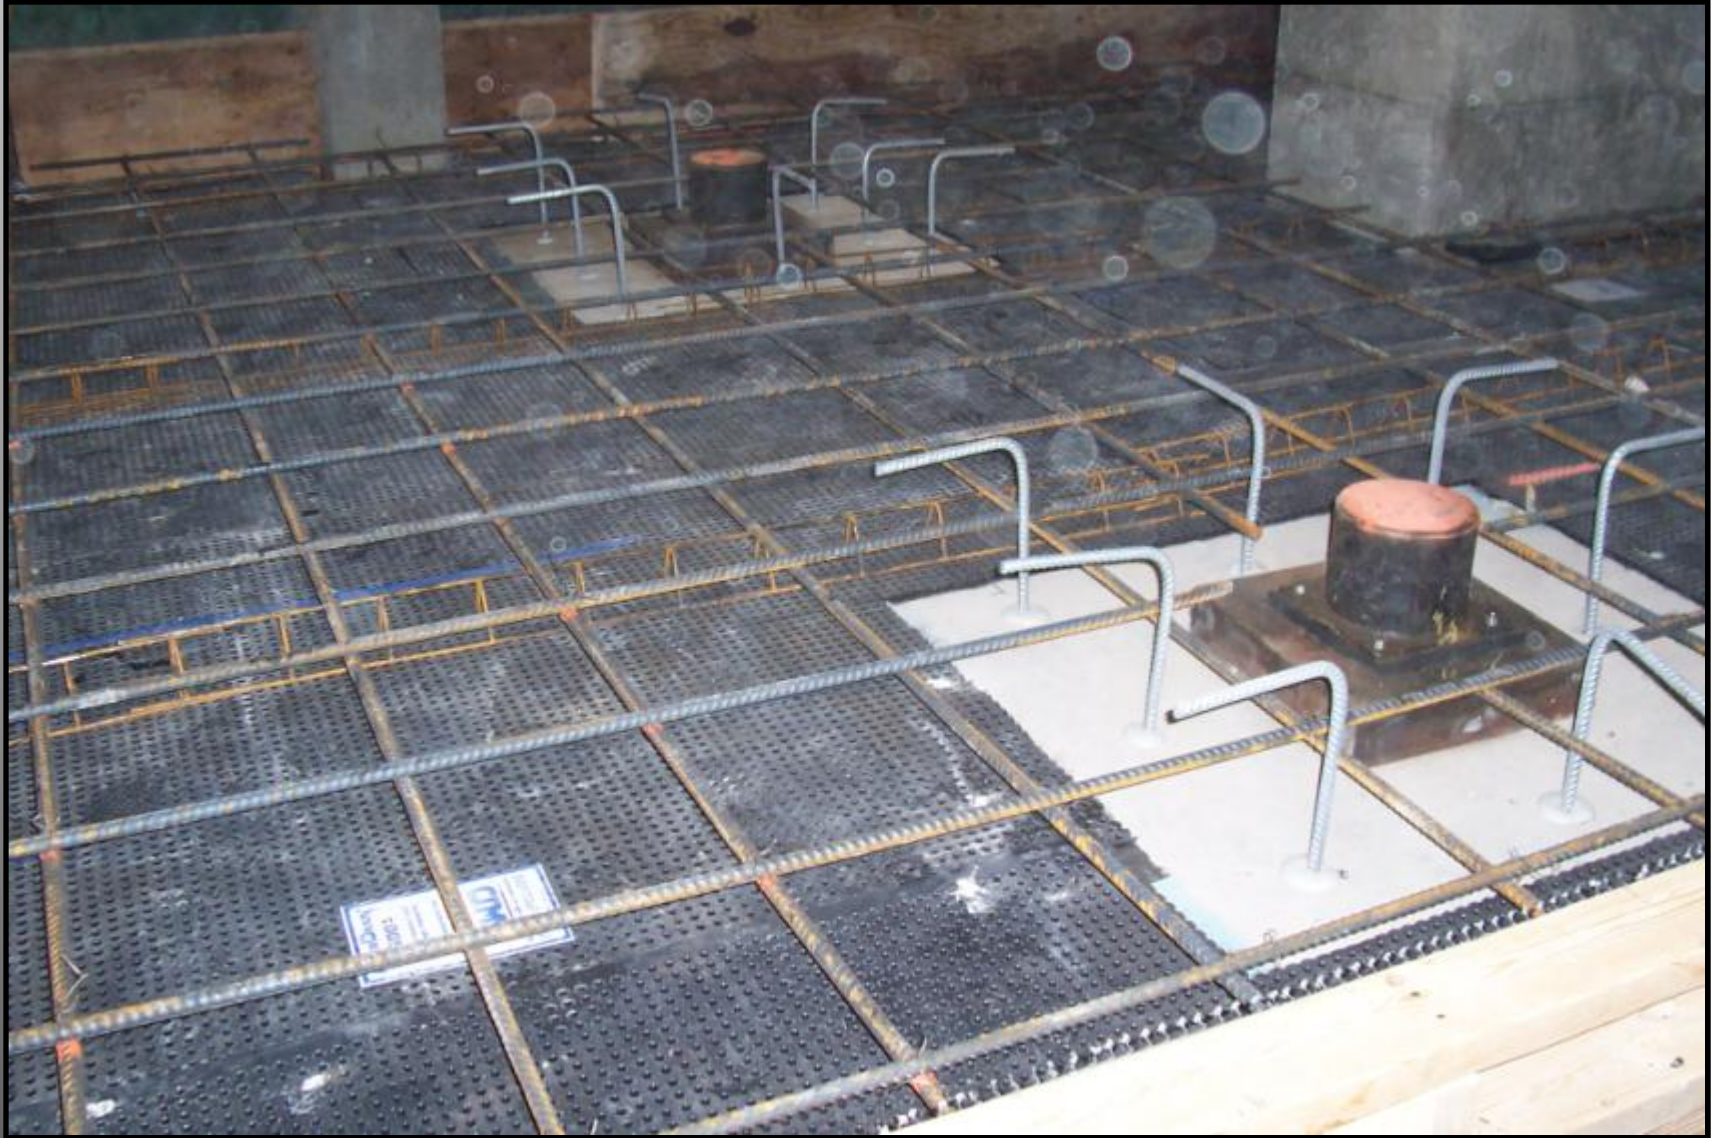
**Transverse  
Bracing**

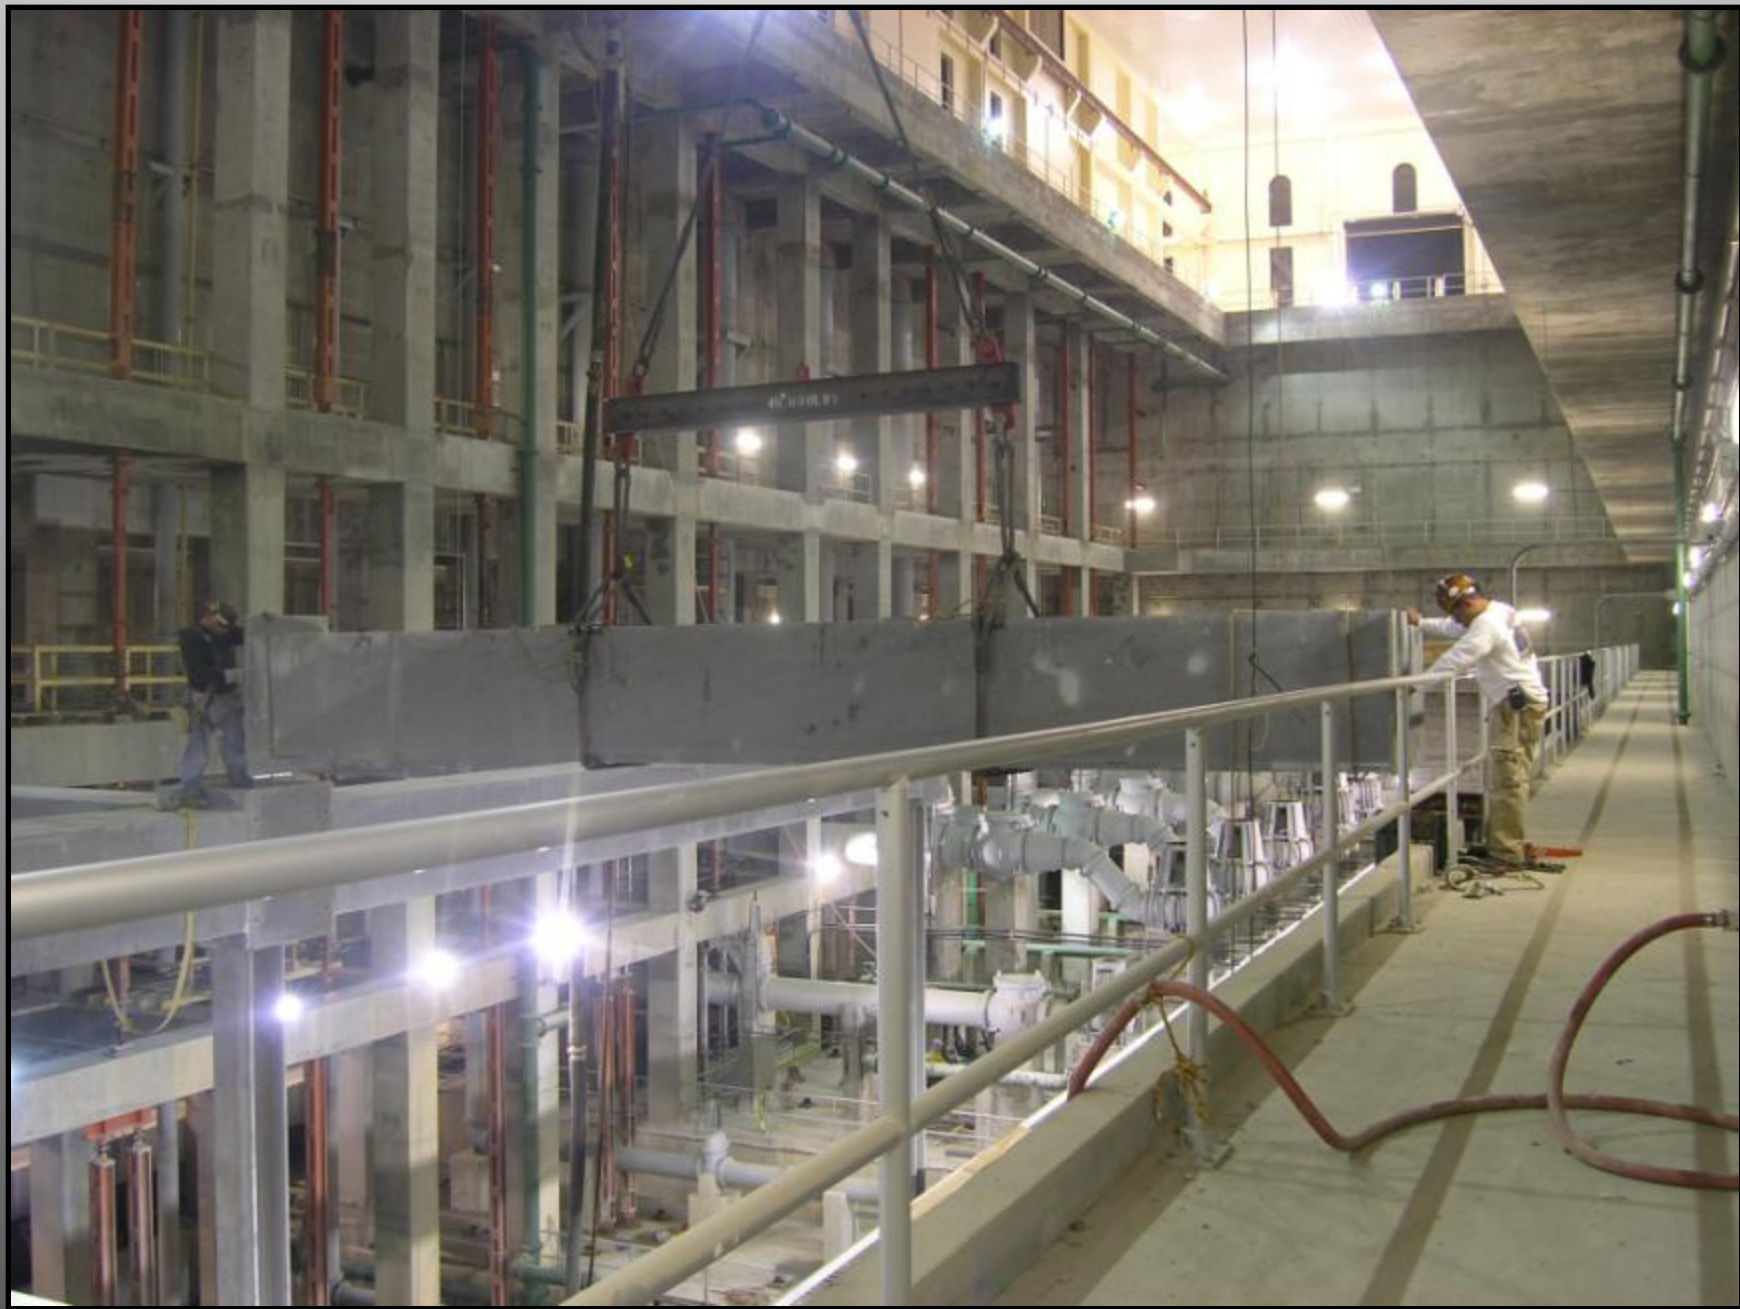
**Waler Beam in  
Wet Well**

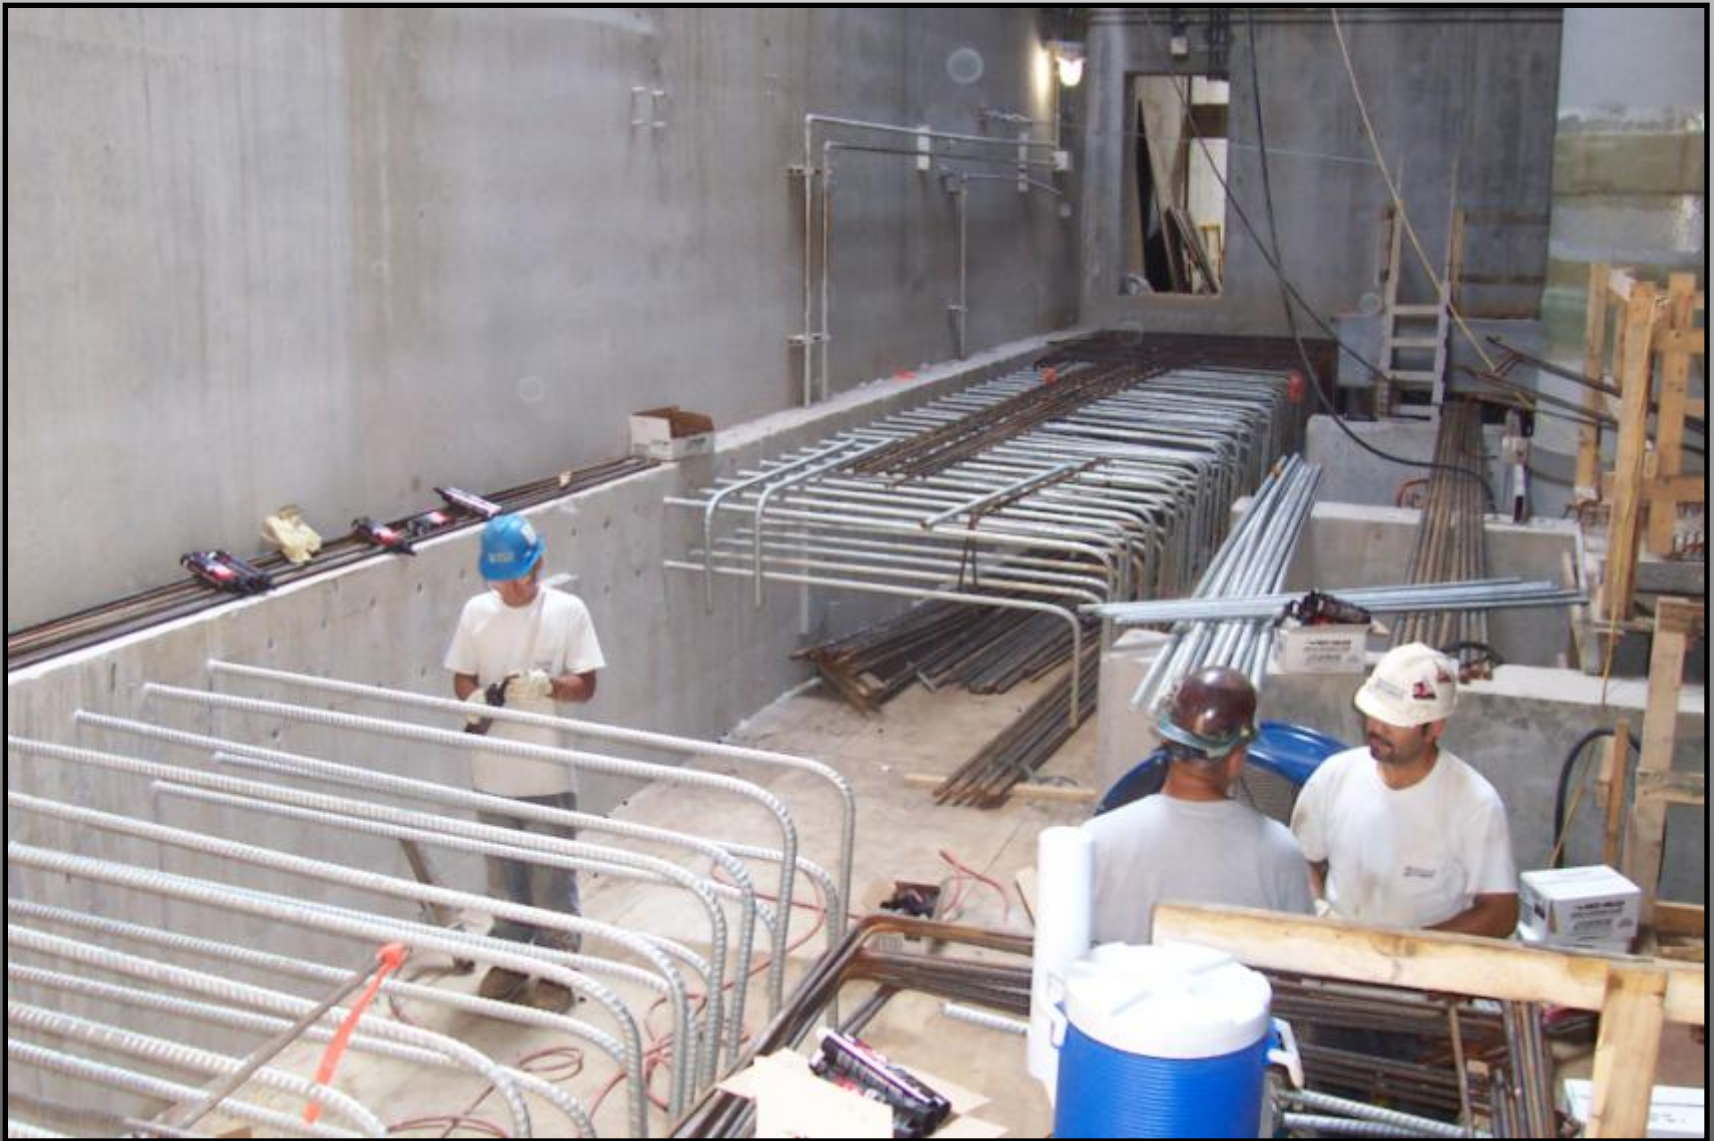
**Wall  
Strengthening**

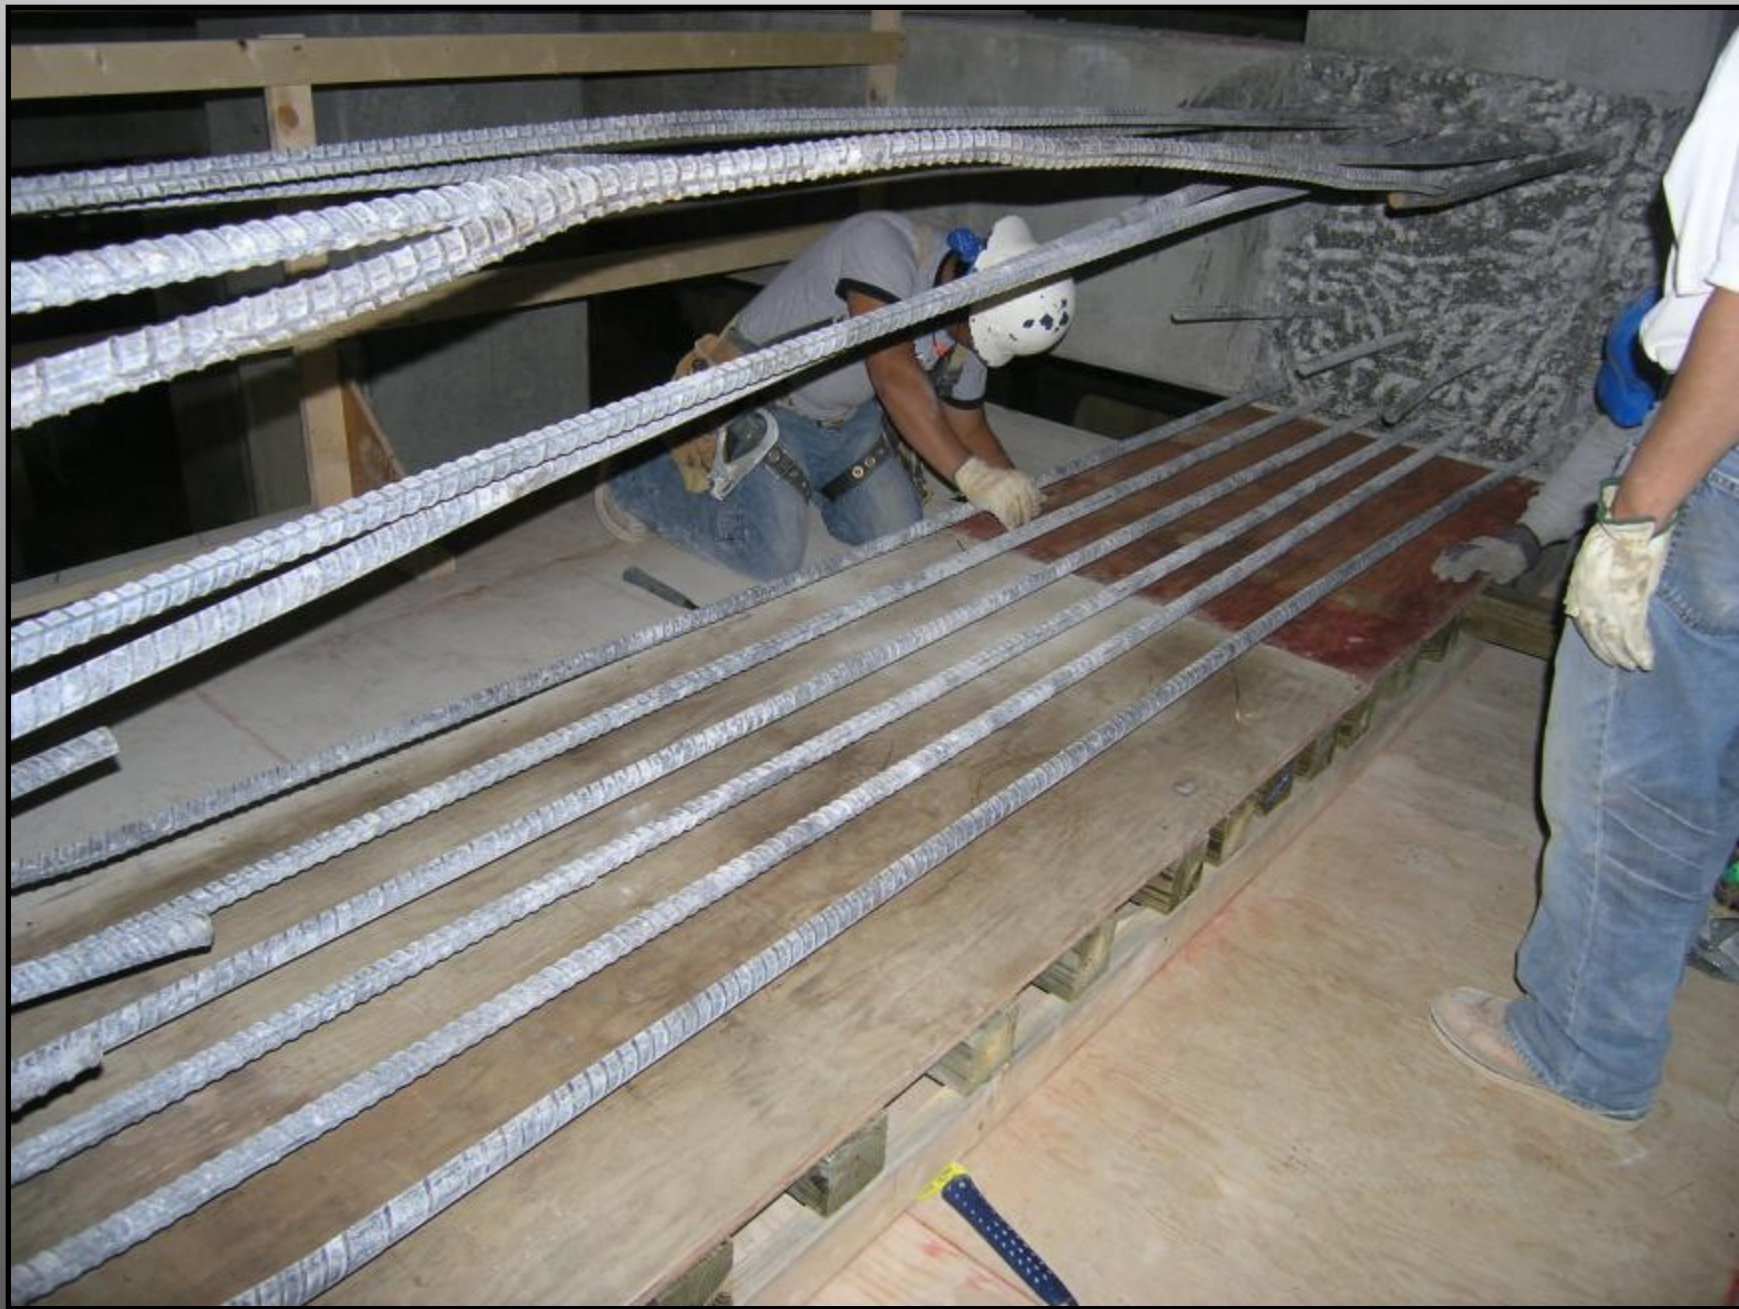
**Externally Bonded  
Ties for Columns  
and Struts**

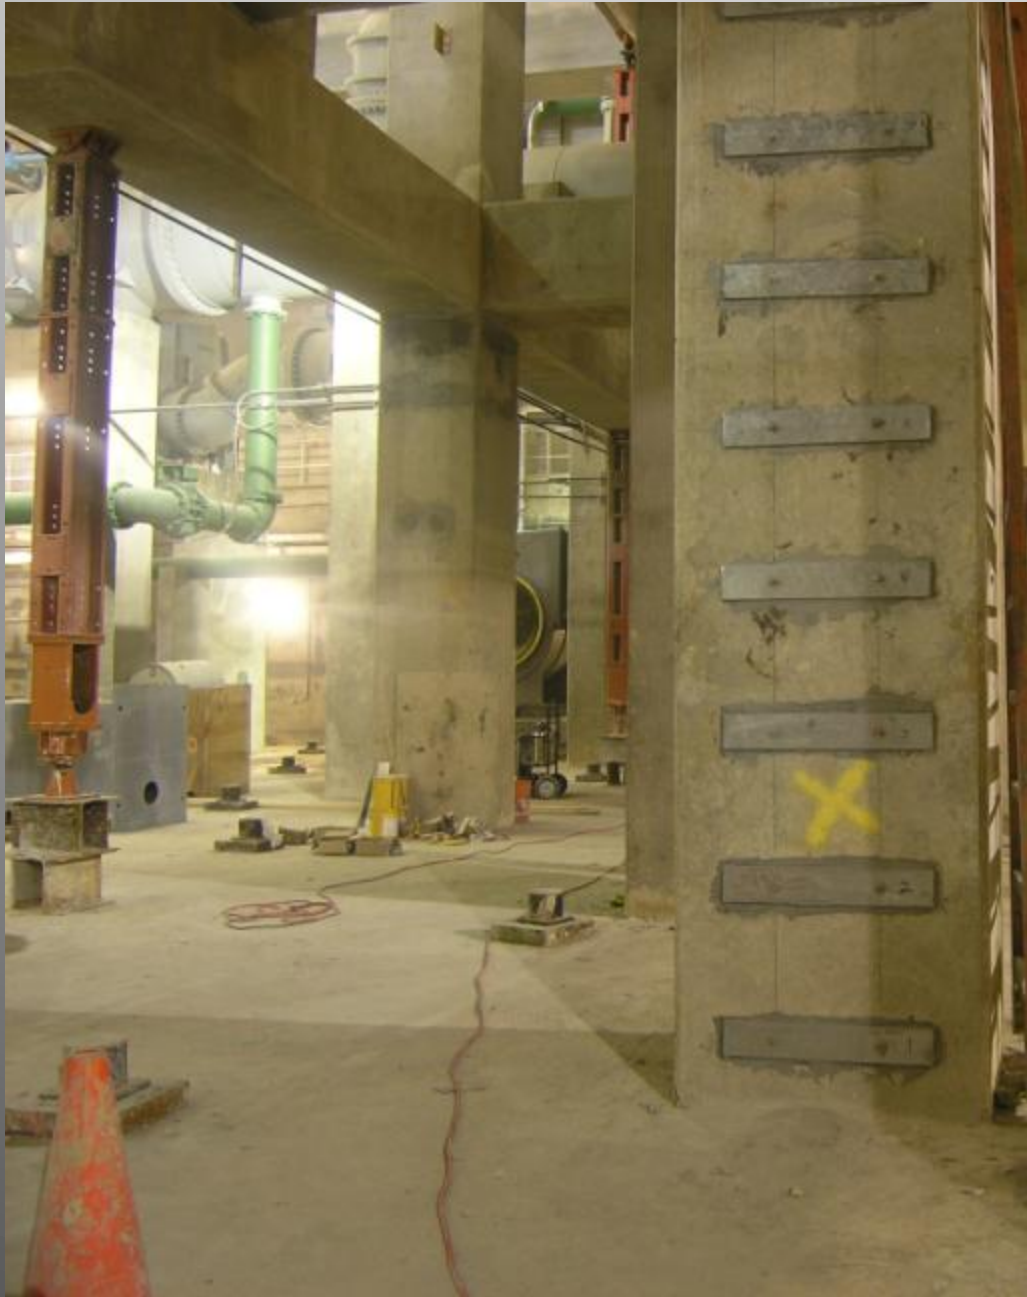
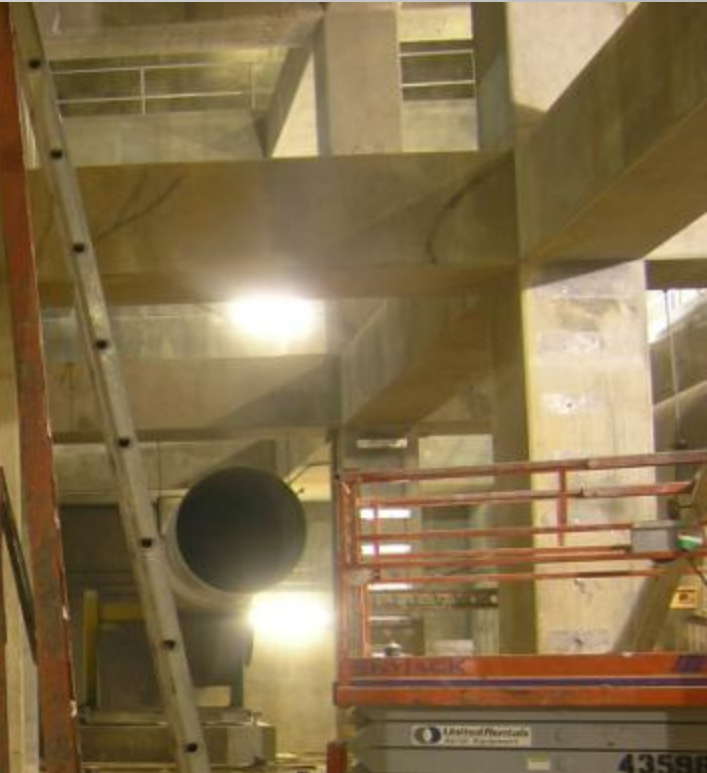
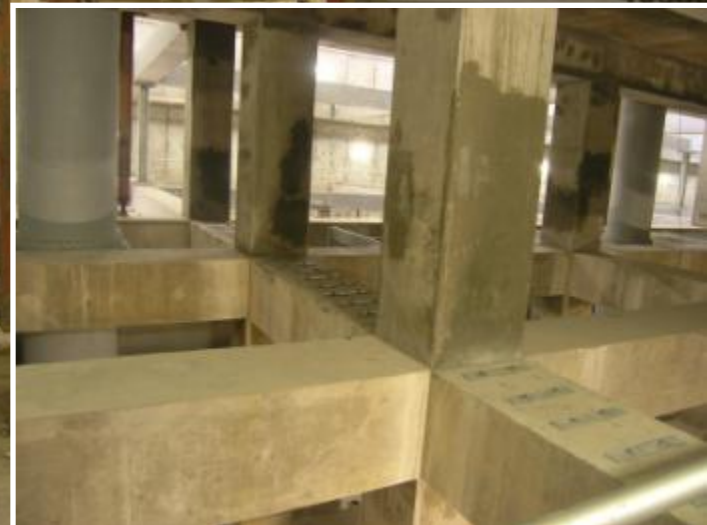
# Concrete Spall Repairs

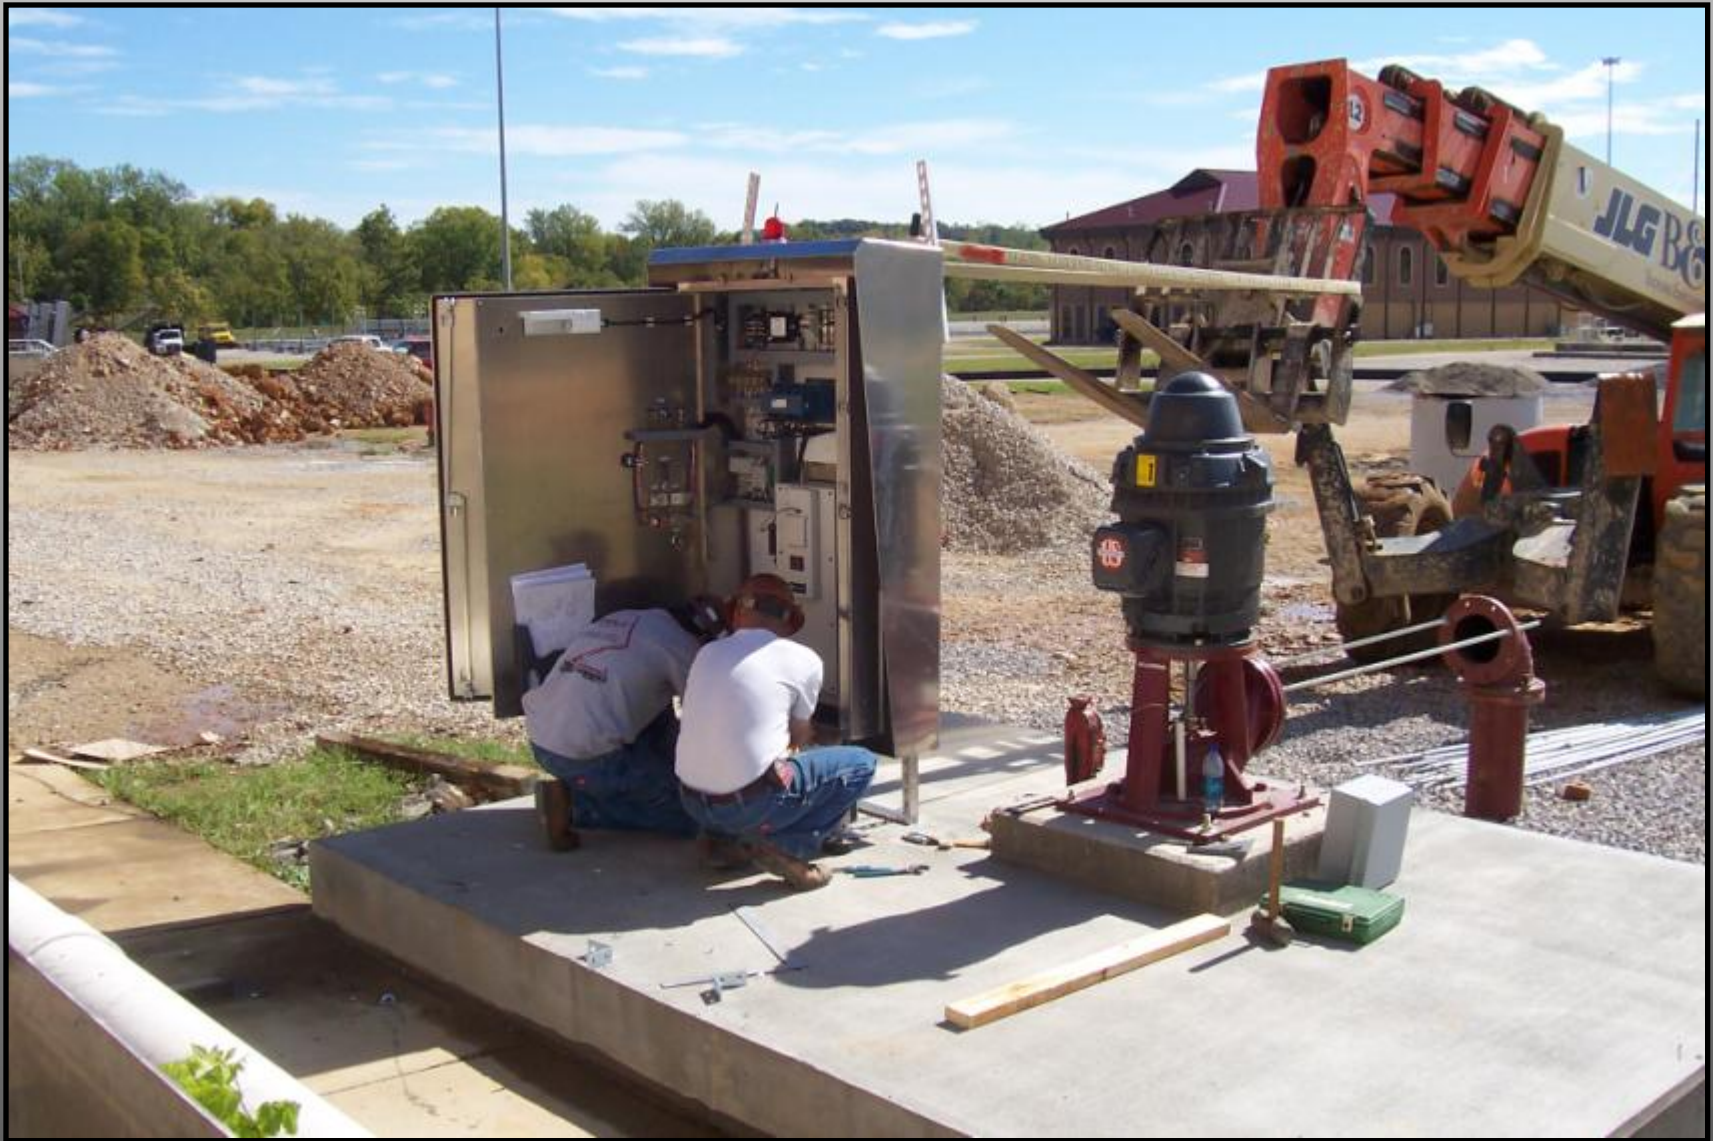
# Permanent Dewatering System
