A Design-Build Project: Repairing the Courthouse Square Complex

Courthouse Square Complex (CH2) Overview

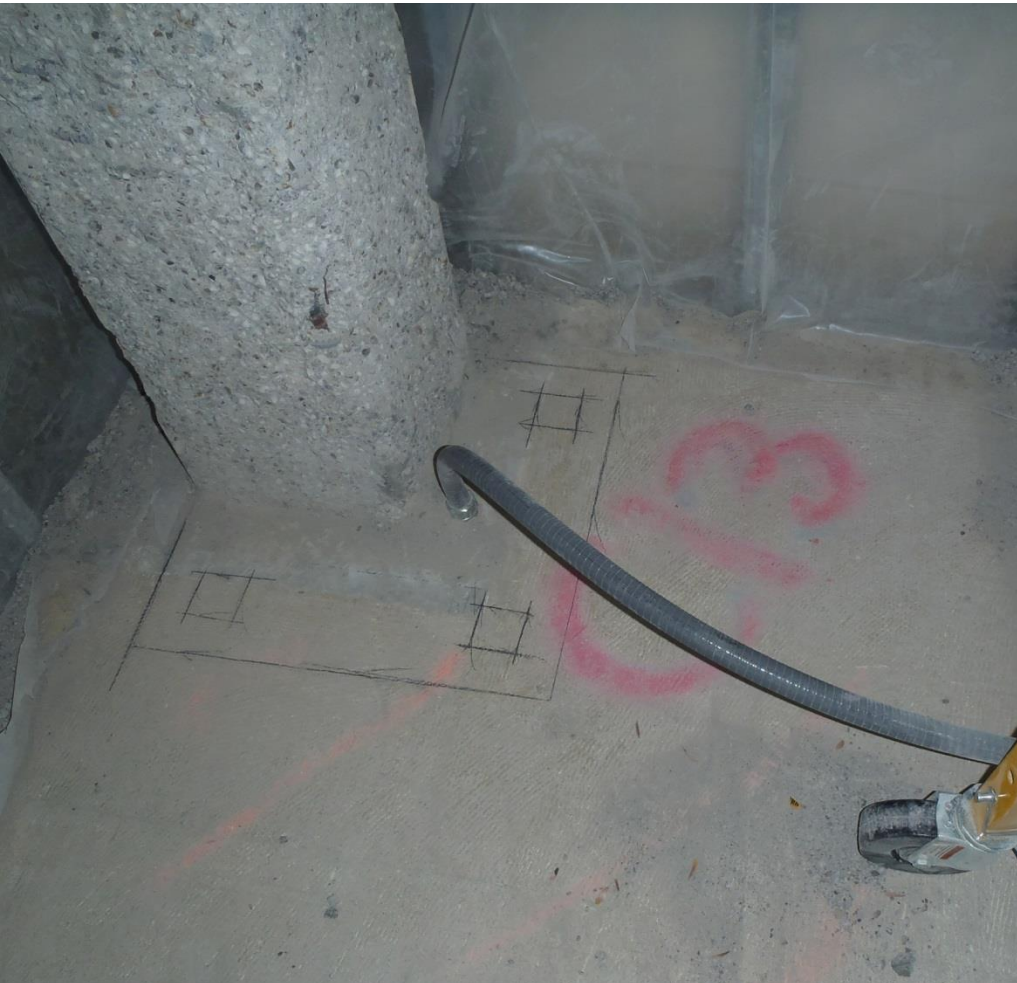
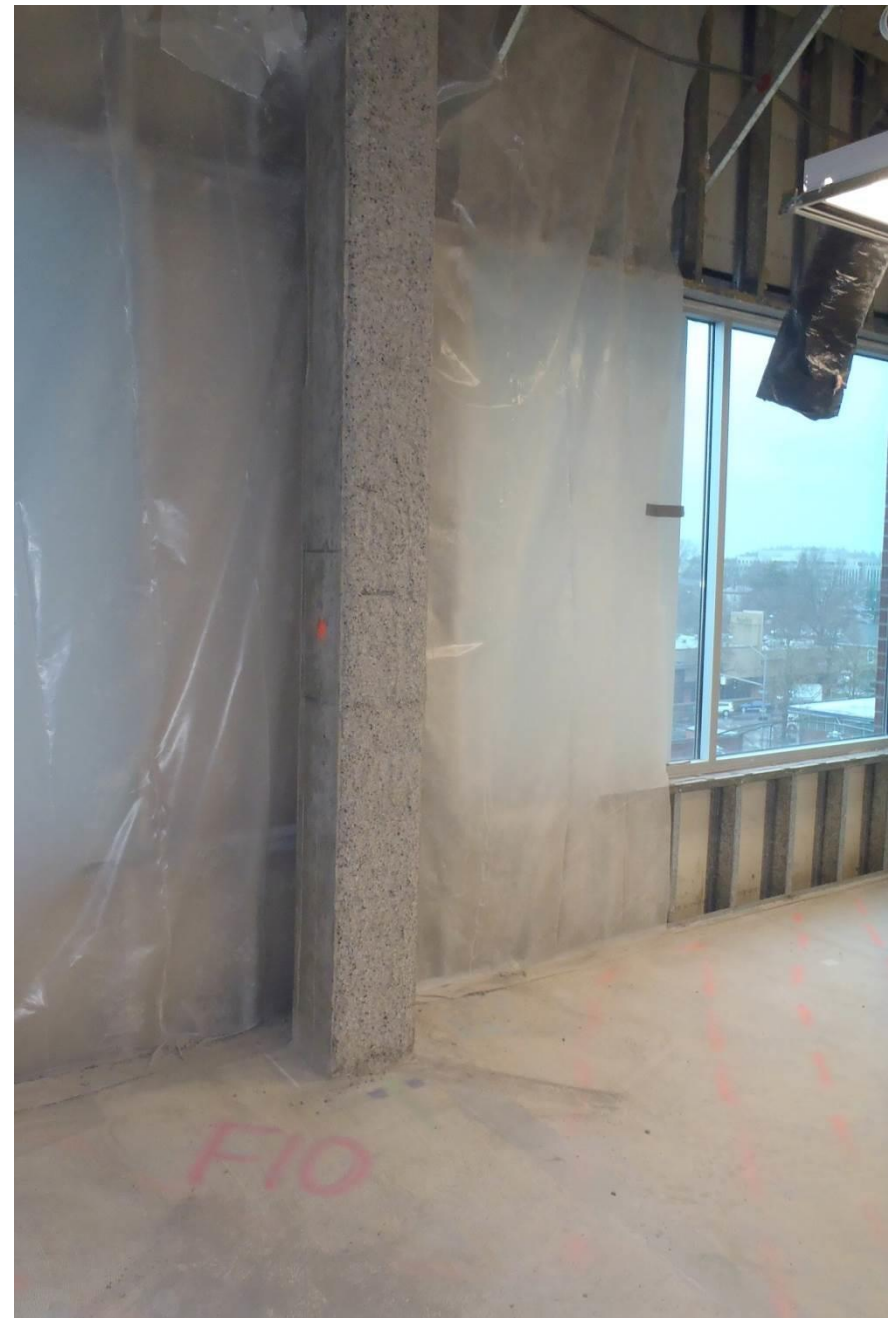
- Example: Office Building
Perimeter Column Enlargements

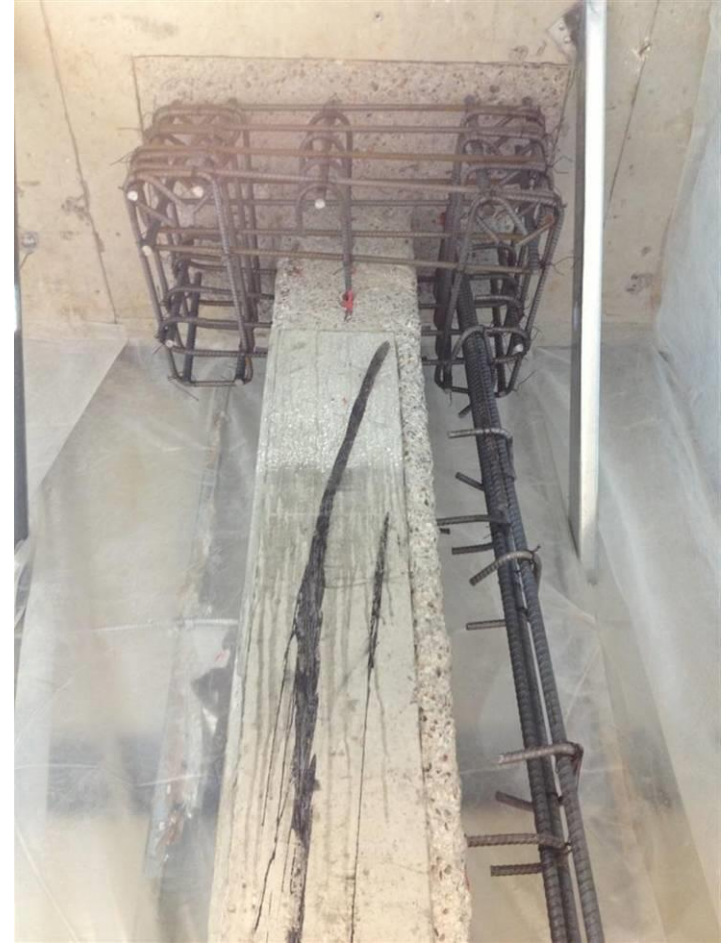
Shear Cap for punching shear deficiency

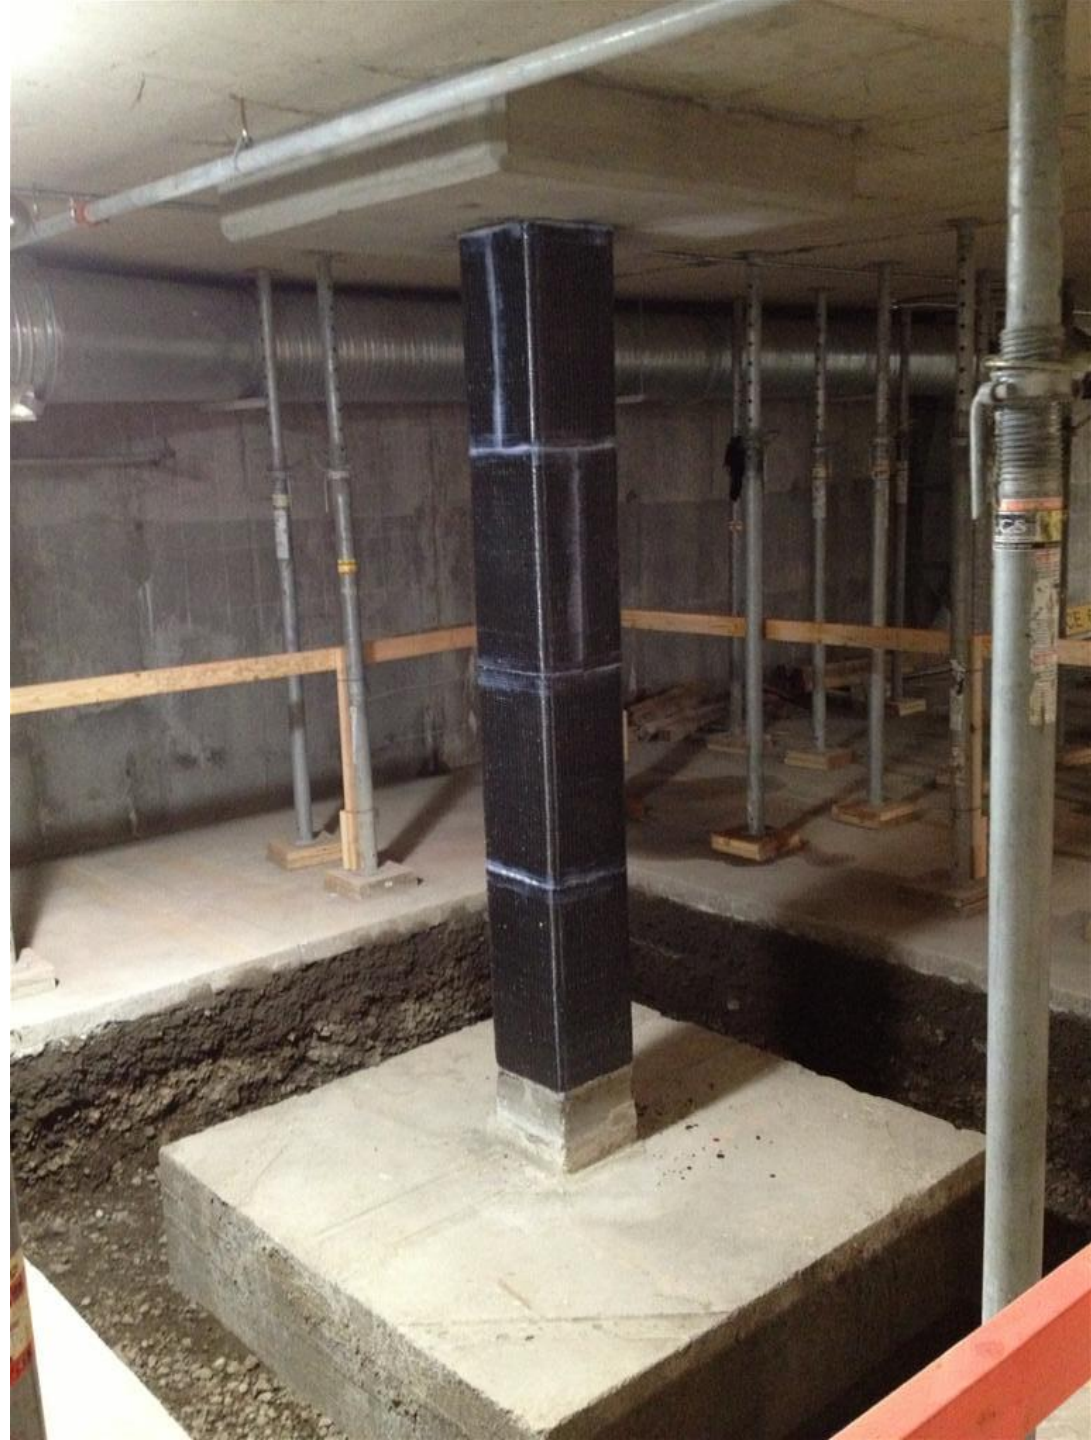
- Transit Mall:
 - Enlarged Footings
 - Strengthened Columns with FRP
 - Drop Panels

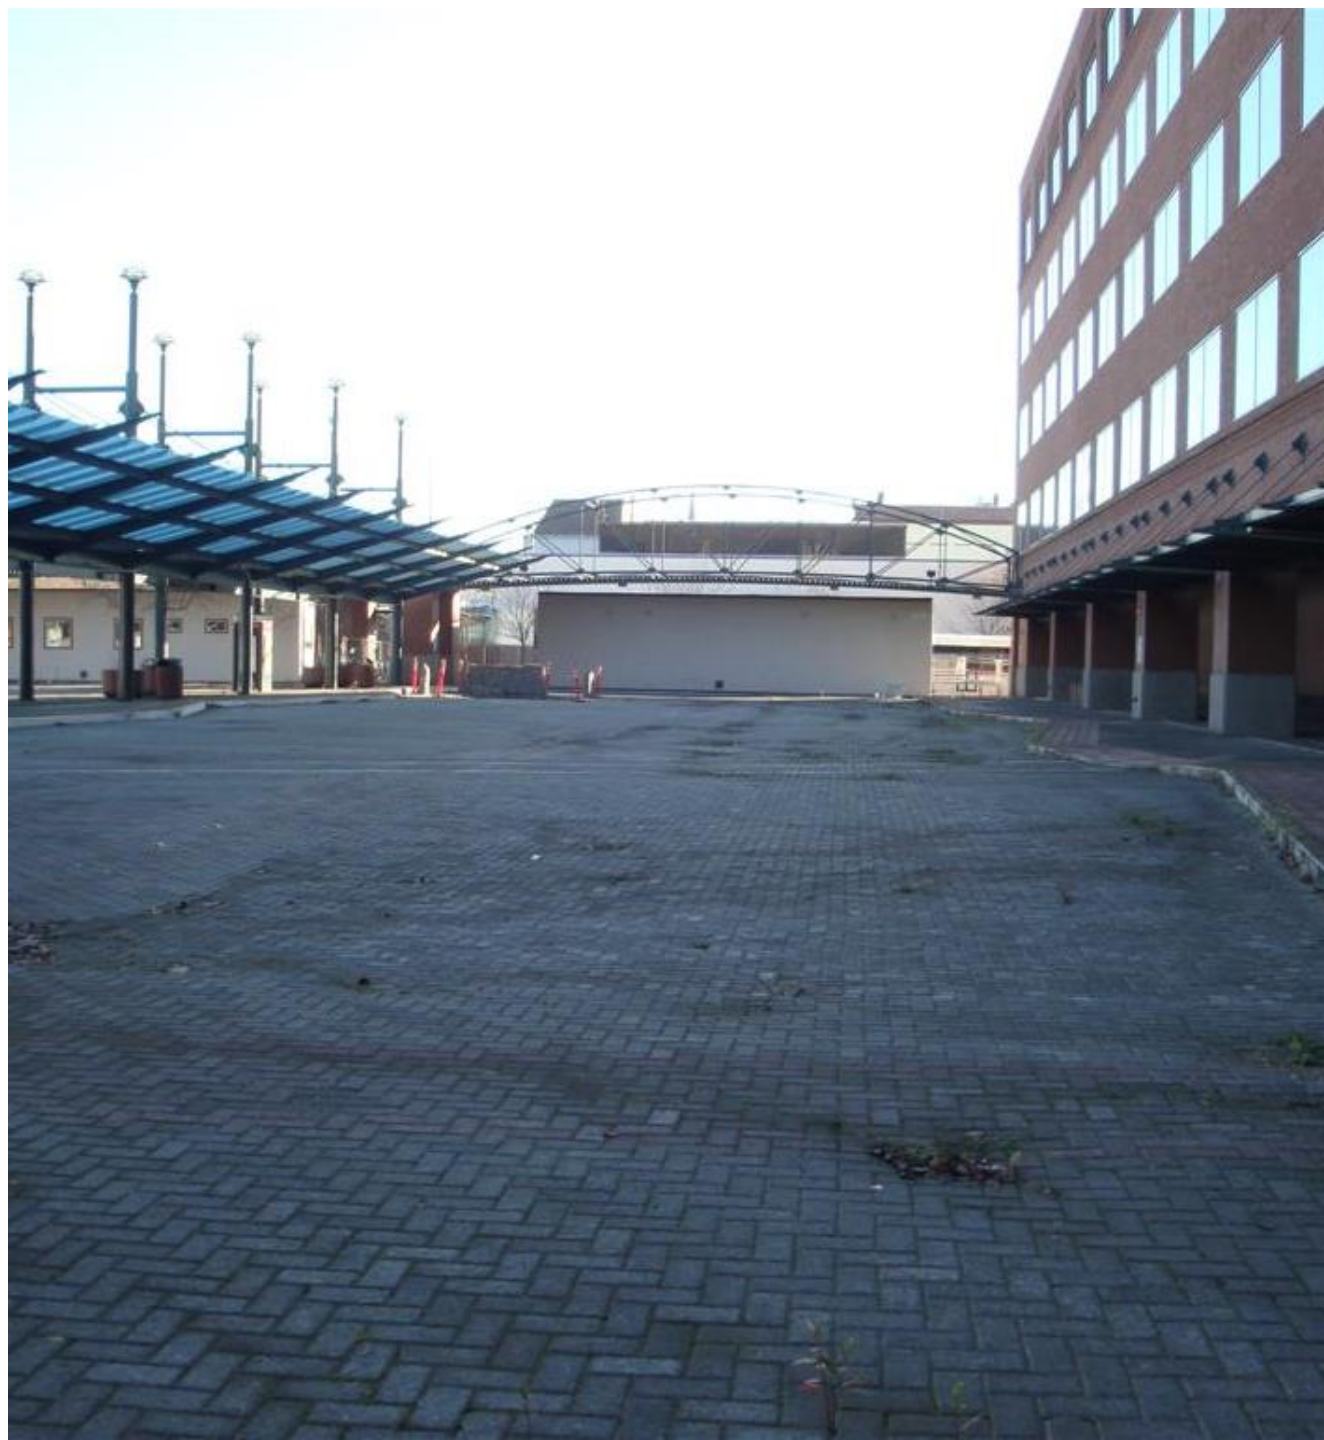
- Example: Transit Mall Bonded Overlay
