Repairs to Classic Spanish Revival Facade

ICRI 2015 Spring Convention
New York, NY

Presented By:
Allen Roth, P.E.

JOSEPH B. CALLAGHAN, INC.
CONSULTING ENGINEERS

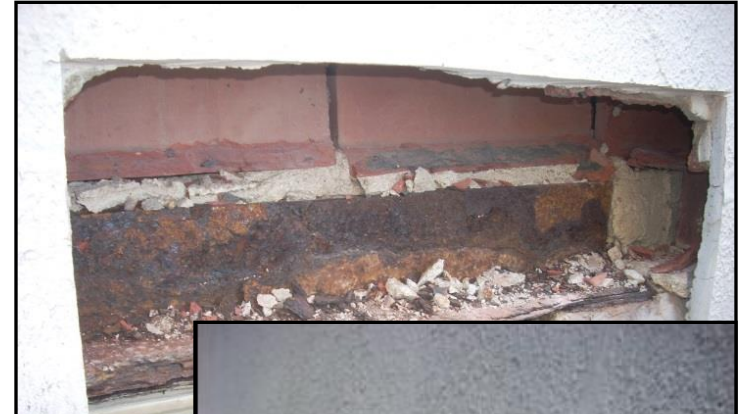
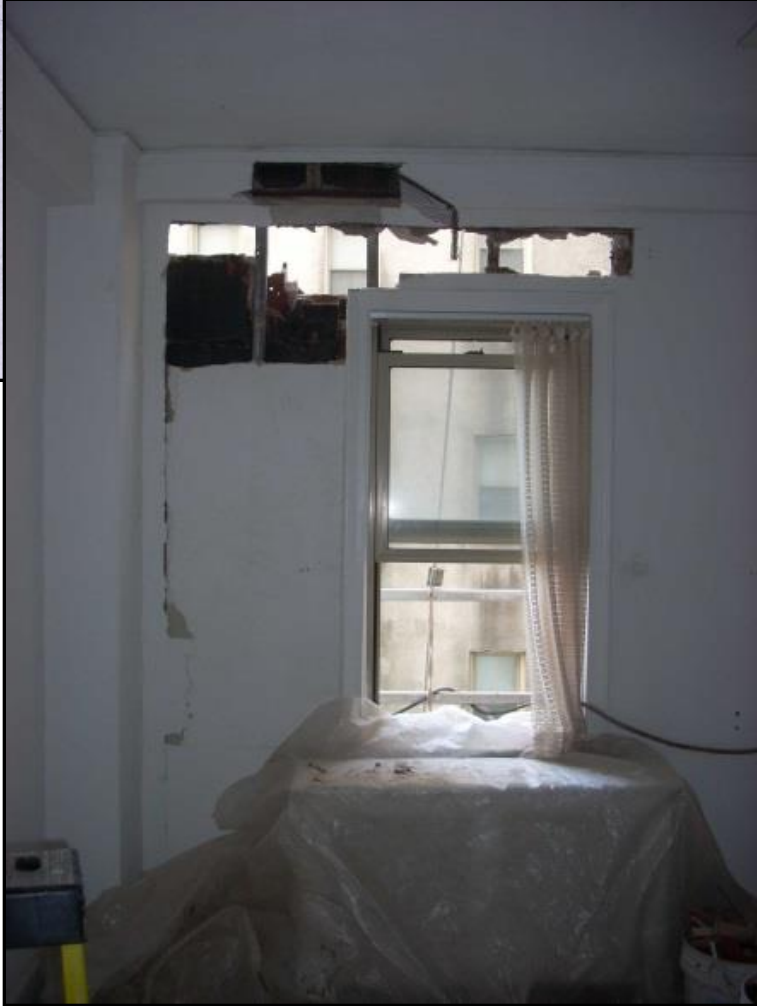
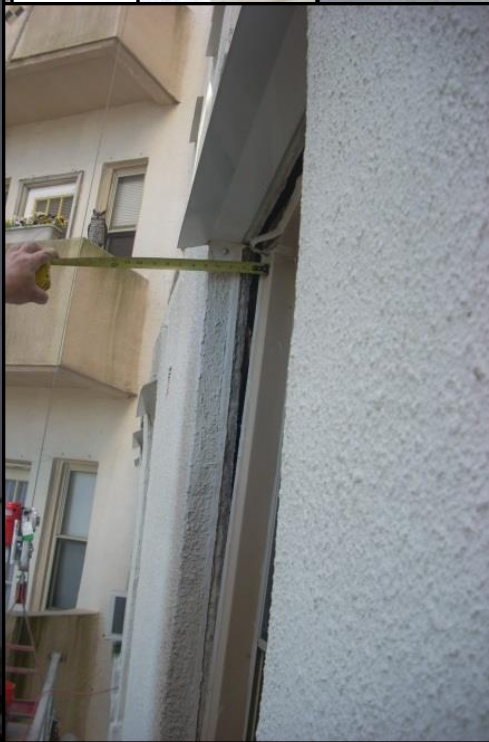
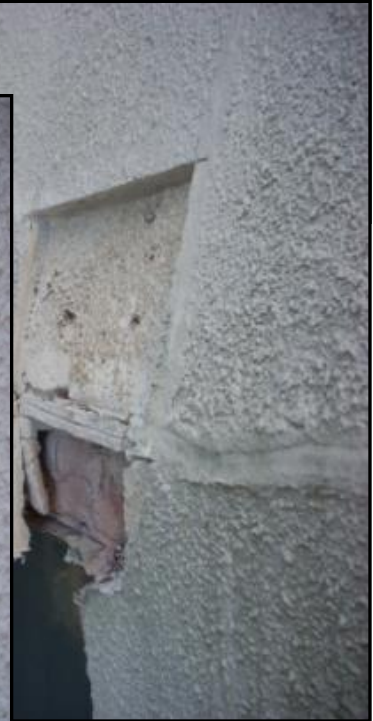
Emergency Repairs Required

- Extensive water intrusion & air drafts
- Extensive stucco cracking above windows
- Extensive stucco spalling, delamination and bulging
- Open vertical cracking at building corners
- Discoloration

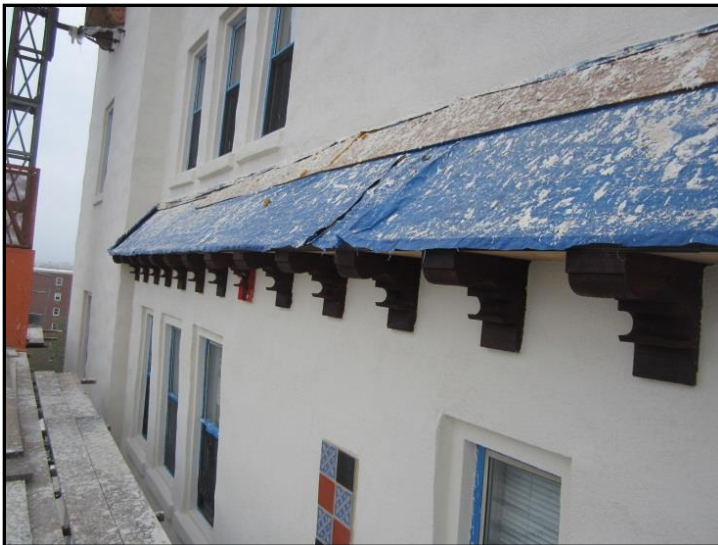
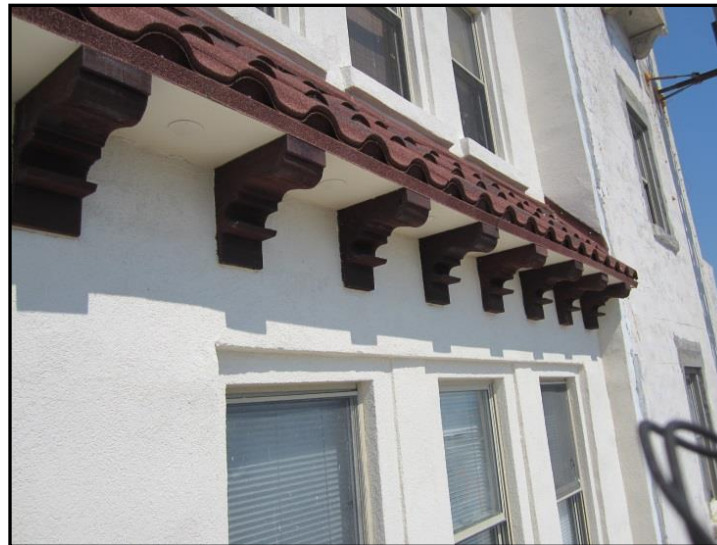
TRUSS AT CORBEL

Shed Roof Repairs

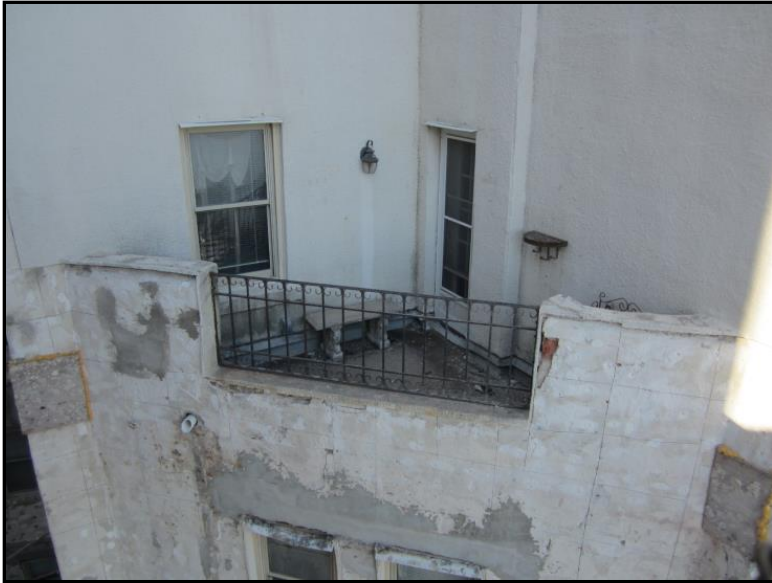
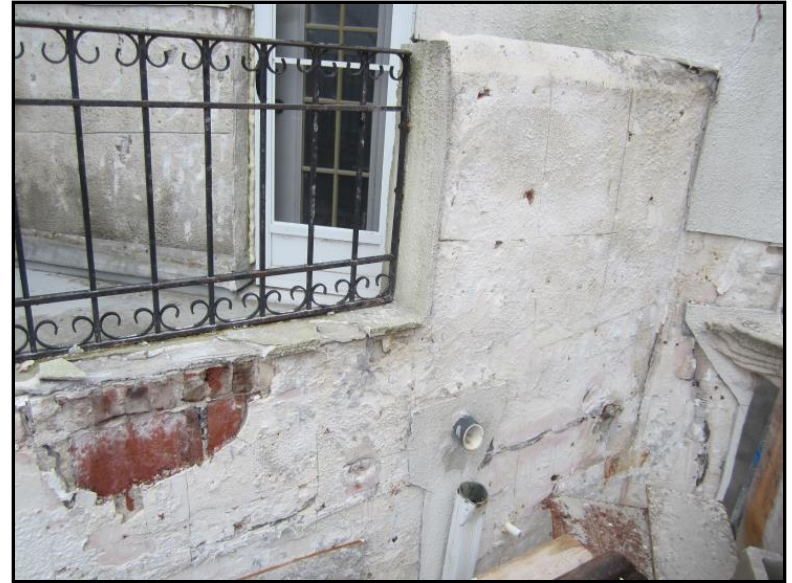
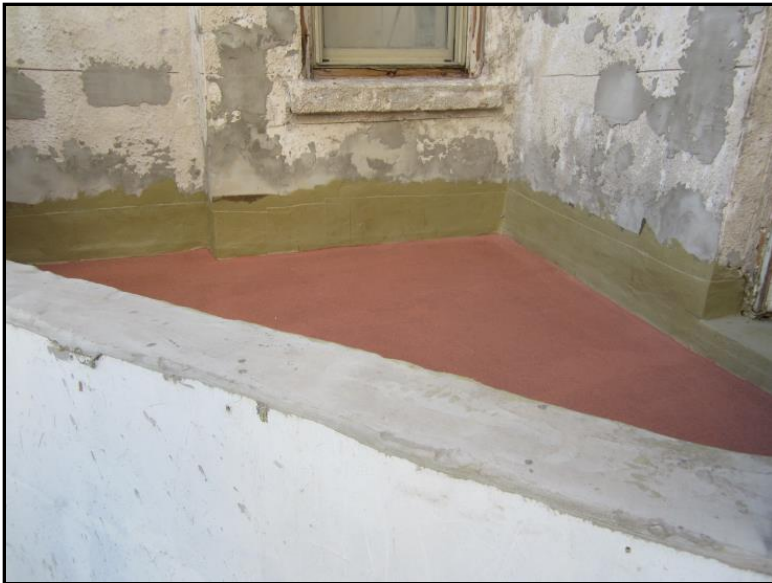
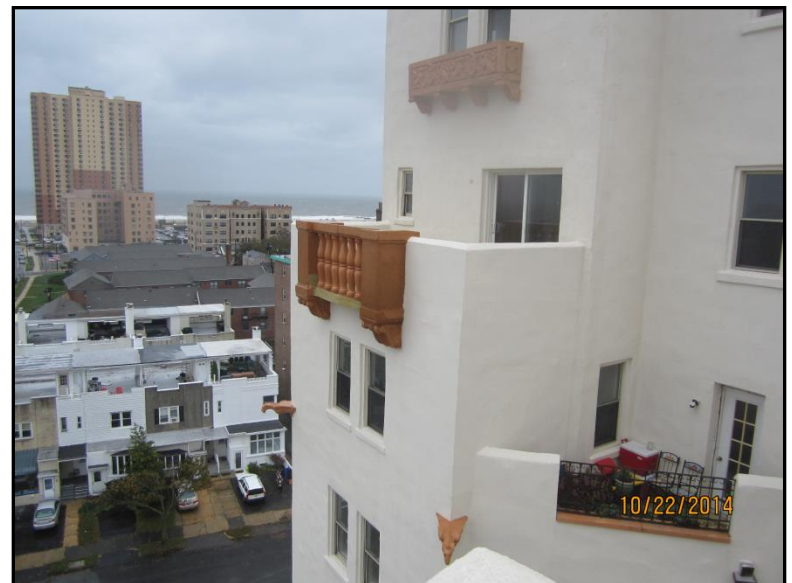
Terrace Waterproofing

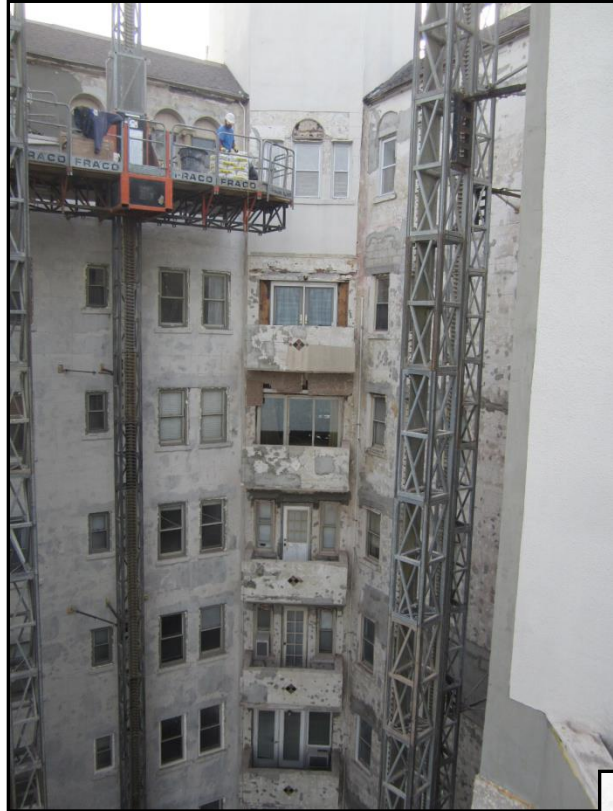
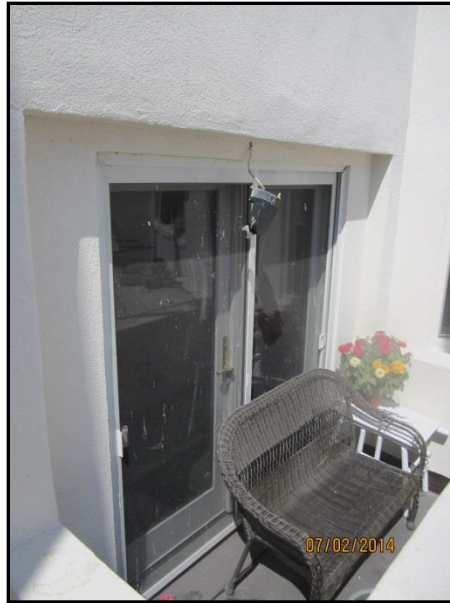
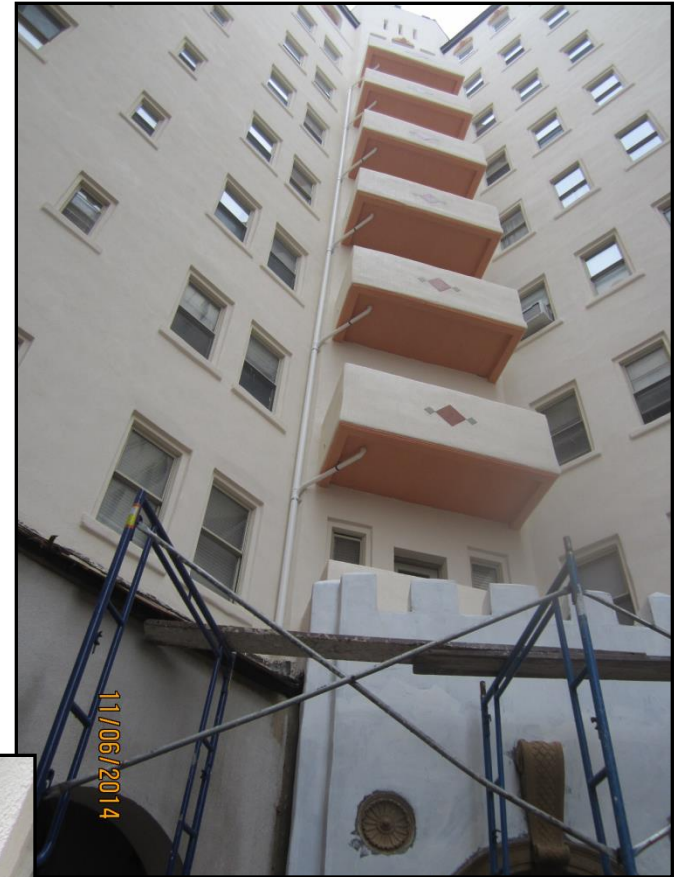
Balcony Restoration

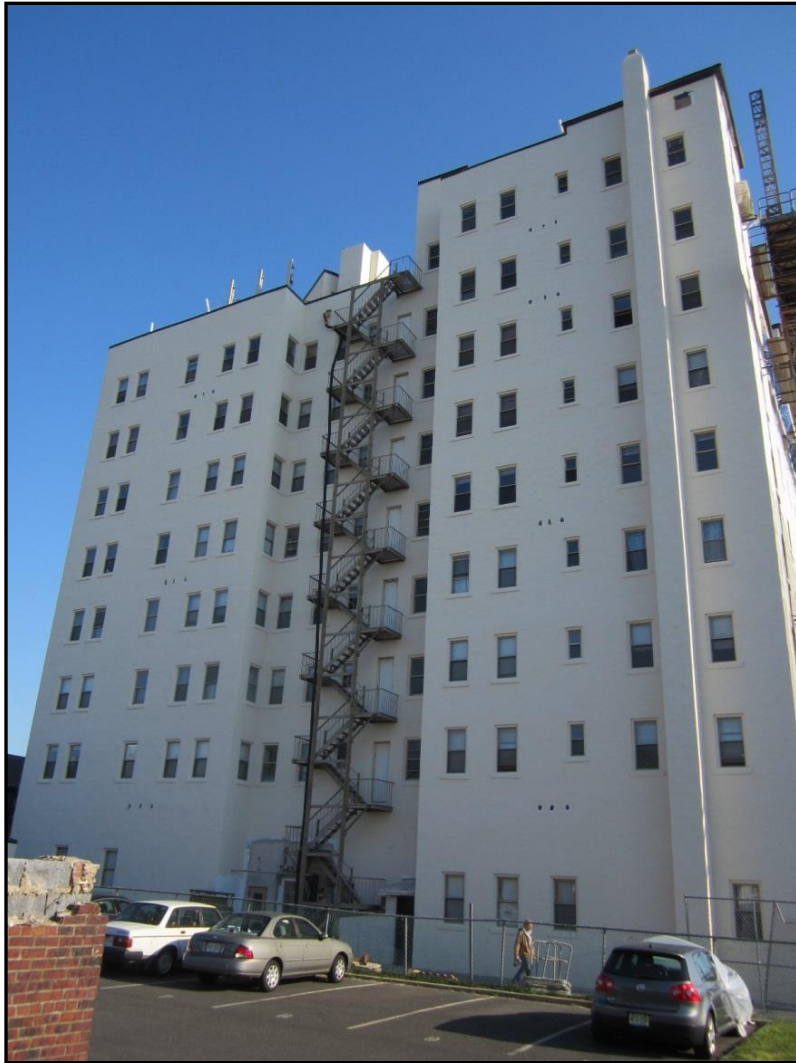
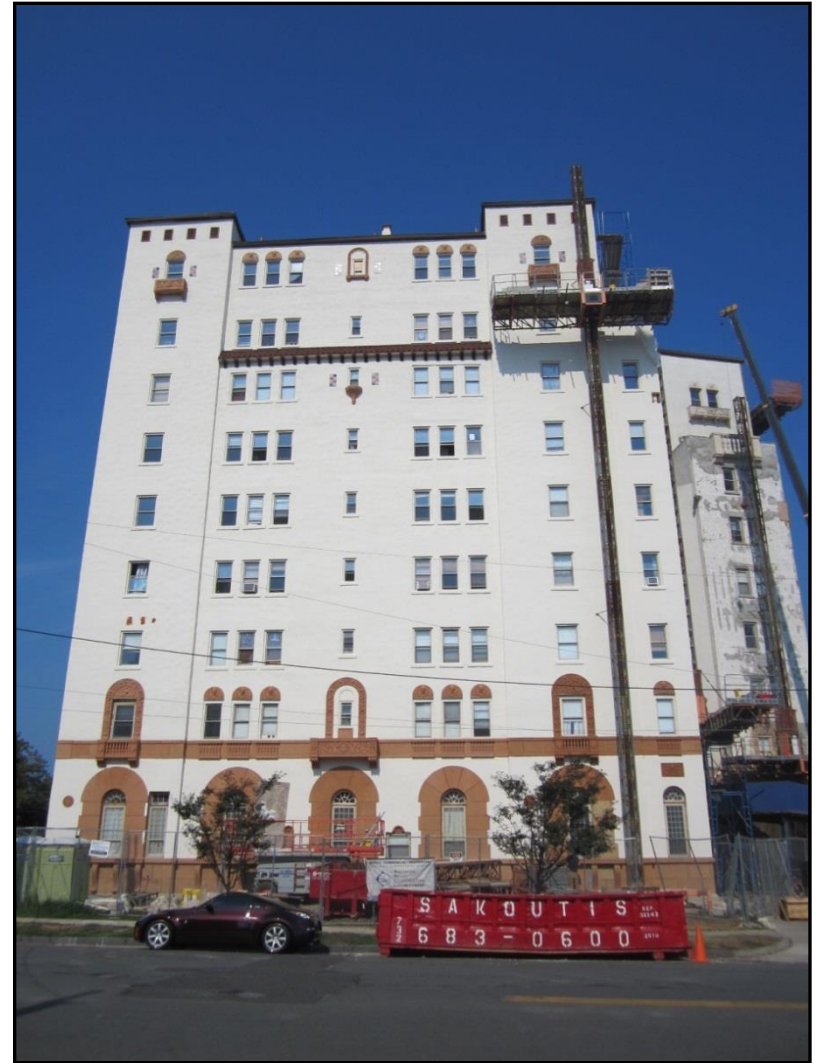
Completed Façade Restoration

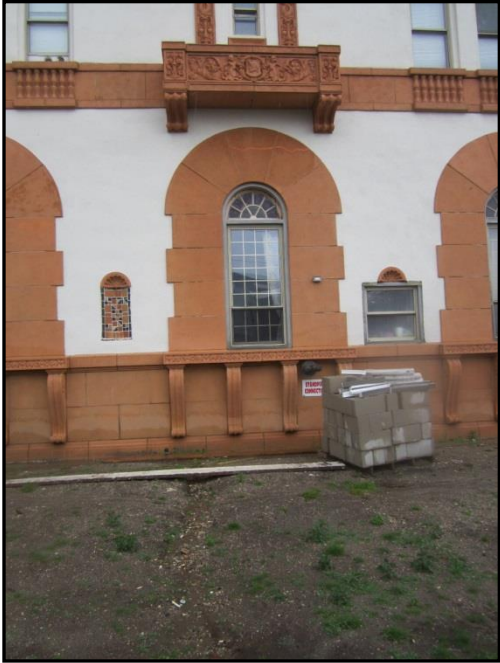
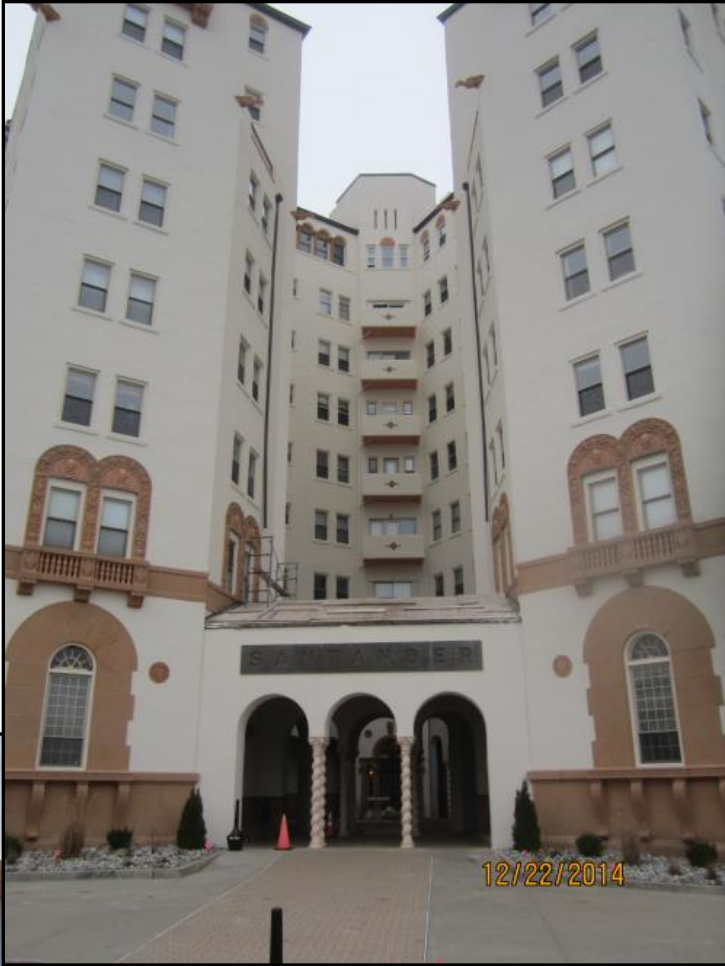
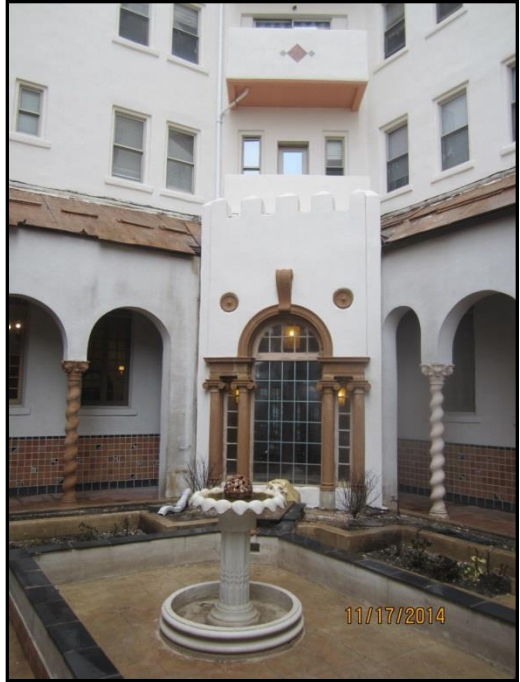
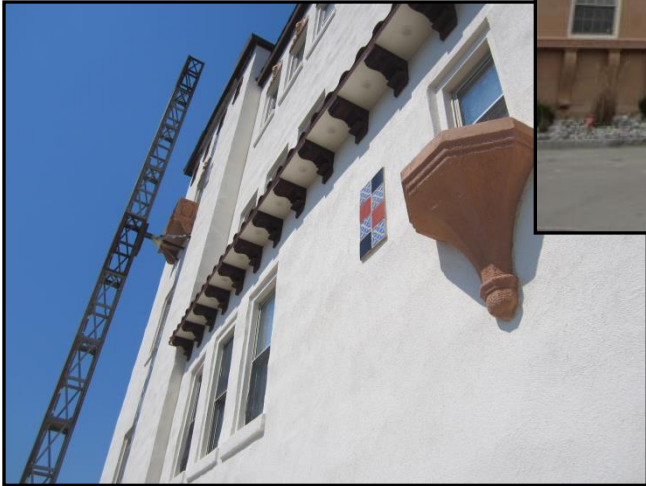
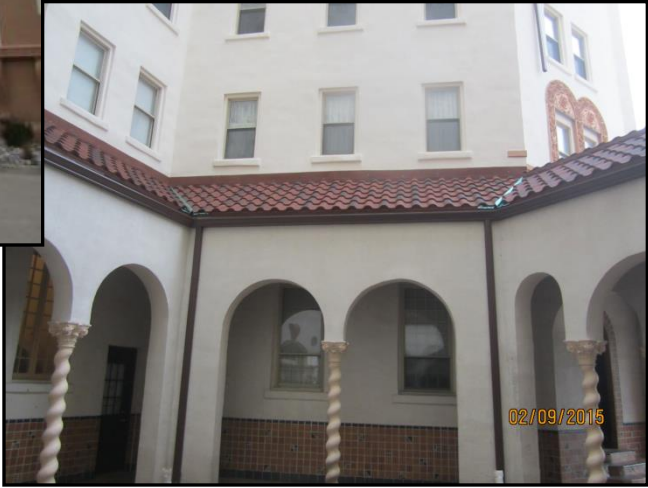
Completed Façade Restoration
