Seismic retrofit of structural elements with FRCM prior to recent earthquakes in Italy: What happened to them?

*Dr. G. Mantegazza
Technical and R. & D. Manager
RUREDIL Spa*

2018 Spring Convention | **seismic**solutions | April 11-13 | San Francisco

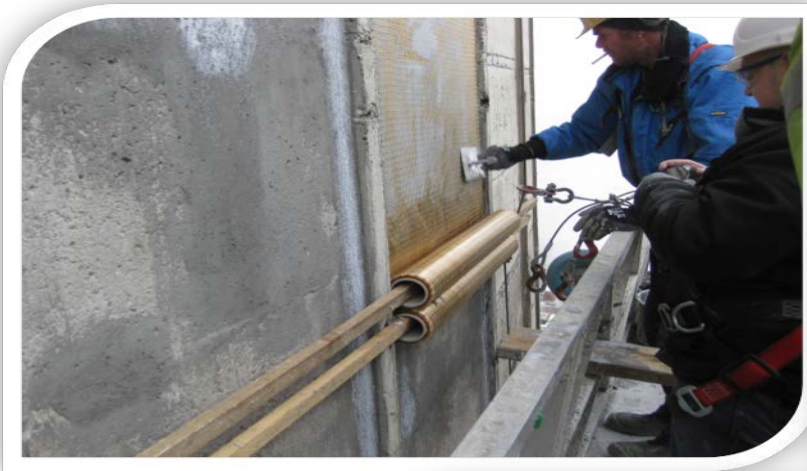
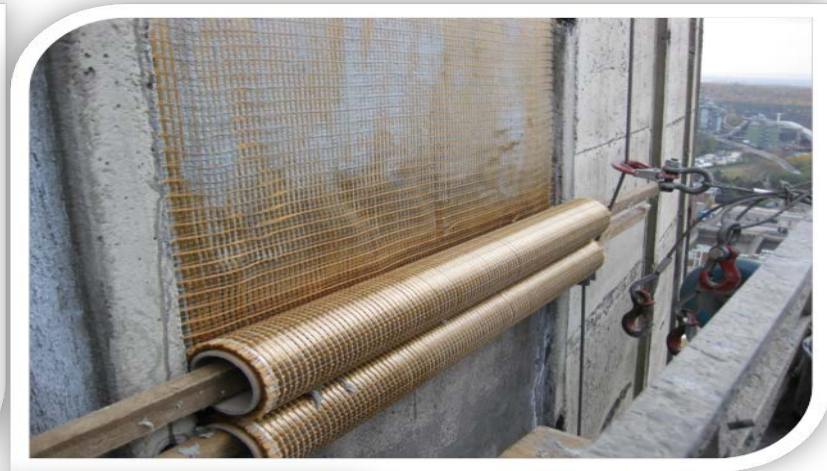
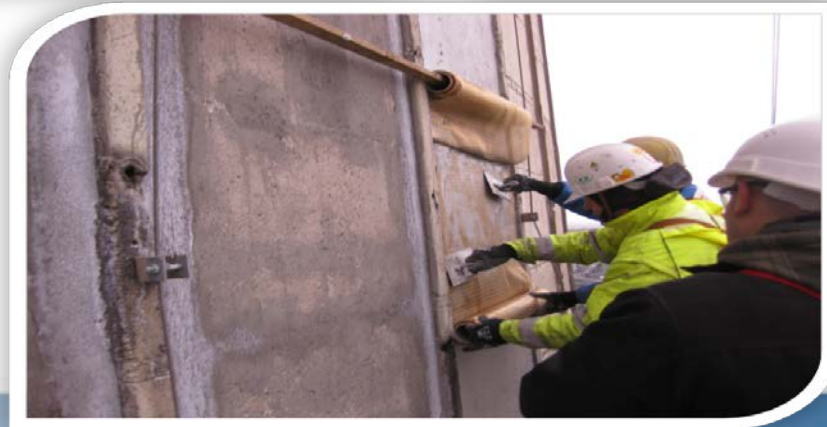
Milan Soccer Stadium- Italy
Beams Shear reinforcement
of first ring

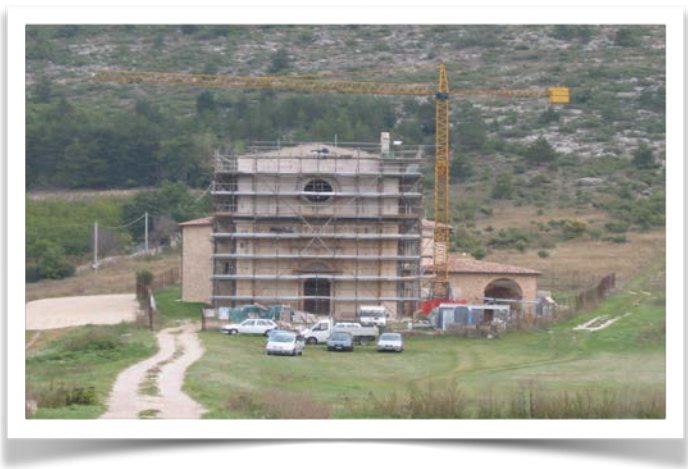
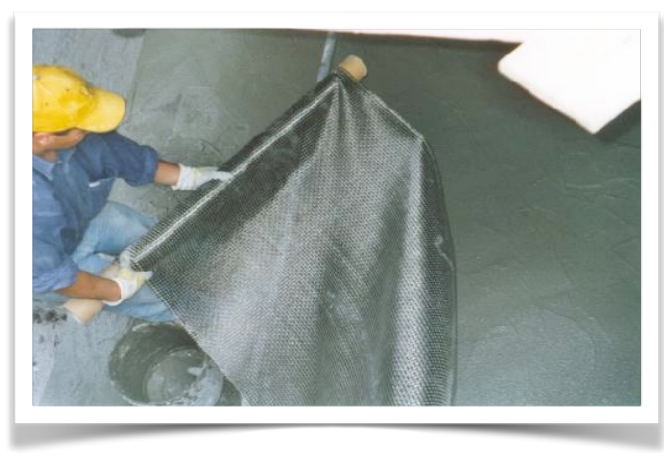
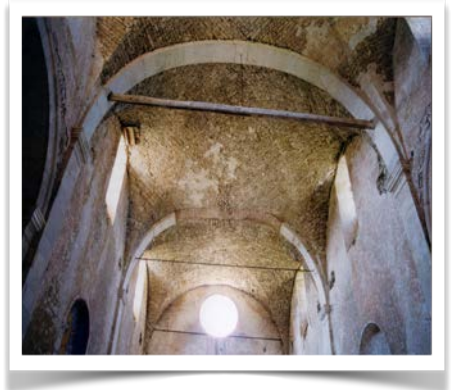
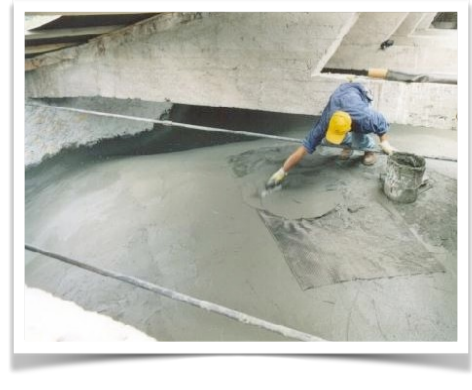
Church of Santa Maria di Centurelli Caporciano (AQ)

**Seismic retrofitting of the
vaults made with FRCM**

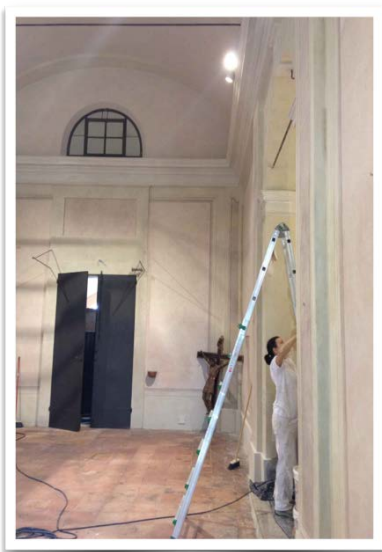
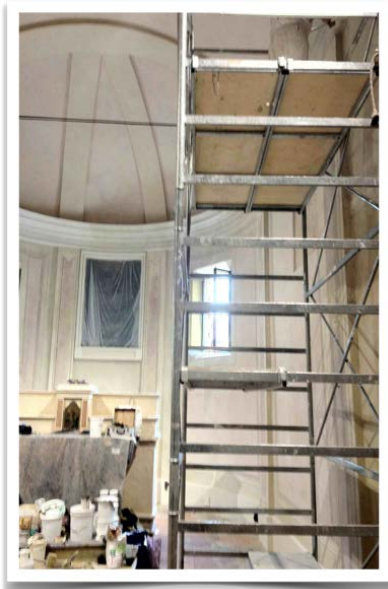
ORATORY CHAPEL ROLO (RE)

**Seismic retrofitting
of the vaults
MADE WITH FRCM
YEAR 2011**

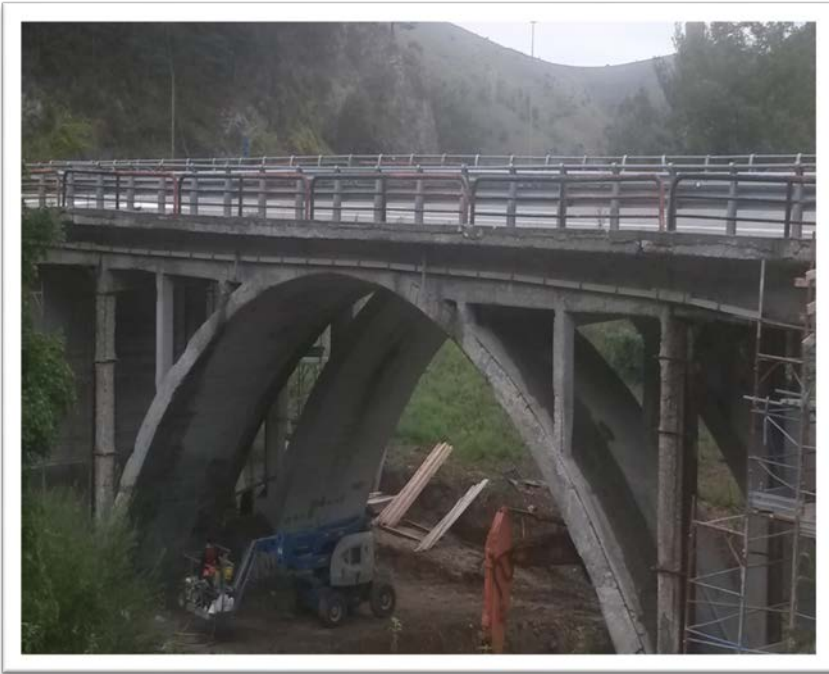
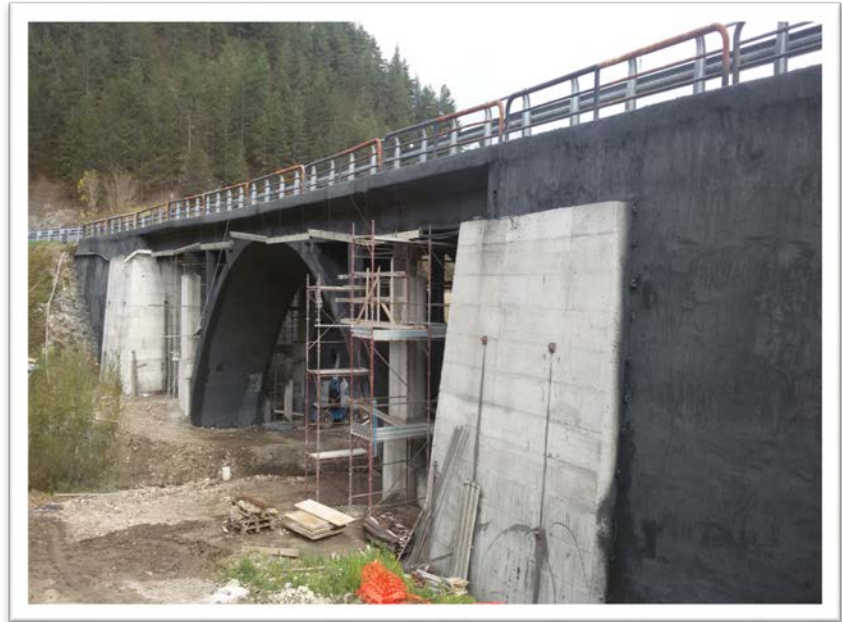
Viaduct 70° mile - Location Posta (Rieti)

Structural Repair with FRCM systems MADE IN 2015

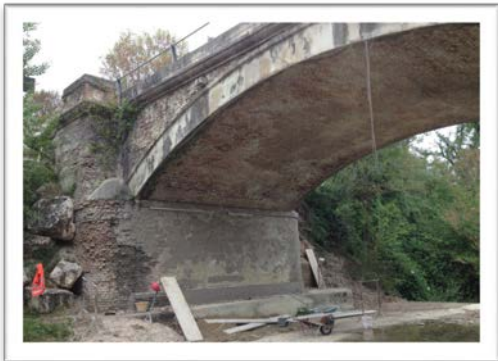
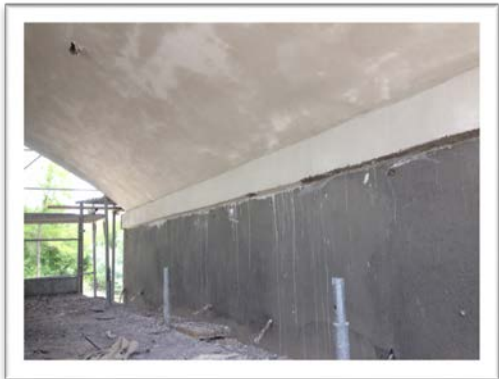
No damage, No cracks or other structural effects coming from the earthquake has been reported by Regional Highway Authority.
